**Poole Barton including  
adjoining wall to north (NHLE  
1170421), Cheriton Fitzpaine,  
Devon**

**Built Heritage Assessment and  
Impact Statement**

ISCA Report: **R01-0065-2**

**February 2024**

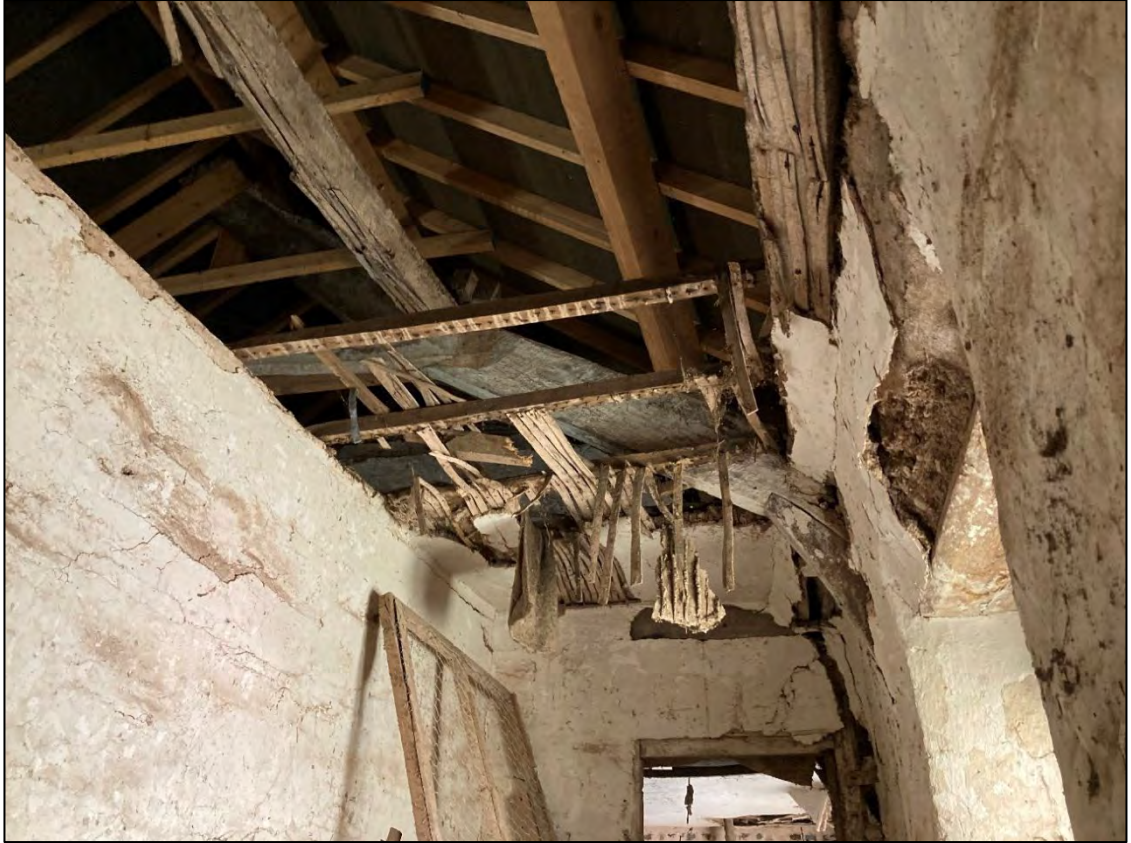
- 6.77. There are two elements to the roof itself. Firstly, the original jointed crucks which appear to need some work in order to preserve for the future, and a 20th century roof timbers suggesting that this part of the block was re-roofed in living memory. A further examination of the jointed crucks within the roof space was not possible owing to safety concerns. However, given the construction techniques within the cruck frame, it is likely that this part of the timbers date to either the late medieval or early post-medieval period (Fig. 44).
- 6.78. Although it was not possible to gain access, the listing information attests to the crucks in the southern part of the building being smoke blackened.

**Figure 44:** Roof structure of the southern block. The jointed cruck frame is overlain by a 20th century re-roofing.

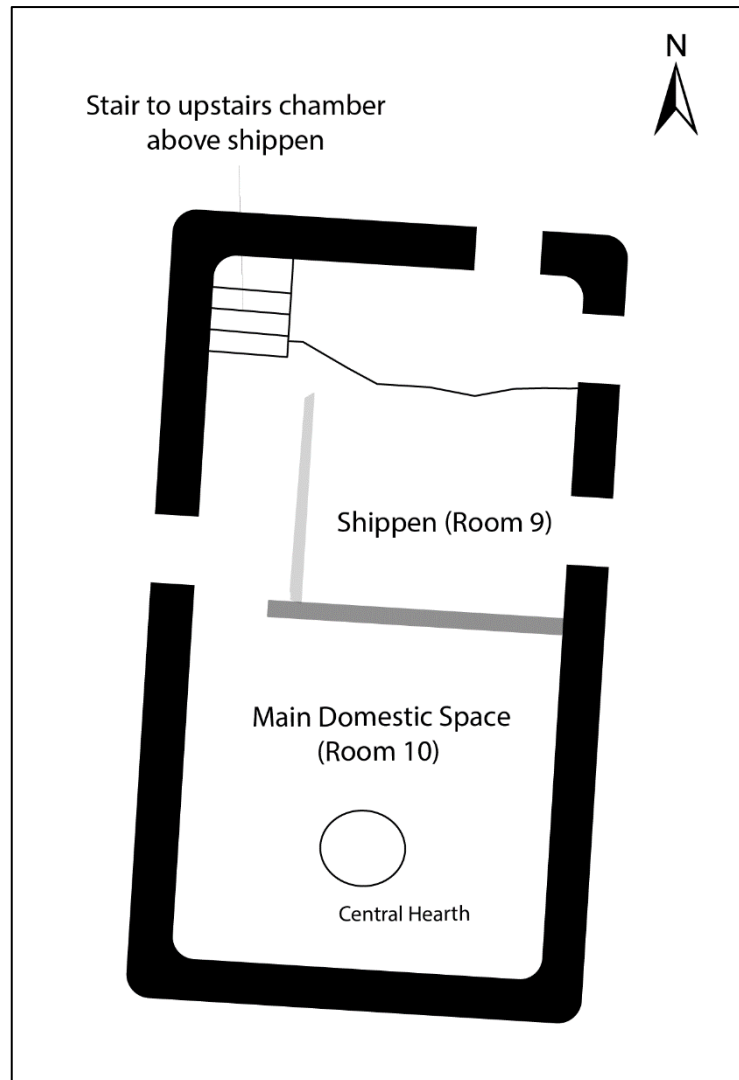
- 6.80. The earliest phase of the building likely relates to its use as a shippon building that served the main hall house. At this time, it would have consisted of a two-room ground floor plan, likely with living space located above Room 9. At this time, the building was likely served by a central hearth. At this time the building was likely hip-ended and the southern stone gable end with the large stone chimney stack was not present (Fig. 45).

**Figure 45:** Phase 1 rear block – late medieval to early post-medieval use as a possible shippen.

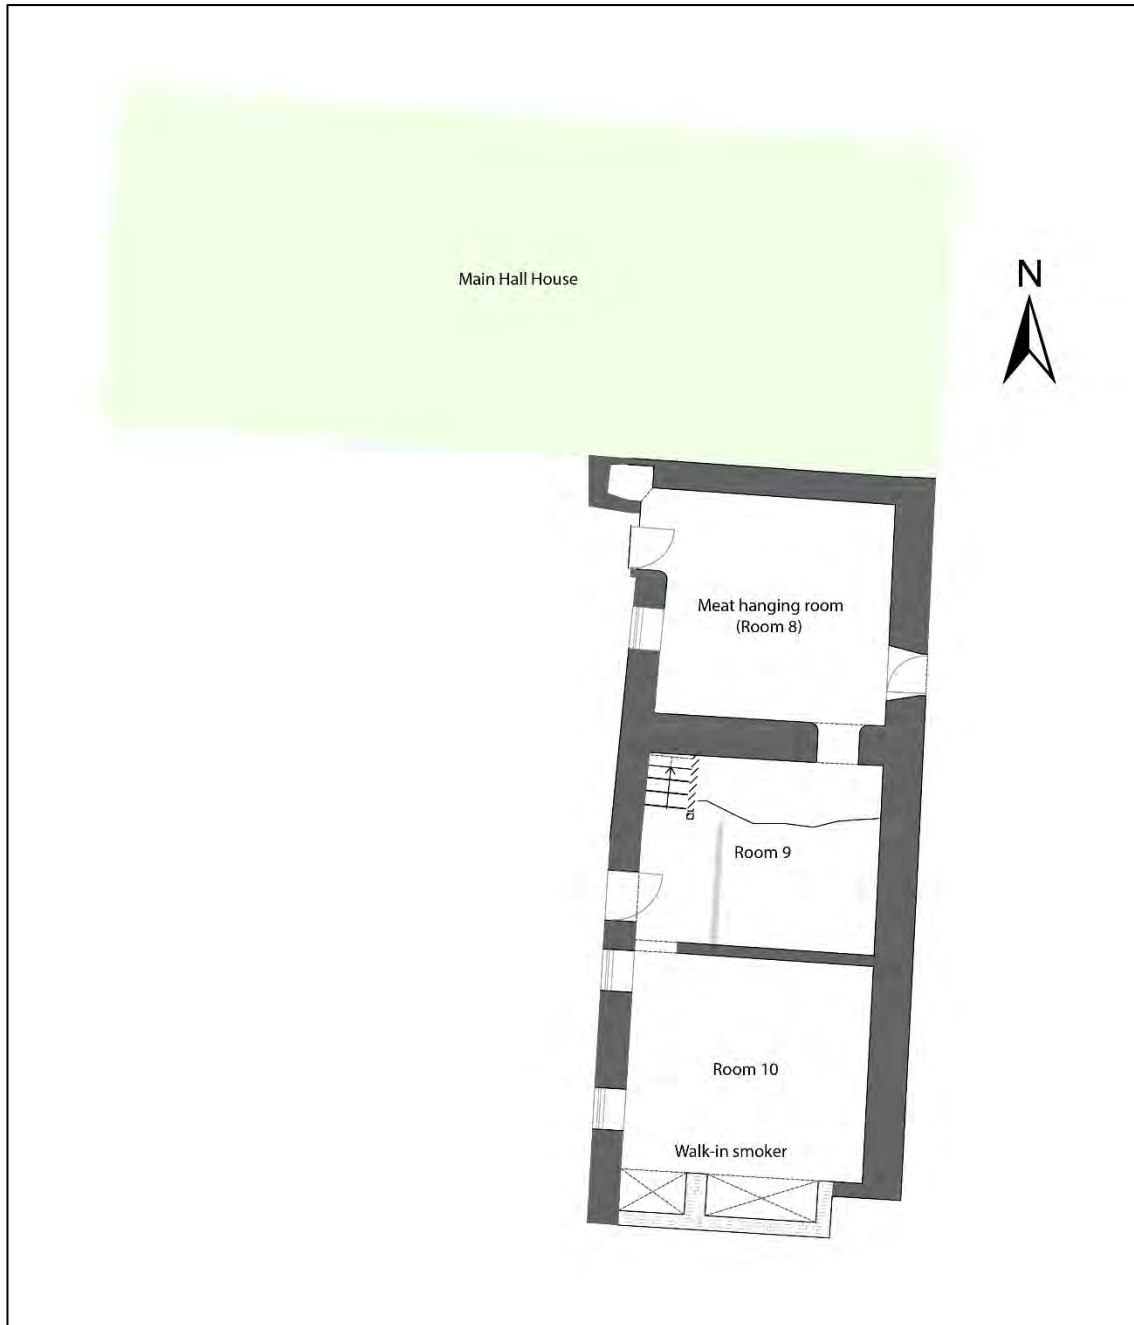
- 6.81. During the 17th century, the block was extended northwards to the main hall house (Fig. 46). The hall house and the southern block were conjoined by a door between Rooms 3 and 8 and the central staircase on the first floor.
- 6.82. The southern end of the building was rebuilt as a gable-end in stone with the addition of a large walk in smoker hearth. Room 8 was fitted with meat hooks from its crossbeams. It is also likely that the first-floor space was installed for use domestically. Further windows were added during this period.

**Figure 46:** Phase 2 rear block – post-medieval use for meat processing and smoker.

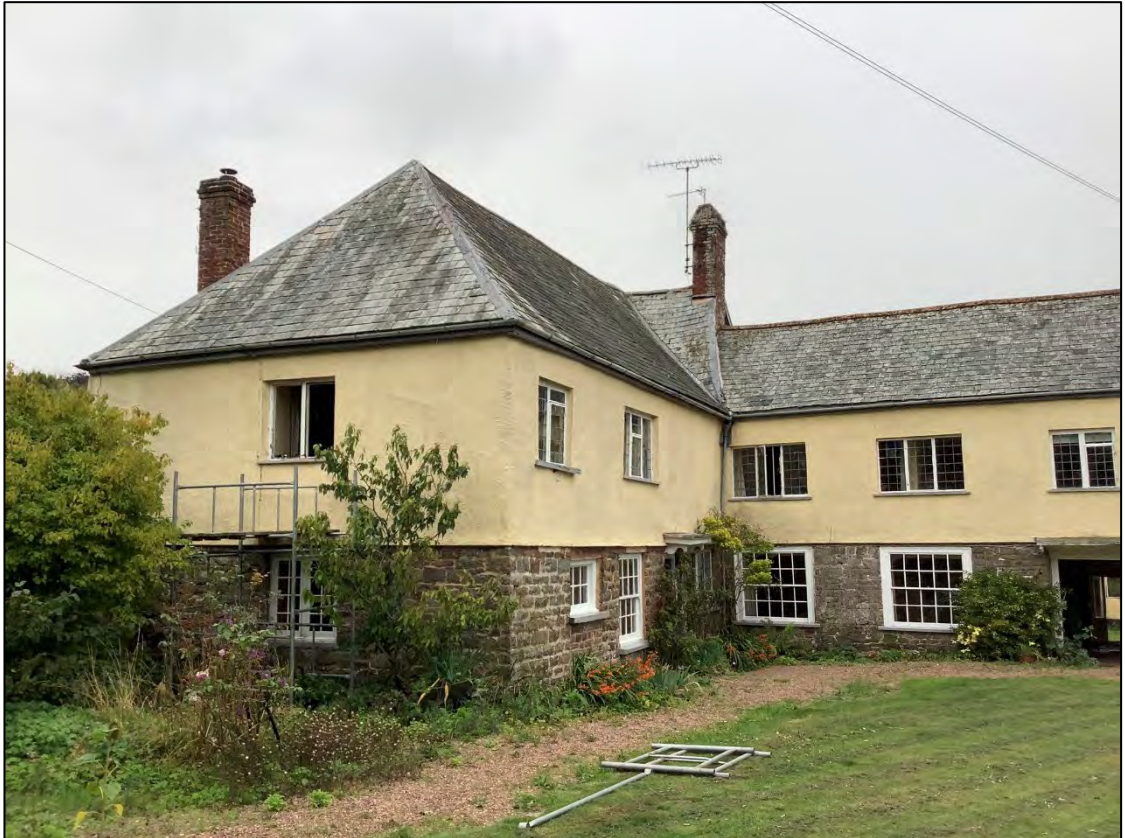
- 6.84. The front consists of a similar cob over volcanic rubble construction. It regains its hip-ended roof in both the southern and northern elevations (Fig. 47). It consists of three late 17th century window openings in its western elevation and a further two windows facing both north and south. Each of these windows retain their original 17th century frames and lead.
- 6.85. A further window opening on the first-floor western elevation has been blocked and a door within the front room (Room 16) has been converted into a window. There are two late 17th century stacks, both along the eastern elevation that have been rebuilt in brick that appear to be of late 18th century date. A conservatory has been built at the southern hip-end of the wing which appear to be of 20th century date.

**Figure 47:** The hip-ended front wing. View to the south east.

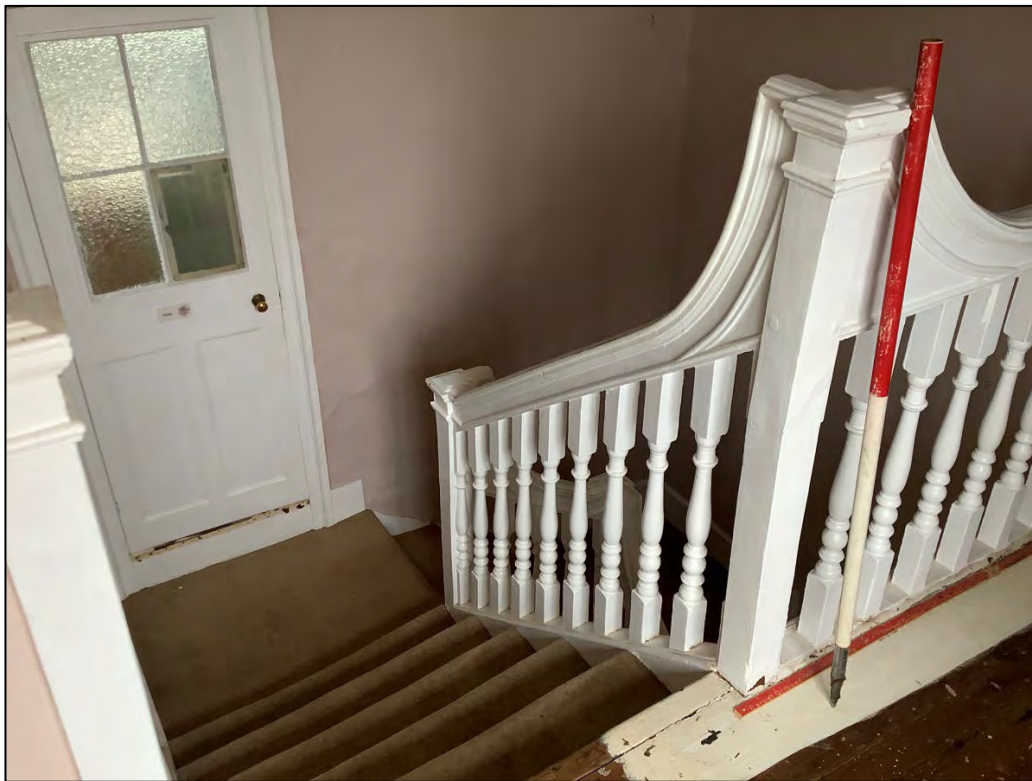
**Figure 48:** The central dog-leg stair.

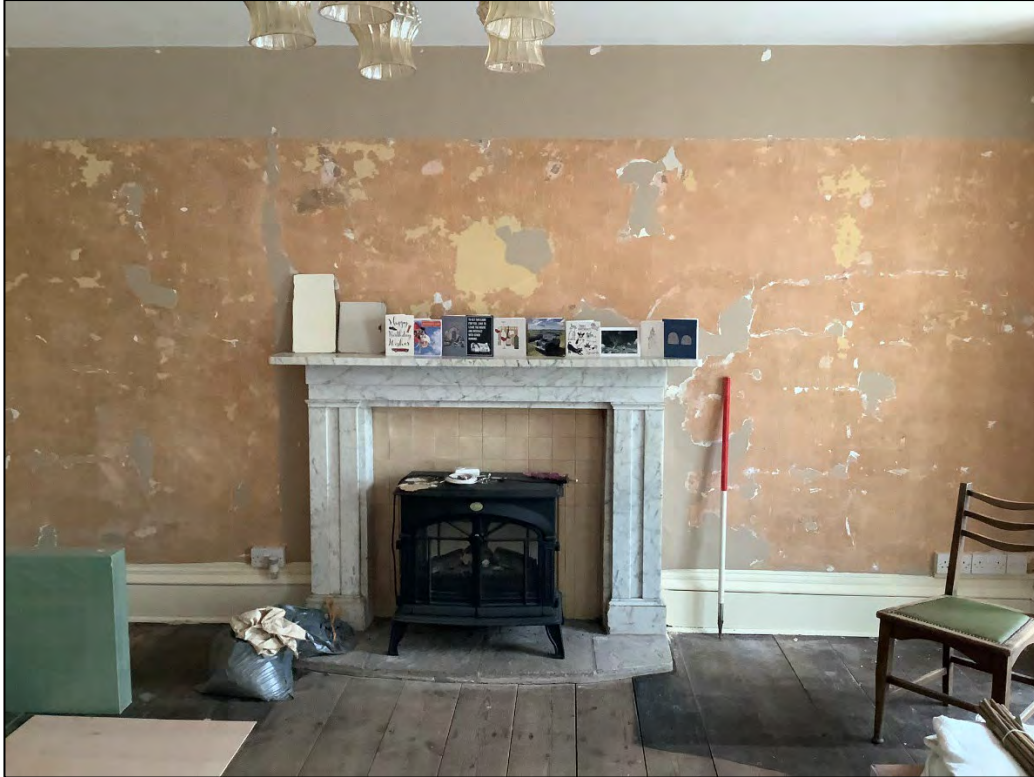
**Figure 49:** The marble fire surround in Room 14.

- 6.88. The rear chamber (Room 17) contains original 17th century features in a large cupboard in the rear chamber with round-headed panelled doors hung on H-hinges with trefoil terminals and a powder room to its south (Fig. 50). Room 14 contains a marble fire surround of high-quality workmanship which may also be an original feature (Fig. 49).

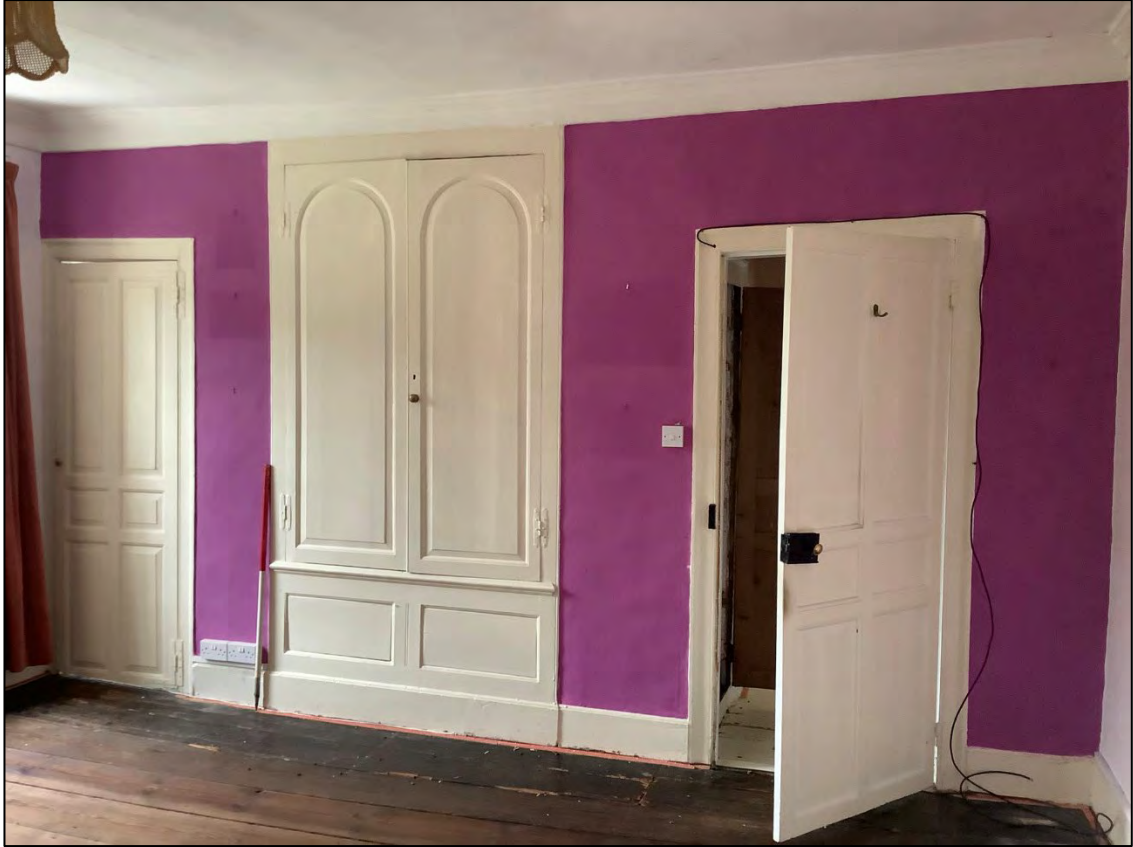
**Figure 50:** Late 17th century cupboard (centre) and power room (left) within Room 17.

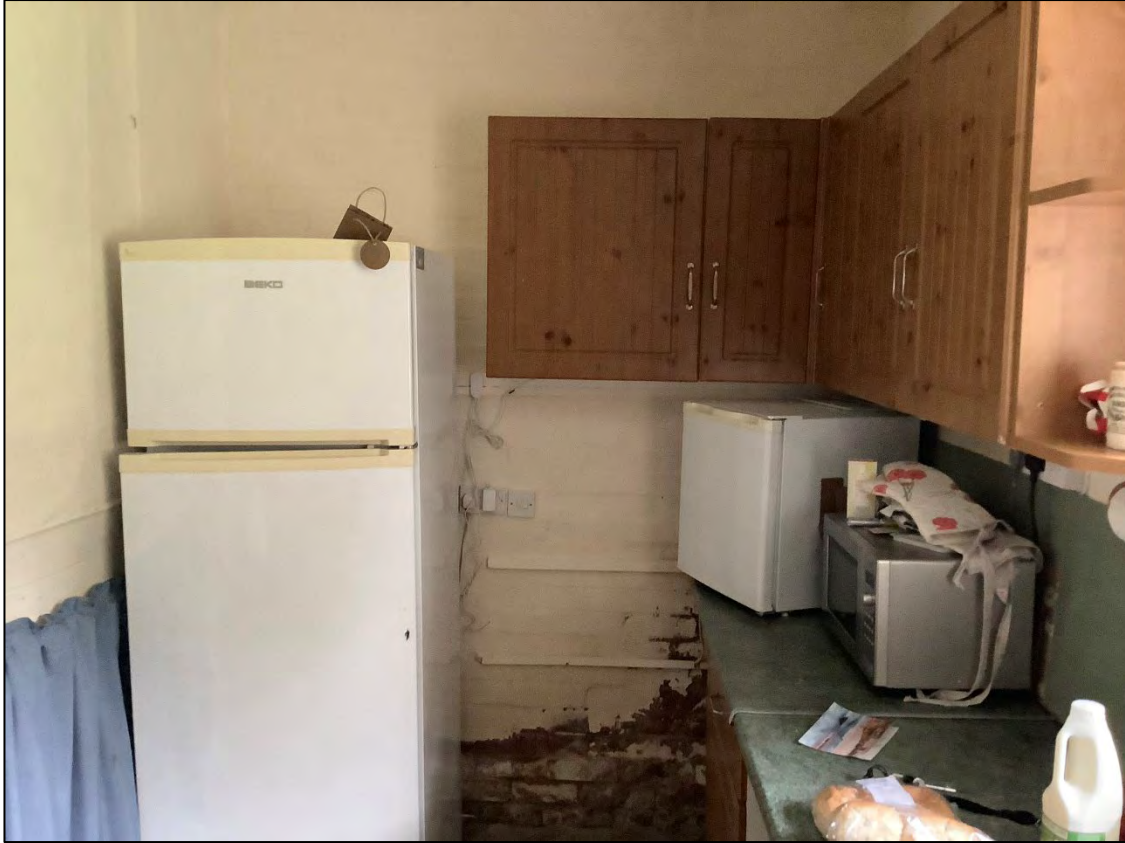
- 6.89. Rooms 15 (what is now the kitchen) and 16 once consisted of one large room which has been participated by an internal brick wall (Figure. 51). This likely operated a grand entrance hall during the late 17th century which focused the main entry of the house away from the hall house to the new northern cross wing.

**Figure 51:** Brick wall between what is now the kitchen (Room 15) and Room 16.

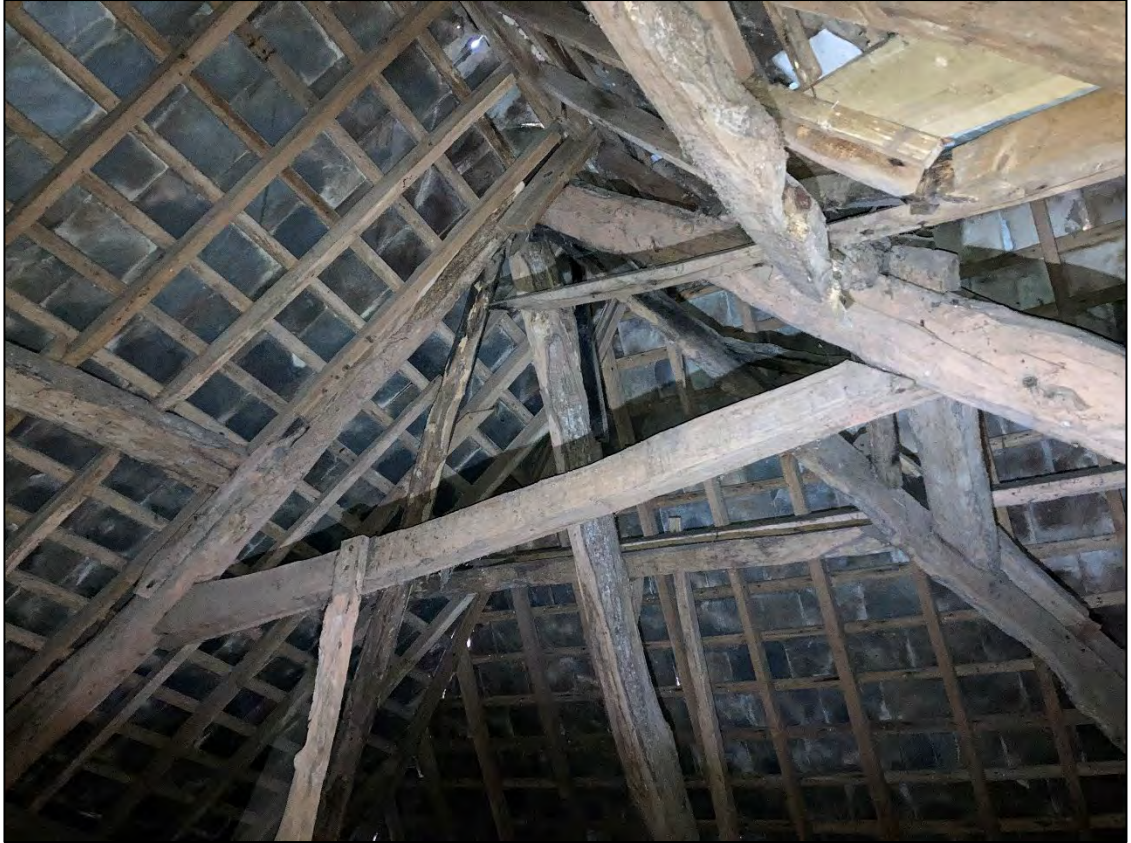
- 6.90. Observation of the roof space demonstrates a standard hip-ended roof with rafters and trusses and collars. It differs from the main hall space and the southern block in that it is not of cruck construction (Fig. 52). The roof also appears to have been subject to various repair works, likely at the same time as when it was converted to slate.

Figure 52: The hip-ended roof of the northern wing.

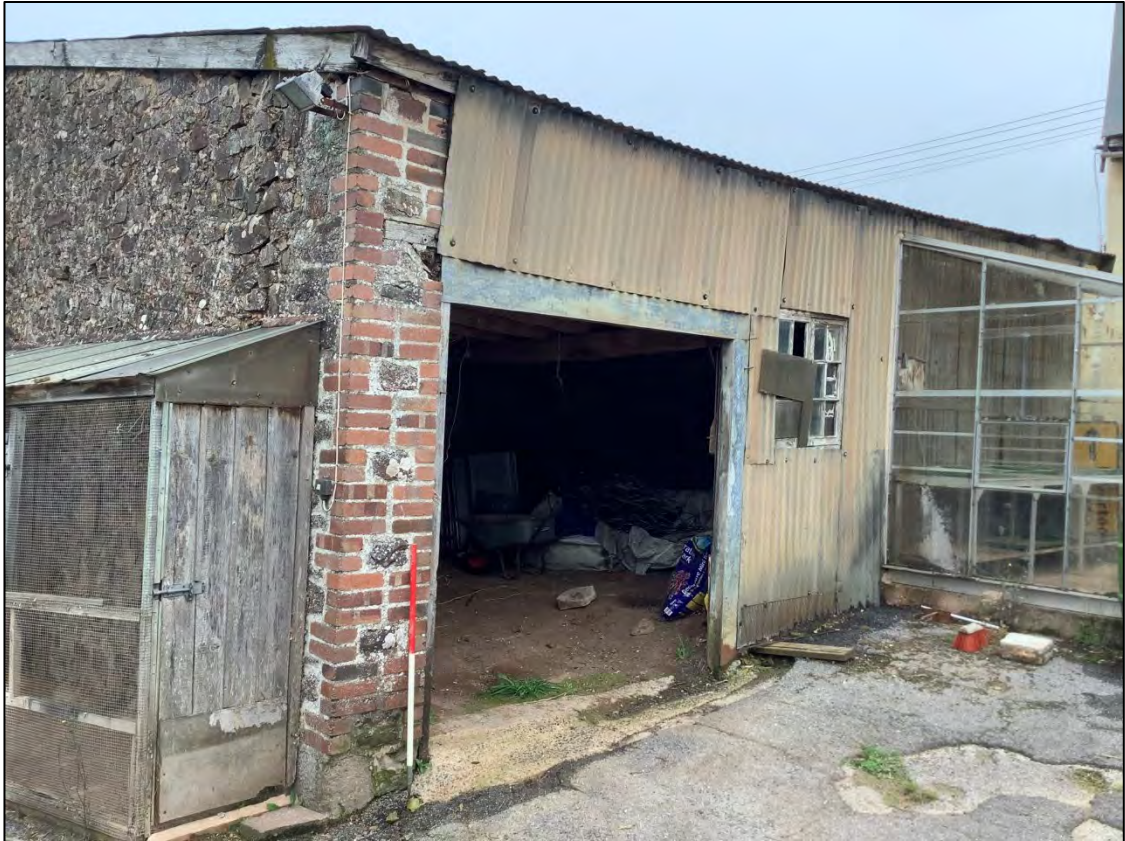
- 6.94. As the barn to the south west of the main hall house is present on the Cheriton Fitzpaine Tithe Map, it is known to be older than 1842 (Fig. 53). The barn consists of a stone rubble construction with an open ground floor and a hay loft above. Although the eastern elevation of the barn has been fabricated with corrugated iron in the 20th century, it was once open to the front. The barn also has a modern corrugated iron roof.

**Figure 53:** Stone Linhay Barn to the south west of the main hall house.

- 6.95. The barn likely originally functioned a small linhay structure in keeping with similar barns within the Cheriton Fitzpaine area. Although its date is not discernible from the site visit, it almost certainly does not predate the post-medieval period owing to lime mortar within its fabric.

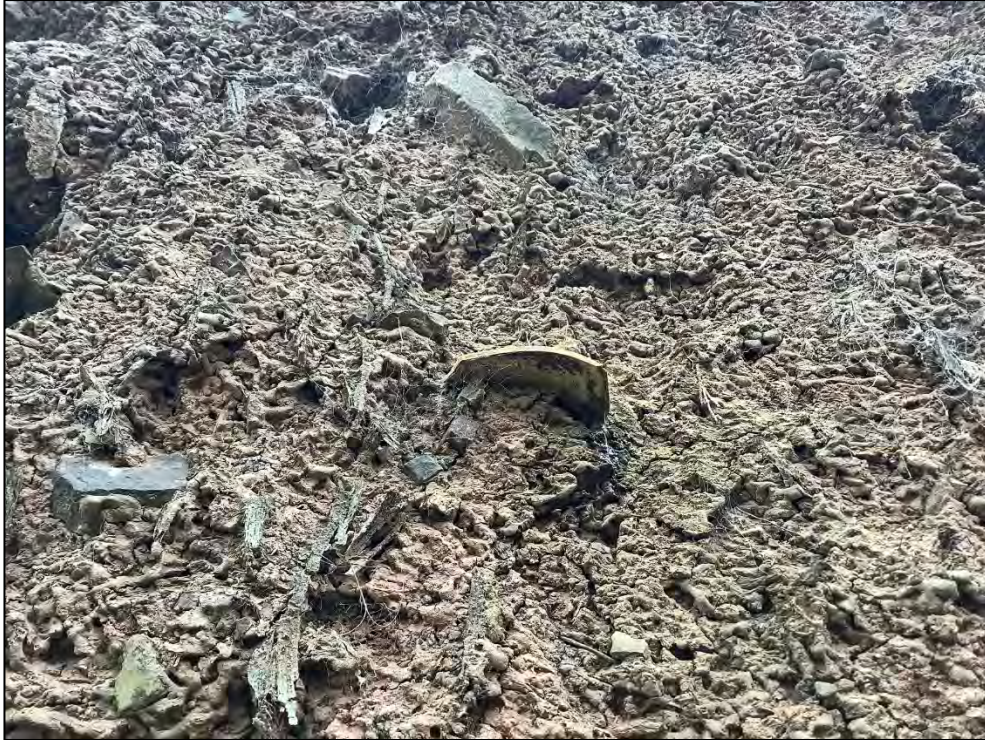
- 6.98. Much of the eastern part of the cob wall remains intact, although the 20th century corrugated iron roof above the stable block offers little in the way of protection to the cob walls fabric (Fig. 54). Subsequently the cob is in a state of erosion. The relative post-medieval date of the cob wall is discernible through observation within its eroded fabric of fragments of china pottery and clay tobacco pipe (Fig. 55). The southern elevation of the cob wall is likely to have functioned as a boundary for a walled garden to the south which was likely to have been laid out in the 18th century.

**Figure 55:** 18th century china pottery within the fabric of the cob wall.

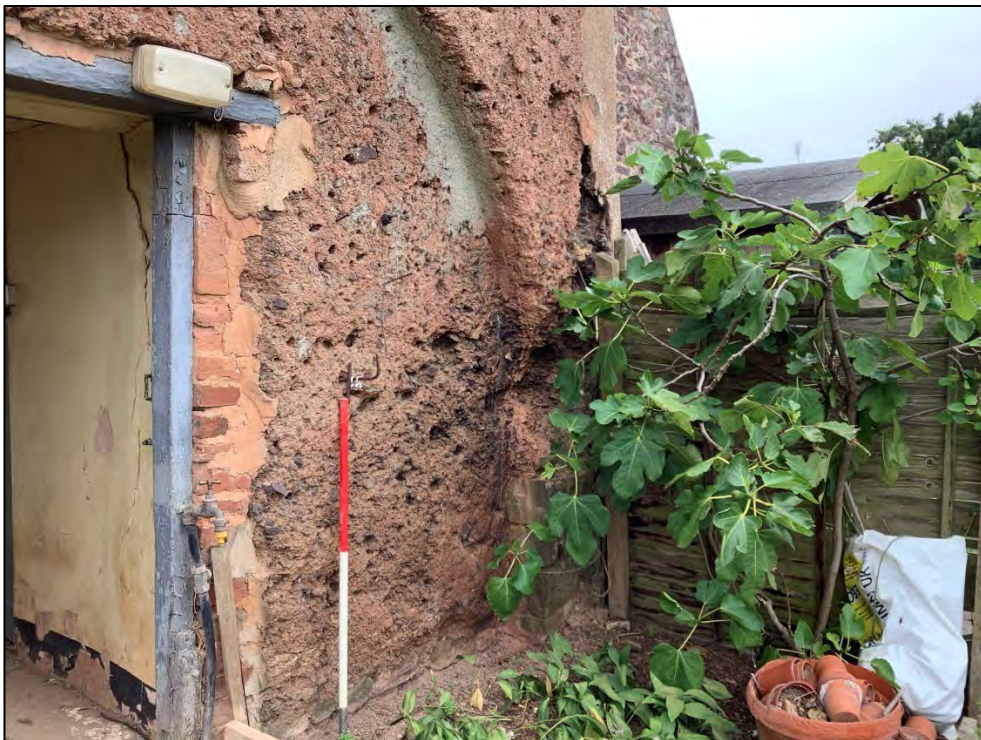
**Figure 56:** The remains of earthen plaster with the cob walls easternmost decorative arch. View to the north east.

- 6.99. The southern elevation of the cob wall contains some interesting architectural features by way of three semi-circular arches cut into the cob. These arches appear to be a decorative feature and in line with the use of the wall as the northern demarcation of a walled 18th century garden. Within the arches, light preservation of the earthen plaster demonstrate that the wall was once fully protected from the elements (Fig. 56). Elsewhere, this plaster has fully eroded.

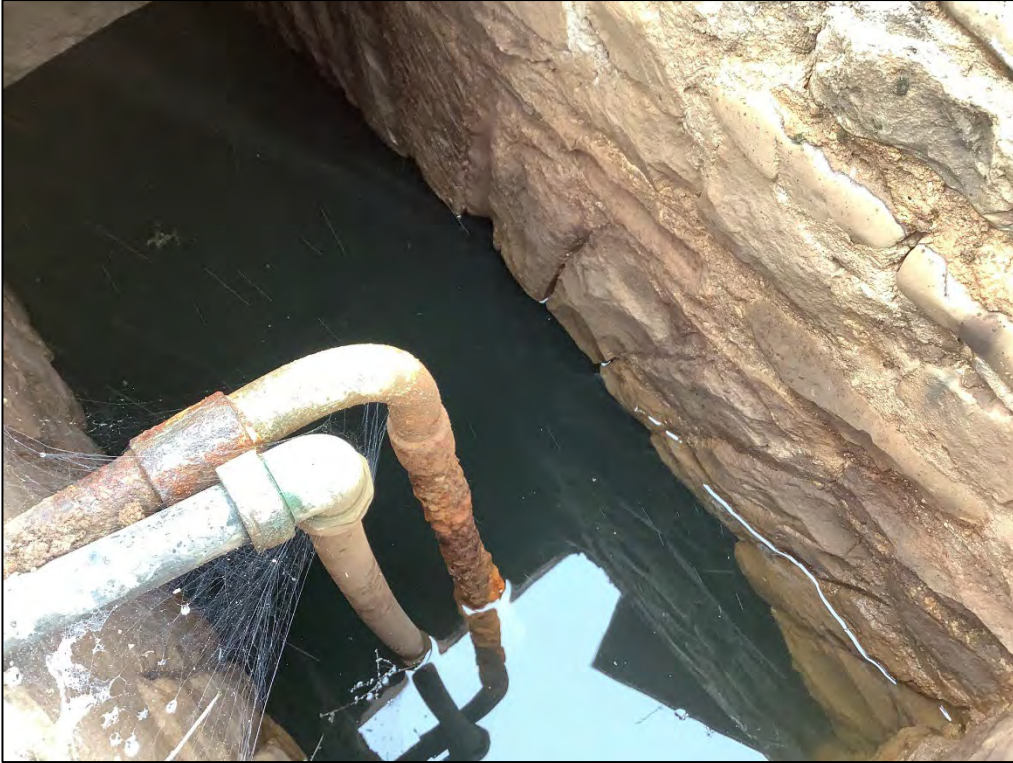
- 6.100. A stone built, arched cistern/well is located beneath the central courtyard (Fig. 57). Although not much can be observed as the tank is still full of water, the arching for the cistern/well demonstrates that it is of stone construction and bonded by lime mortar.
- 6.101. The cistern/well would have provided Poole Barton with water prior to the property being connected to the mains water supply. It is likely to be fed by rainwater and from the leat to the properties south (Fig. 2, 2). Copper plumbing leading into the cistern/well suggest that it was still in use during the mid-20th century. A previous resident of Poole Barton can still remember its utilisation during this period (per-comms).
- 6.102. Owing to the lime mortar within the cistern/well's construction, it is likely that it does not predate the post medieval period.

**Figure 57:** Cistern/well beneath the central courtyard. Its stonework is bonded with lime mortar.

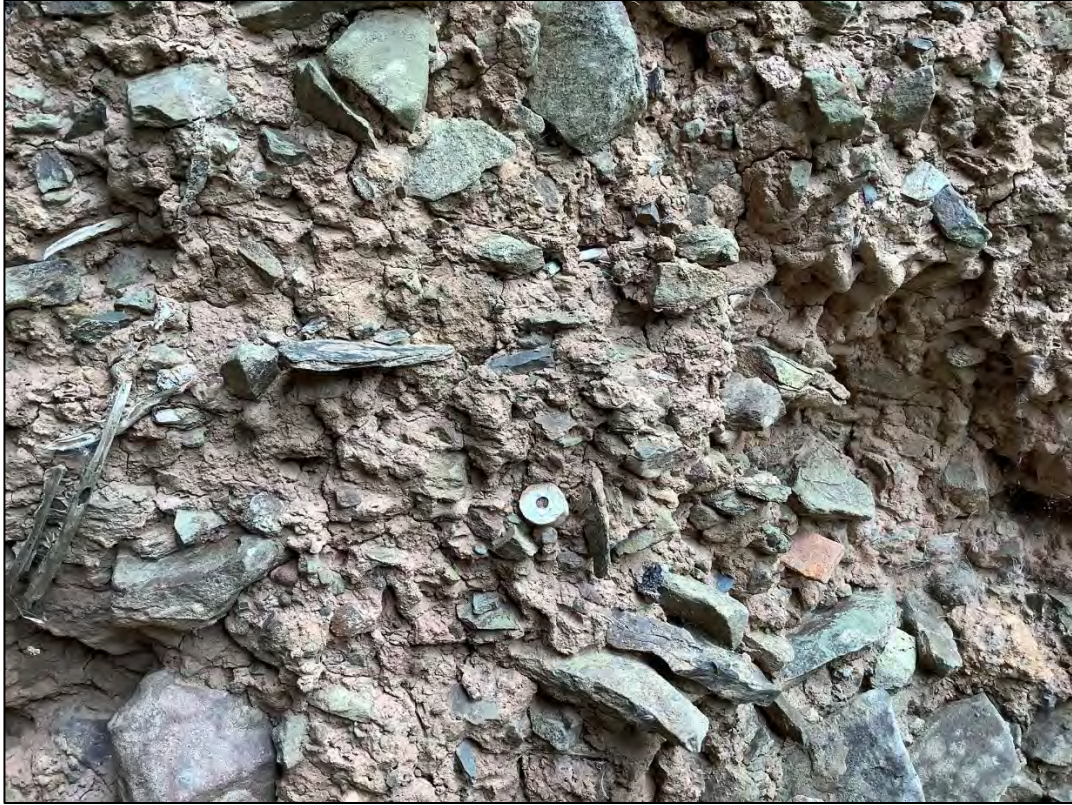
- 6.103. A further section of cob walling is located to the east of the property separating Poole Barton with the property to the east and with the road to the north (Fig. 2, 5; Fig. 58). Similarly, this section of cob on rubble wall dates to the 18th century due to post-medieval glazed pottery and fragments of tobacco pipe within its fabric (Fig. 59).

- 6.104. The fabric of this wall is suffering similar erosion to that of the cob wall to the south of the stable block. It is, however, although being broadly in line with the cob wall to the east, it is not observed to be of different construction to that of the western section of wall. It is therefore likely not to be originally part of the same wall. The eastern wall is protected by a hood of slates; however, these are in a state of disrepair which has resulted in a general erosion of the cob. The cob is no longer protected by what would have been a layer of earthen mortar.

Figure 59: fragments of post-medieval tobacco pipe within the eastern cob walls fabric.

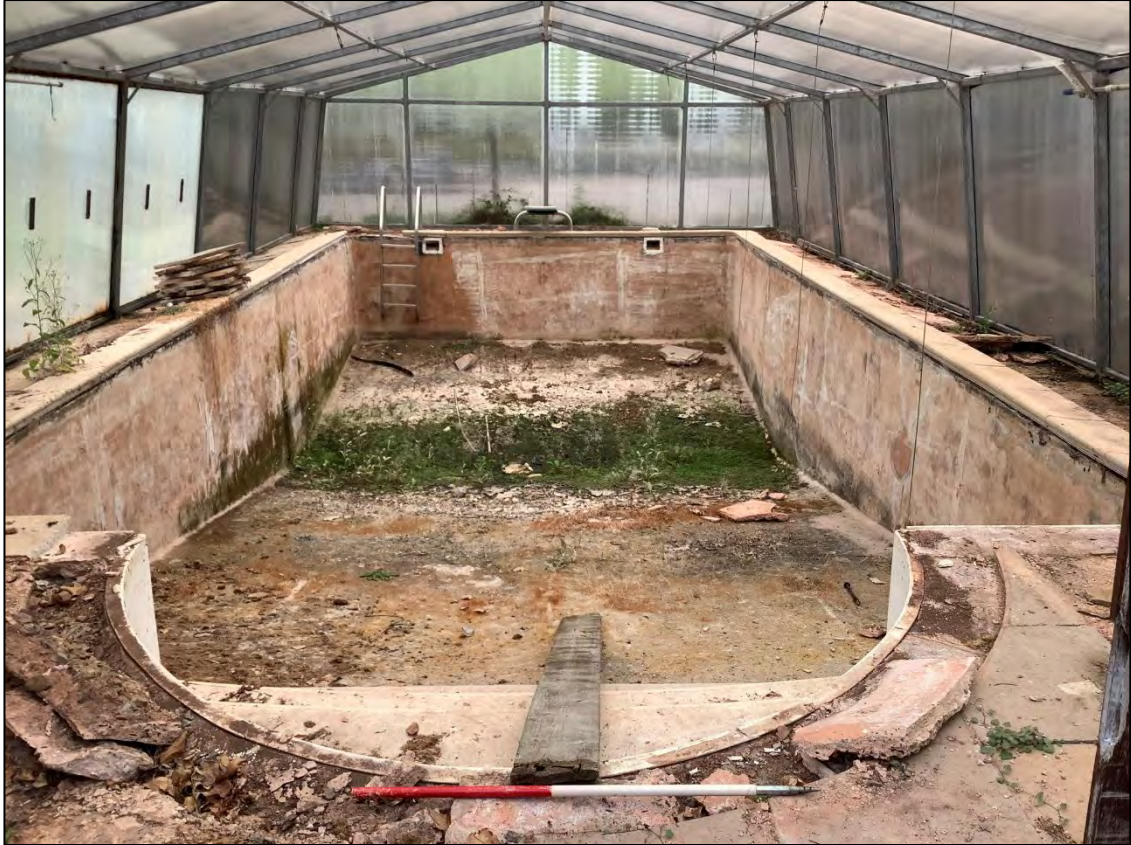
- 6.106. Structures and features that should not be considered as part of Poole Barton's listing include;
- 🌀 A late 20th century swimming pool building not included within the 1962 OS map (Fig. 6; Fig. 60);
  - 🌀 Various 20th century lean-to sheds and a summer houses; and
  - 🌀 A late 20th century tennis court.

Figure 60: Late 20th century swimming pool and associated building. View to the south.

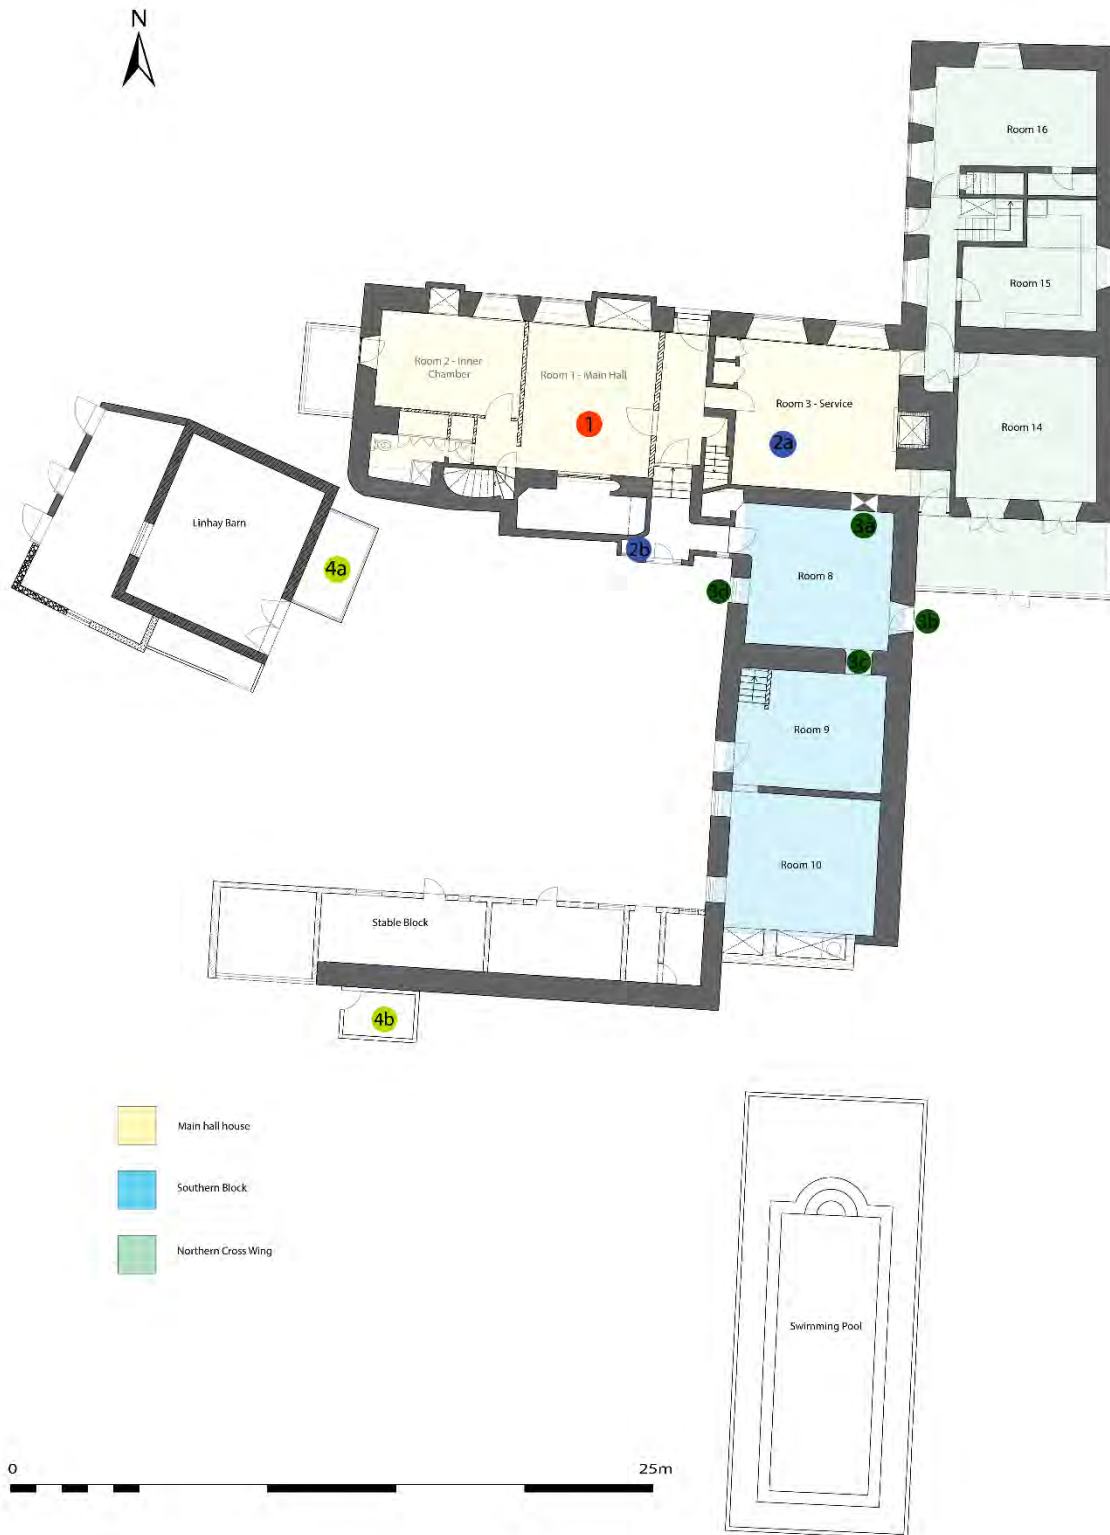
<p><i>Plan No.</i> 61</p>	<p><i>Plan Title</i> Ground Floor: Locations of Phase 1 Proposals</p>

- 9.3. As previously established, this room relates to the former Main Hall. This work is deemed necessary as the current concrete floor directly overlays made ground resulting in damp coming through the floor. This has resulted in damp being transferred to the oak plank-and-muntin screens in this location. As these oak plank-and-muntin screens are imbued with a high degree of heritage significance, preservation of these features is paramount. Without the replacement of the concrete floor with an underlying layer of DPM plastic and insulation, the preservation of these features is under threat.

- 9.6. The modern concrete flooring is out of keeping with the original flagstone floor of the Main Hall House. Furthermore, as damp is being transferred through the concrete floor, this has resulted in potential damage to the walls and the oak plank-and-muntin screens within Room 1. The concrete flooring, as well as the fact that it has been laid directly atop made ground with no waterproofing or insulating layer, is therefore seen as a detriment to the overall heritage significance of the property.

- 🔗 Replacement of the concrete floor within Room 1 of the Main Hall House (Fig. 61, **1**);
- 🔗 The proposals to change the use of Room 3 to that of a kitchen (Fig. 61, **2a**) including a required upgrade of the drainage system to allow for the flow to an open drain in the back porch (Fig. 61, **2b**);
- 🔗 Internal/external adjustments to Room 8 including the installation of three new doors and a replacement window (Fig. 61, **3a, 3b, 3c** and **3d**); and
- 🔗 Removal of modern lean-to greenhouses external to the property (Fig. 61, **4a** and **4b**).

- 9.5. The proposal is to replace the current concrete flooring with volcanic flagstones sourced from the local Knowle Quarry (Fig. 63). Sizing would be consistent with the historic flagstones *in-situ*.

- 9.12. As this work would result in no impact to the historic fabric of the property, and the drain within the back porch (Fig. 61, **2b**) is entirely modern, these proposals would result in **No Harm** to the heritage significance of the Grade II Listed Poole Barton.
- 9.13. ***Internal/external adjustments to Room 8 including the installation of three new doors and a replacement window (Fig. 61, 3a, 3b, 3c and 3d)***
- 9.14. This part of the proposal features four distinct additions/replacements within Room 8 of the southern block.
- 9.15. The first of these is to reinstate a previous doorway opening between Room 8 and Room 3 (Fig. 61, **3a**). The Heritage Assessment has effectively demonstrated that a doorway once existed between these two rooms which functioned to link the Main Hall House with the southern

- 9.16. The second of these proposals outlines the replacement of the current ledge/brace door along the east of Room 8 with a door of same design but of oak rather than pine (Fig. 61, **3b**). The current door, which includes a polycarbonate windowpane, is likely to be late 19th to 20th century in date and is a replacement of an earlier door set into the external cob wall (Fig. 35). Its reinstatement/replacement in oak is more in keeping with the historic doorways throughout the house and likely to be more in keeping with the original door. The proposal is to use 12mm double glazing within the new door which will provide more insulation and energy efficiency to this part of the house.

- 9.24. The other greenhouse proposed for removal (Fig. 61, **4b**), although not forming part of the curtilage Listing of the property itself, abuts a cob wall proven by historic mapping to be older than that of 1839 Cheriton Fitzpaine Title Map (Fig. 4). However, its careful removal is anticipated to result in minimal impact to the historic fabric of the section of cob wall. Its removal will provide the added benefit of providing an insight into the preservation and structural condition of the section of cob walling that the lean-to greenhouse currently prevents observation of.
