Preliminary Geo-Environmental and Coal Mining Risk Assessment Newark Road, Ollerton Delta-Simons Project Number 87854.545436

# Appendix F- Coal Mining Consultant's Report

# Appendix G – Refurbishment Asbestos Survey Report

Refurbishment
Asbestos Survey Report
of
Building B & Building A - Room F

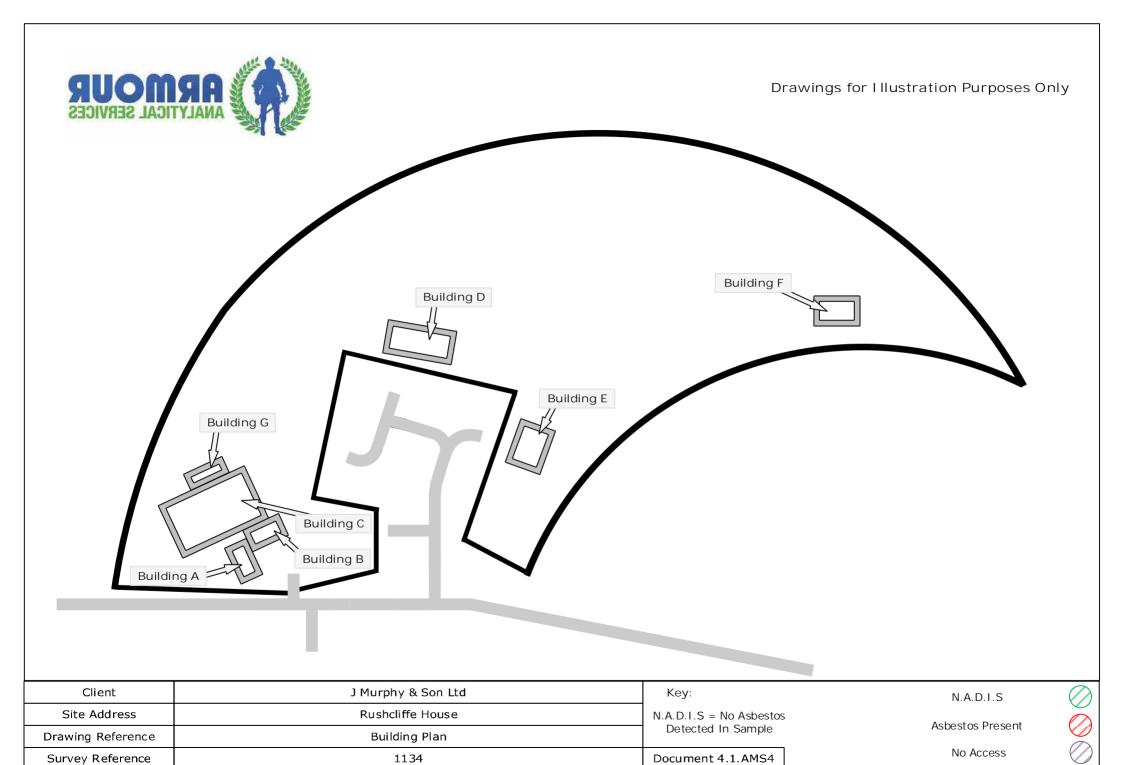
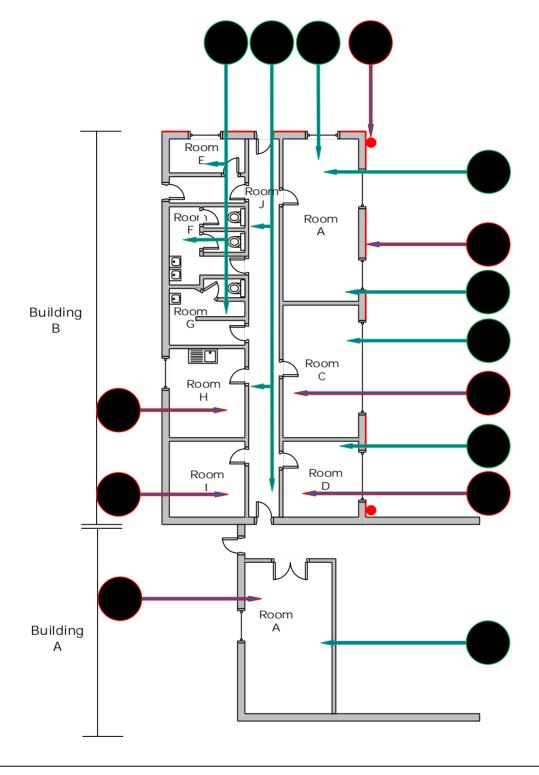
# Appendix II: Site Drawings

B001 = Dust & Debris B007 = Vinyl Floor Tiles B013 = Damp Proof Course B002 = Dust & Debris B008 = Dust & Debris A004 = Wall Sample B003 = Vinyl Floor Tiles B009 = Debris Under Floor A005 = Debris Above Ceiling

B004 = Vinyl Floor Tiles B010 = Vinyl Floor Tiles B005 = Dust & Debris B011 = Downpipes
