Widdington Recycling Road Improvement Scheme

Highways Works Report

REPORT TITLE: Highways Works Report

Hollow Road – Highways Condition Report

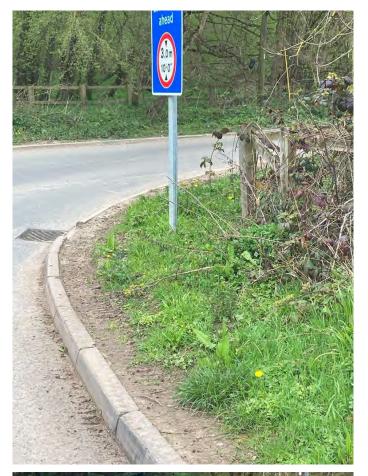
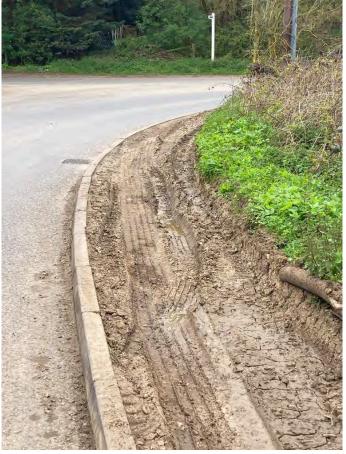
- 5.11 The wearing course is generally in good condition on this section, however there was a significant amount of mud which had been allowed to build up against the verges.
- 5.12 There was evidence of a few cracked kerbs on the southern side of the highway close to the junction.

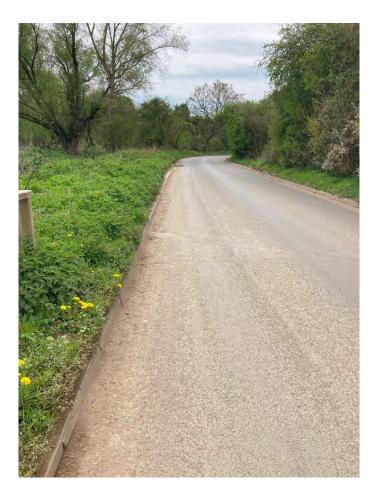
- 5.15 The pothole is approximately 1.0m x 1.5m
- 5.16 Confirmation on the status of the road surfacing:

- 6.3 Repair works to fill these potholes are to be conducted as per the following methodology:
- 6.3.1 Confirm the existing carriageway buildup layers at the repair location by the excavation of a trial hole(s). Using standard details of an existing road type design from the Local Highway Authority agree reconstruction for the different types of repair required, noting that at some locations, it will be prudent to replace the carriageway foundation with concrete.

- → Fill pothole with build-up materials to tie into surrounding carriageway build-up as per agreed (see para 6.3.1 above) details.
- 6.4 Minor resurfacing works will also be required at locations identified in points 5.21 and 5.33 of the Highway Condition Survey.
