Asbestos Management Survey

**99 High Street
Yatton
Bristol
BS49 4DR**

Project Number:	Survey Date:	Issue Date:
N-42284	15 August 2023	23 August 2023

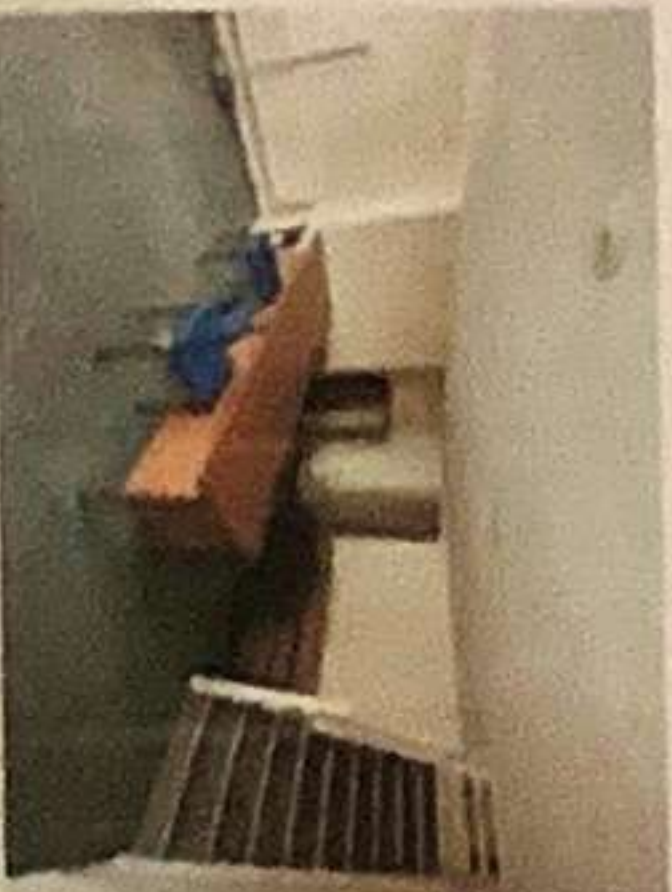
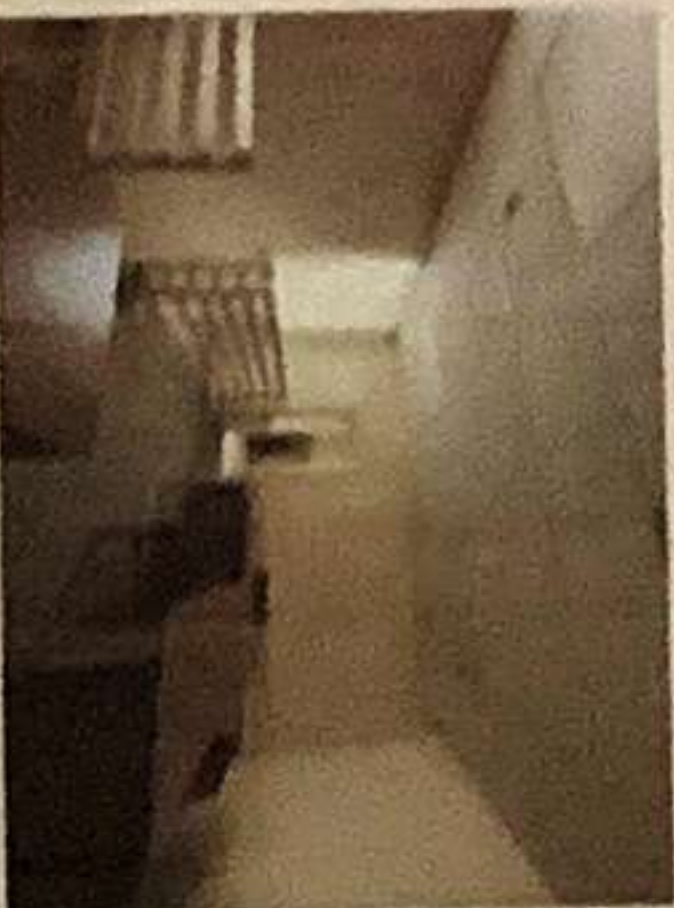
Building: 99 High Street		Photos	
Location:	Construction Overview		
Ground Floor	<p>Floors: The floors comprised of carpet over concrete and timber floorboards, quarry tiles below boiler unit, and modern sheet vinyl.</p> <p>Walls: The walls comprised of plaster finish to masonry, areas of woodchip lining paper, textured coating finish, plaster finish to plasterboard, and areas of modern ceramic tiles.</p> <p>Ceiling: The ceilings comprised of textured coating to plasterboard and lath and plaster, plaster finish to plasterboard, MMMF suspended ceiling tiles within a metal framework, and timber panels to underside stairs.</p> <p>Ceiling Void: The ceiling void comprised of tops MMMF ceiling tiles, textured coating to ceiling above, electric cabling, and metal framework.</p> <p>Other: modern live electrics, wall mounted metal radiators with associated metal pipework, timber doors and frames, uninsulated metal pipework, modern sanitary units, UPVC framed windows and doors, plastic conduit, and modern rubber stair nosing.</p>
