Schedule of Works

Park Farm Braiseworth Lane, Braiseworth, Suffolk, IP23 7HB

Listed building Grade 2

This 17th century farmhouse has suffered neglect through lack of occupation, ransacking and well-meaning but in appropriate past maintenance.

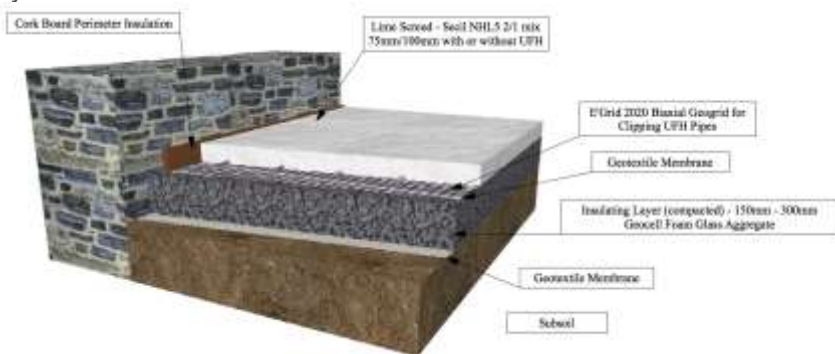
Limecrete floor systems are a modern interpretation of traditional solid floors that are both insulating and effective at managing ground moisture.

Glasscrete floor systems consist of a non-capillary material (GEOCELL Foam Glass) at their base to deal with ground moisture and improve insulation. The latter is particularly important if you are considering the use of underfloor heating systems in your home.

The floor slab is made of natural hydraulic lime (NHL) and appropriate aggregates rather than from cement.

The proposal is to remove the cement floor throughout the ground floor and replace, following build up as shown in the illustration.

The under-floor heating will be laid as shown. The softer more porous nature of lime will mean that should need arise the new handmade clay tiles shall be able to be lifted without damaging individual tiles.

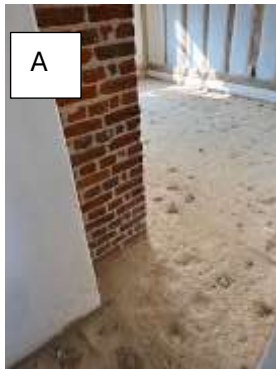
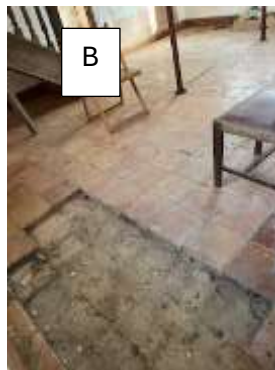
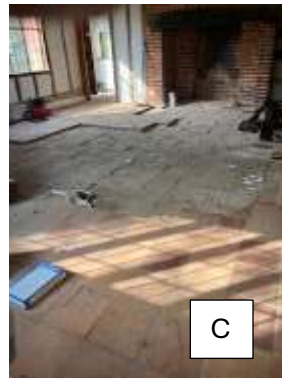
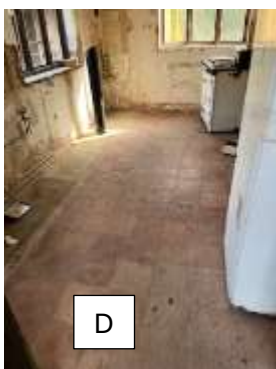
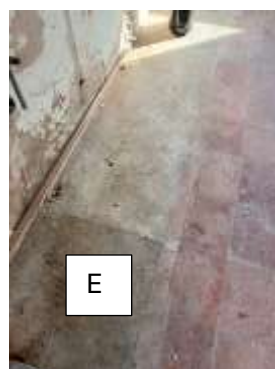
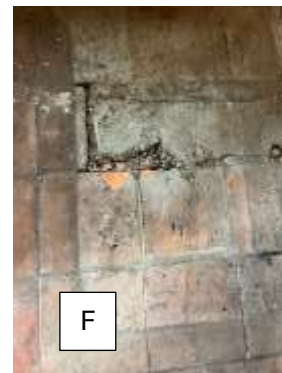
The pictures show that theft of floor tiles has taken effect throughout. Although the tiles taken and those remaining are old tiles they are not thought to be original.

The tiles have been over laid to concrete that can be destructive to timber frames.

E, shows that the tiles have been laid up to fitted kitchen units demonstrating modern application.

F damaged condition.

Although ransacking has taken these characterful materials it is planned that the floors will be restored with greater functionality.

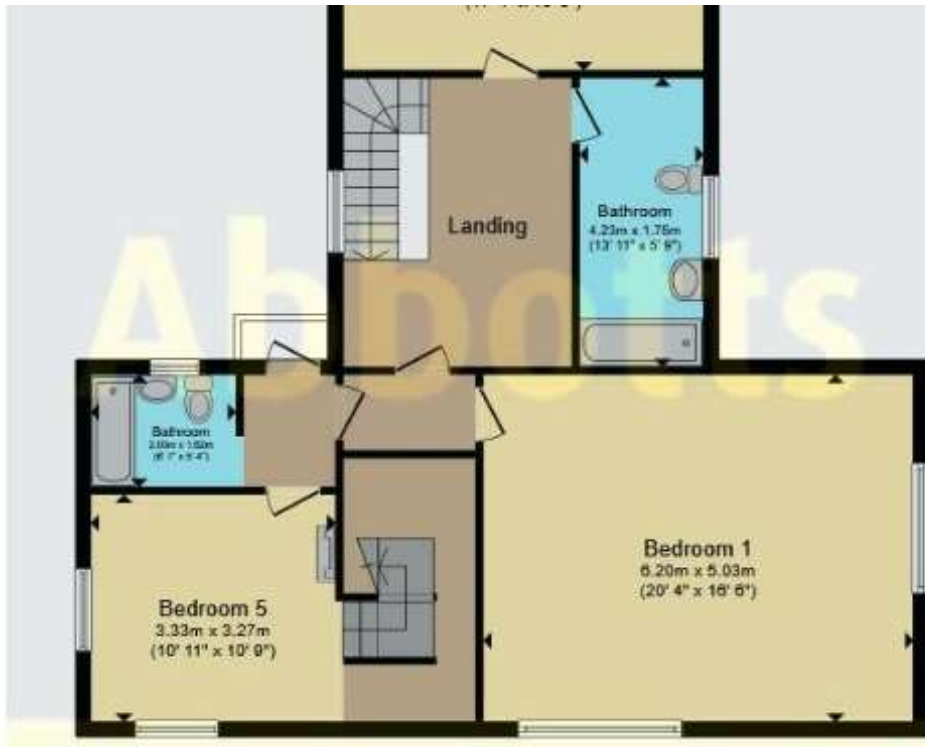
Existing bathroom layout

The applicant plans to split this bathroom to form two bathrooms. This will involve creating a new doorway onto the landing. The wall in question is very modern, formed of modern stud work and plasterboard. It is felt that by backing the second bathroom onto the first there shall be little or no further requirement for external services.

The applicant feels that this is an opportunity to not only improve the living experience within the building but also to replace the modern plasterboard wall with a lath and plaster wall again furthering the breathability of the building.

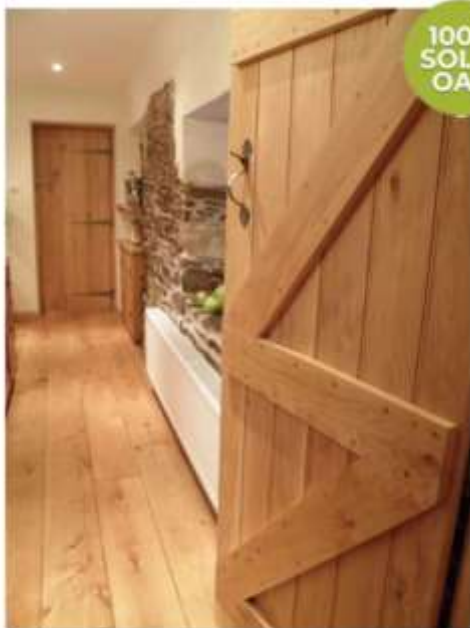
Left: Example of proposed doors to be used matching similar style to the only two remaining doors seen internally in the house, one of which seemingly is of considerable age.

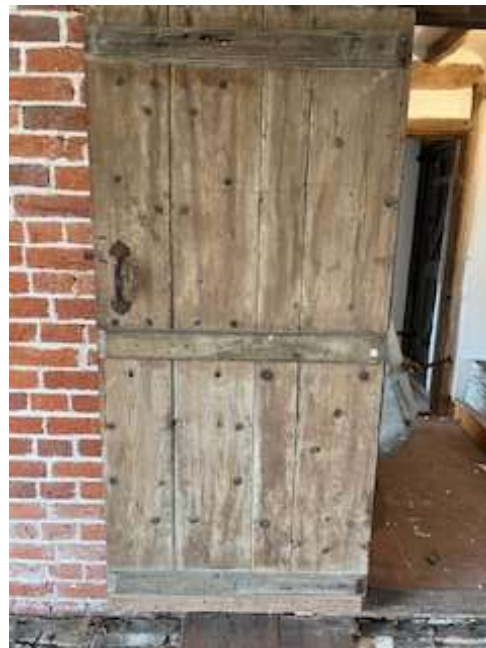
Right: Last remaining internal door

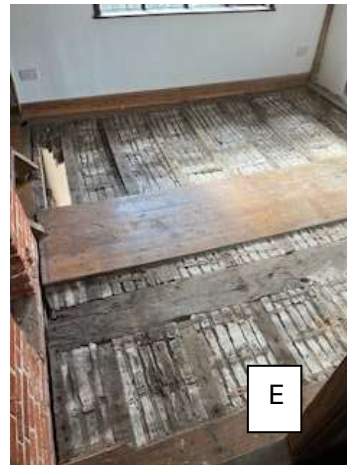
E and F: A from above

A: Nine infill panels damaged during ransacking previously skimmed with gypsum plaster, seeking permission to replace wooden laths with lime plaster.

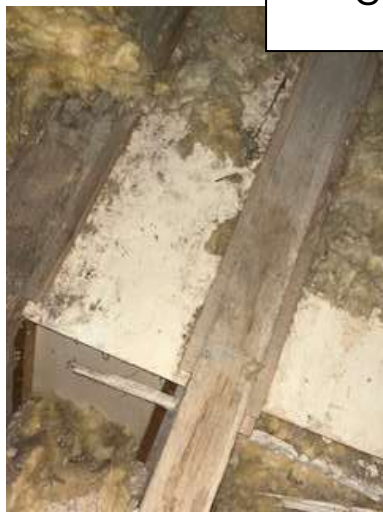
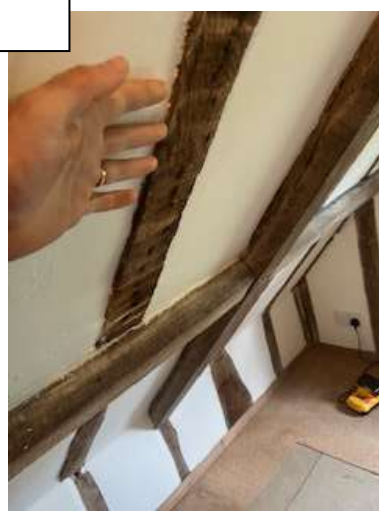
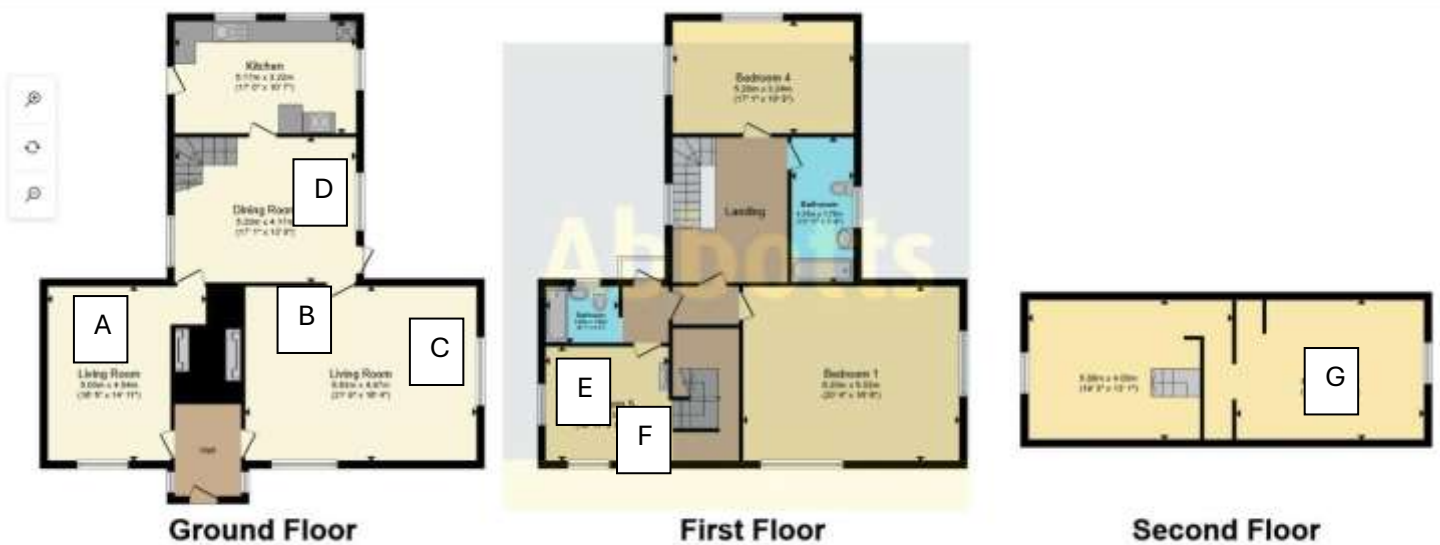
G: This room can be seen to have been plaster boarded on all of the infills. This is visible from the picture provided from inside the loft space. This room has also been boarded out and chip boarded over a layer of plastic and inappropriate glass fibre insulation. The applicant is seeking to remove up to 25% of the infills in this room and replace with timber laths and lime plaster. The applicant also wishes to remove the chipboard flooring, plastic and glass fibre insulation and replace with square edged wide oak floorboards.

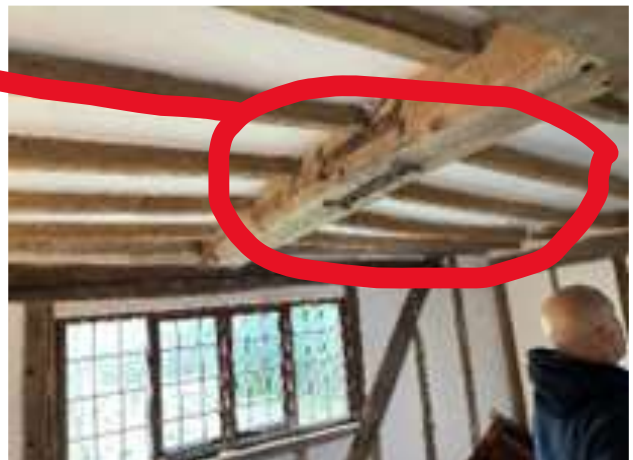
The thick red band illustrates the corner of the house that is affected by extreme insect infestation.

It is proposed that up to five floor joists be replaced with new oak timbers.

Were timbers are found to have structural stability repairs will be affected.
