Shane and Anne have recently taken ownership of a grade II listed 17th century farmhouse. Park Farm Braiseworth, Suffolk IP23 7HB.

Proposed work at Park Farm Braiseworth:

Updated 20/02/2024

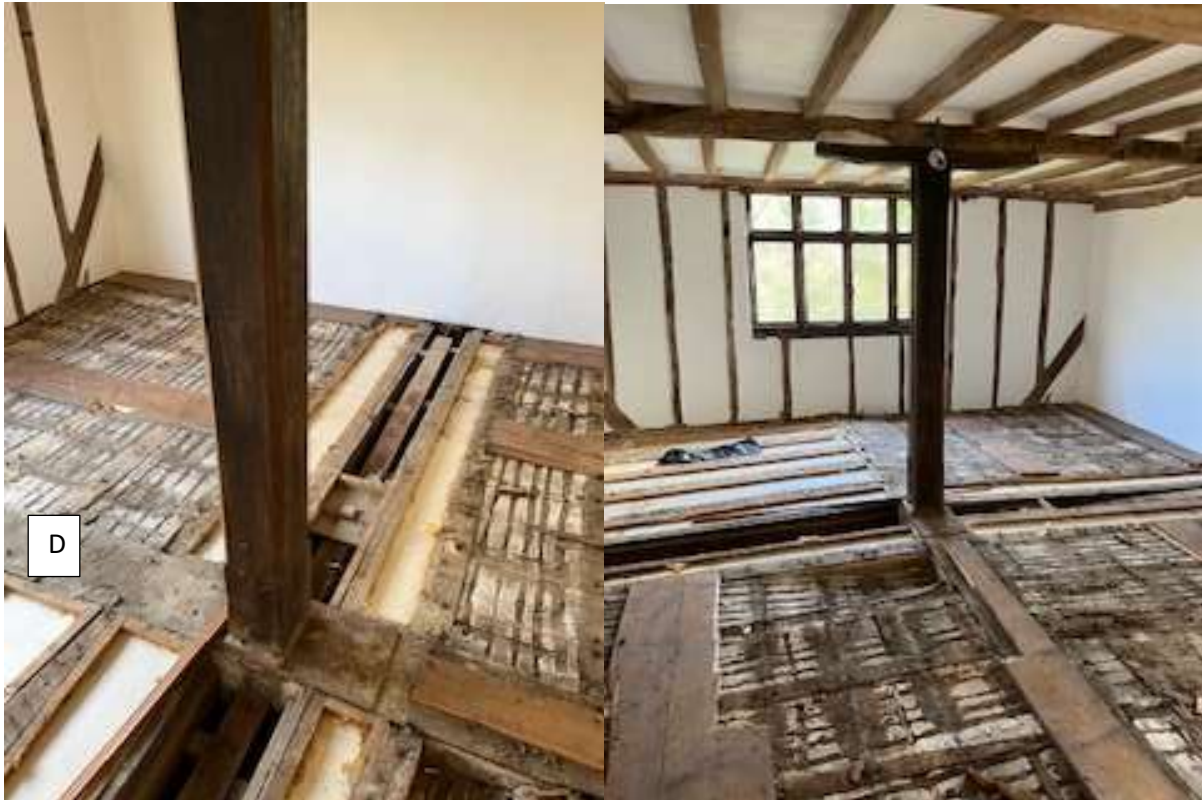
Whilst most timbers appear sound, the most easterly bay shows as many as 5 badly deteriorated floor joists. One is visibly broken through.

RSJ replacement of original timber

The above illustrations show a significant timber {A} within the frame has been replaced with a metal RSJ housed in an oak panelling.

{B} The RSJ inserted in place of a timber.

{C} A few timbers have suffered chronic destruction from boring insects.

{D} The sections of Lath and plaster have been removed and replaced with plaster board.

Smaller degraded timbers would be replaced with aged oak or elm to suit the frame and restore integrity.

During these works any disturbed plaster work would be replaced with laths and lime plaster in the traditional style and method. Increasing breathability of the building.
