# Structural Appraisal

Barn at Hen Fache Fach  
Llanrhaeadr Ym Mochnant  
POWYS  
SY10 0DD

25 Jul. 23

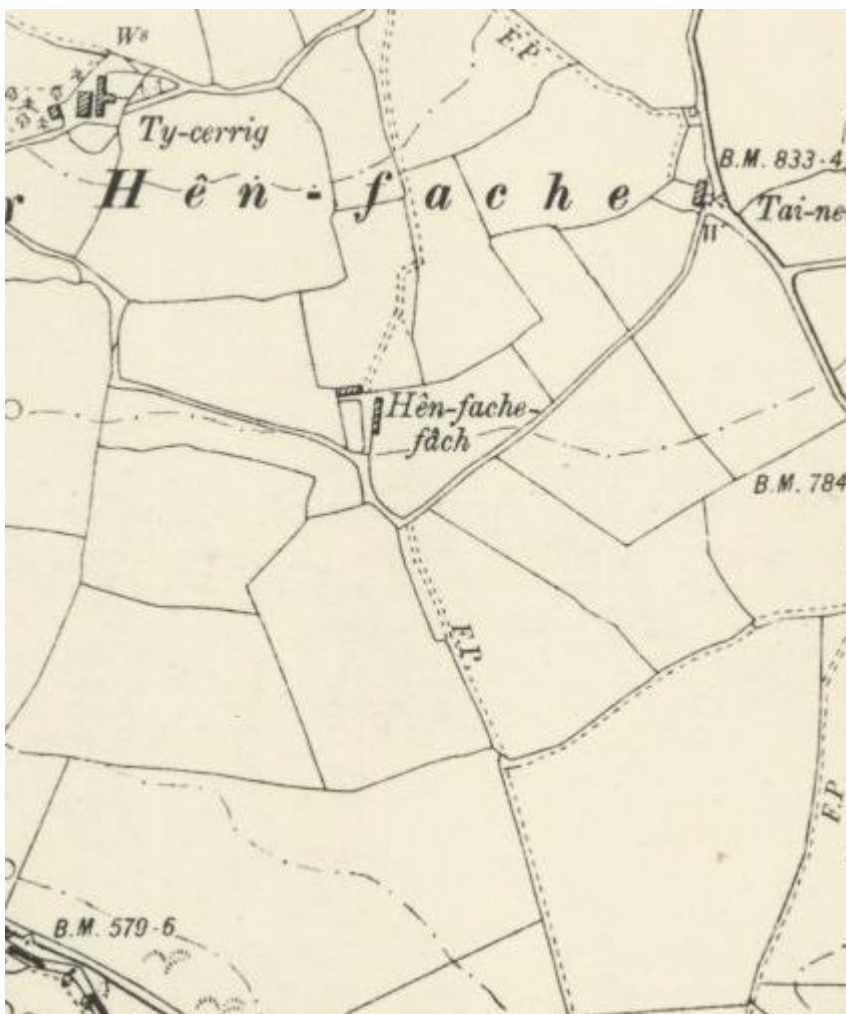
The exact age of the building is not known, but it is estimated to have been built in the latter part of the 19C. It is shown on the 6-inch OS map series from 1888.
