Our Ref: 12632

Twywell Barn - Cottages

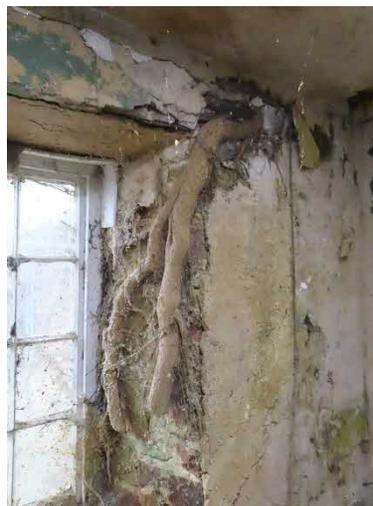
On the opposite side the ivy roots have caused noticeable damage and this will require removing and then repaired.

The methodology for removing the wall should be as per previous walls in that operatives should be above the area being taken down so they would be clear of loose masonry which could fall. On the south-eastern side the work should start at the end of the barn wall as this is noticeably leaning and it can be taken down working up towards the gable.
