**HISTORIC BUILDING RECORDING
OF THE FARMHOUSE AND BOTHY,
SPRING GRANGE,
WOOD END,
ARDELEY,
HERTFORDSHIRE,
SG2 7BB**

PCA REPORT NO: R15208

NOVEMBER 2022

Historic Building Recording

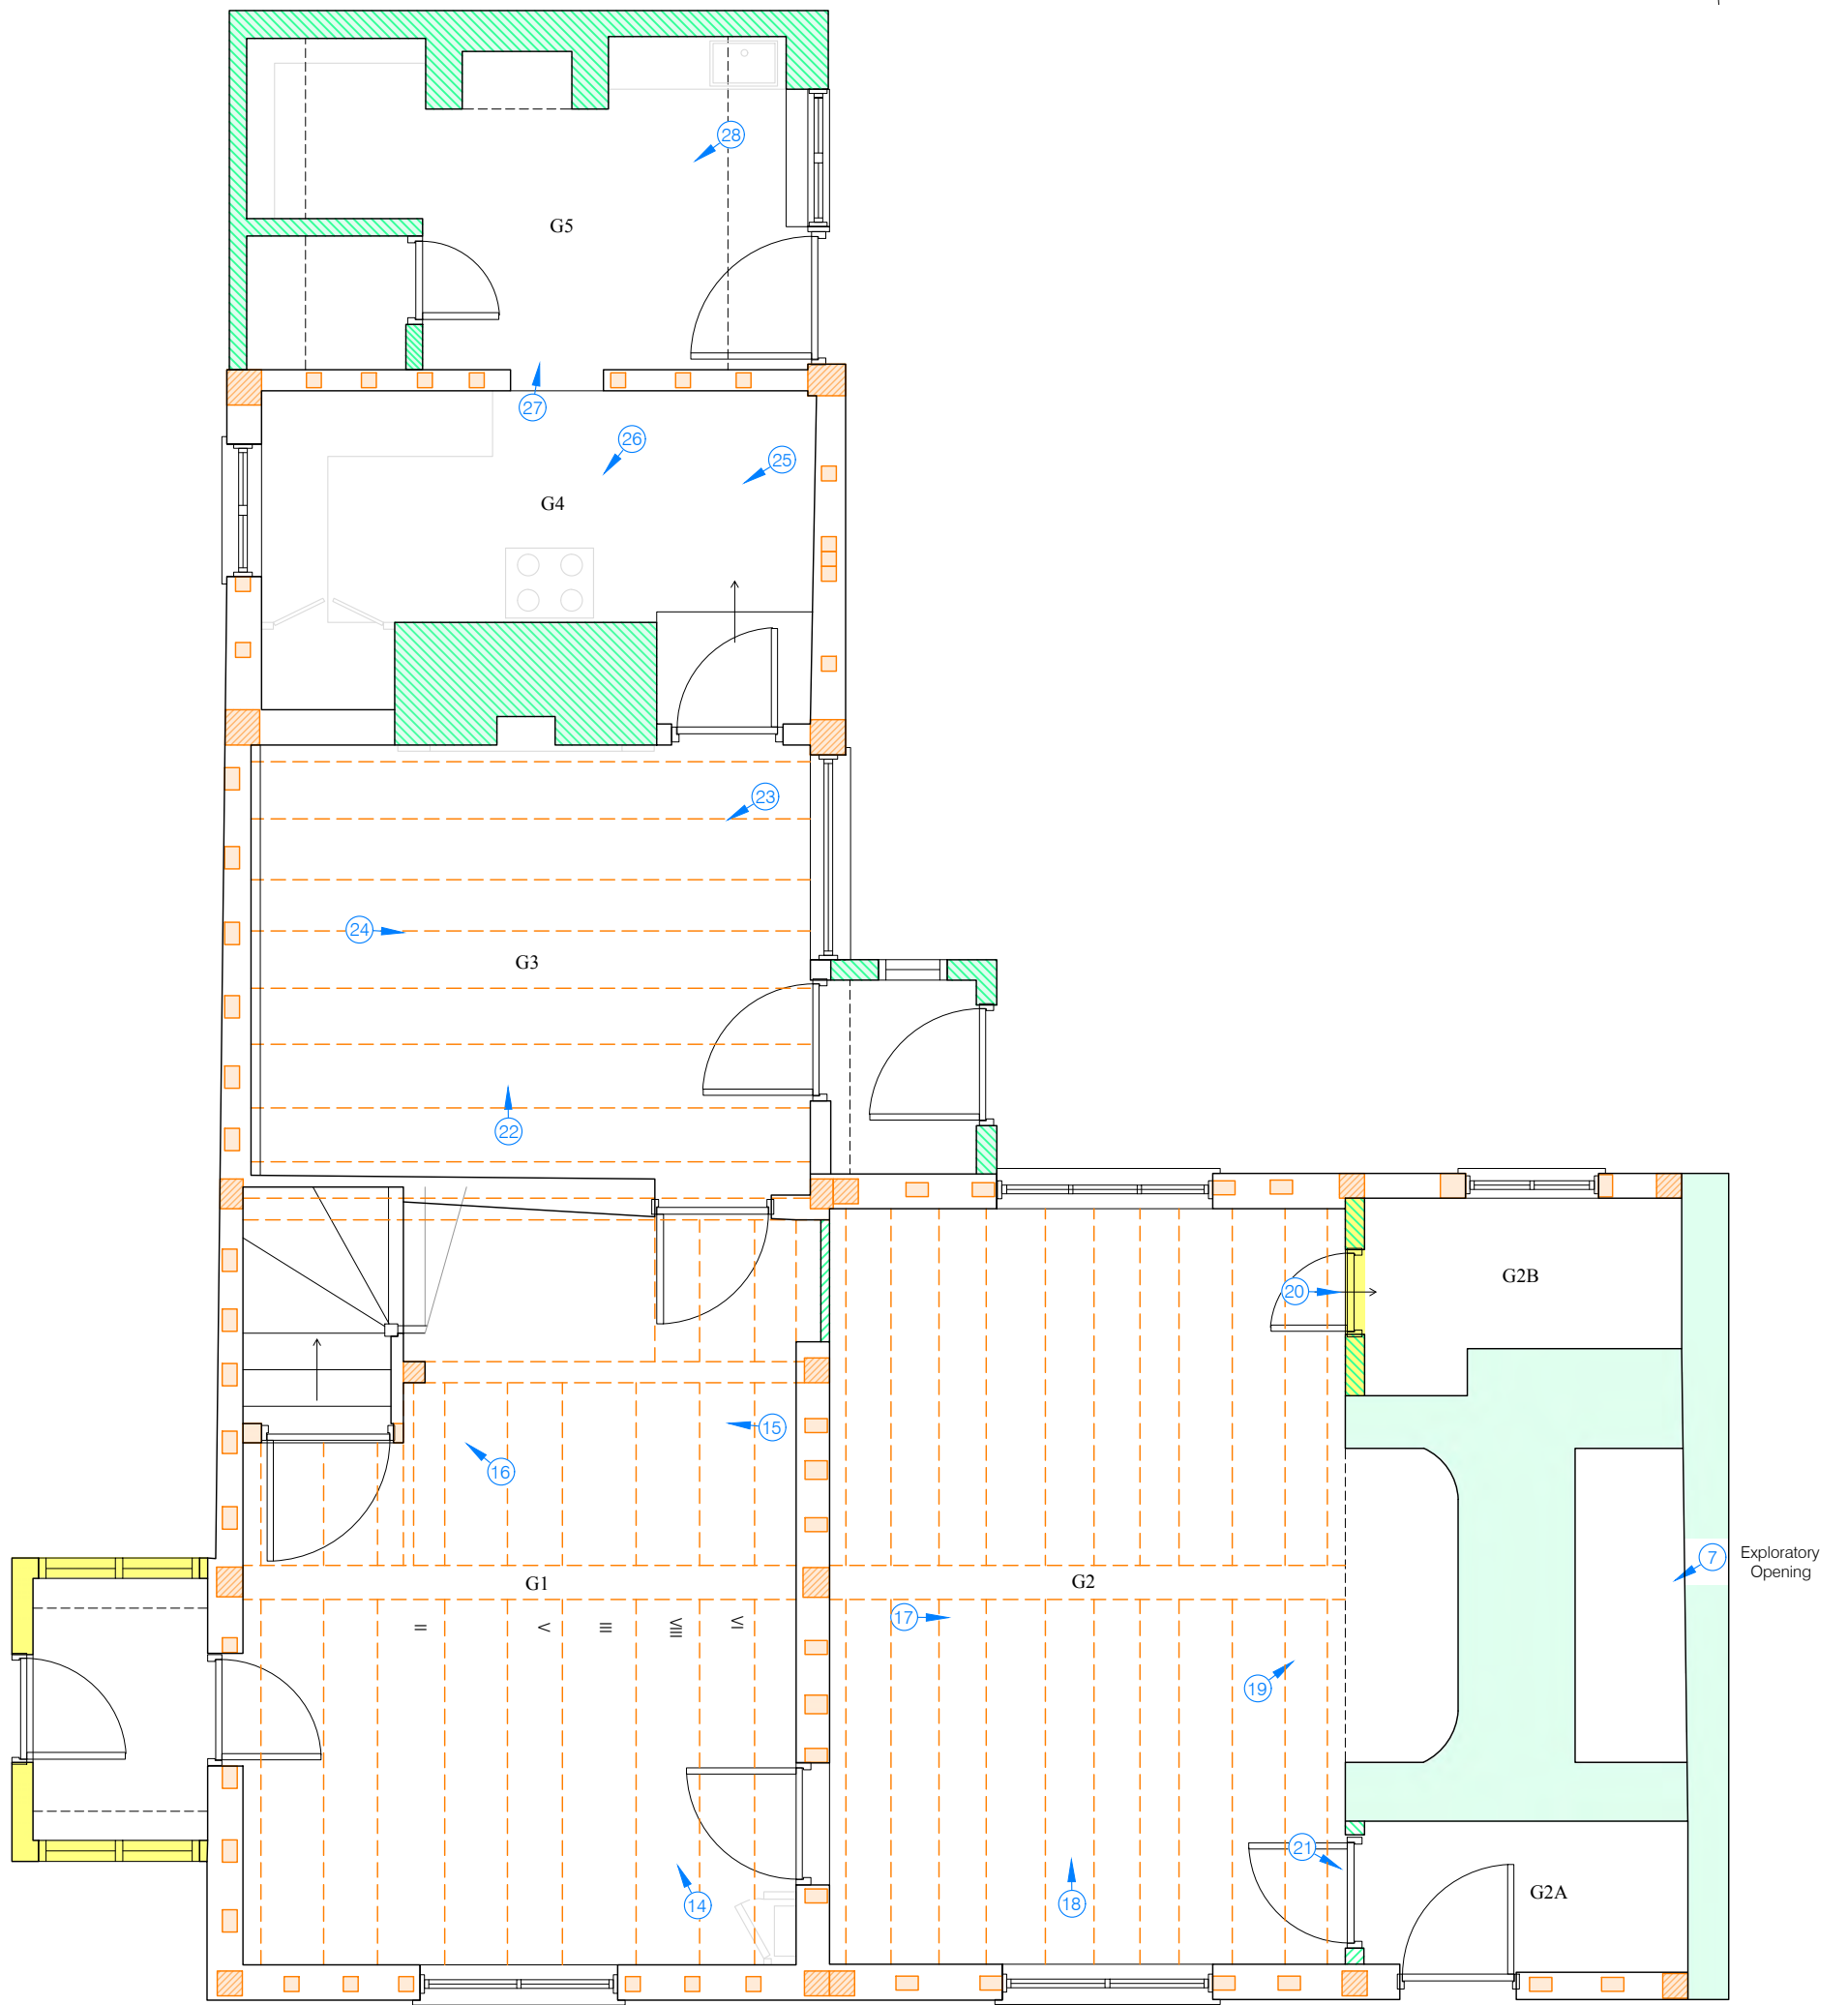
Figure 12
Existing Ground Floor Plan
1:50 at A3

6.7.1 This room lies at the southern end of the cross-wing and extends to a width, (north-south) comparable with the hall range to its east side (**Figures 12 and 15**). It can be entered via the secondary porched external door in its western side (**Plates 5 and 6**), or via internal doors from the living room (G2) or to the former kitchen (G3) (**Plate 14**). It is from this room (G1) that sole access up to the first-floor rooms is possible. As the room is unheated it may have been historically the 'low or service end' of the building.

6.7.2 The original or a secondary timber floor has been replaced with the present concrete screed floor, probably due to wet rot of the previous floor structures, a factor clearly evident within the present floor structure in the adjacent living room (G2). The ceiling is crossed by an axial or bridging beam, aligned east-west and centrally placed (**Figures 12 and 15; Plates 14 and 15**). It is a heavy scantling (10x9inch) oak beam with deep soffit chamfers, but without stops. The floor joists are laid flat and vary in scantling from c.5½-6 inches by c.4½ inches. The joists appear to be tenoned into the axial beam using a soffit tenon with diminished haunch, indicative of an early to late 16th century date. Many of the joists are not straight and are still partly 'in the round', with those, in particular to the north side of the axial beam, comprised of re-used timber, many showing empty mortices and one example sockets for diamond mullions (former windowsill). There are nine joists to the south side of the axial beam and ten to the north, the discrepancy due to the addition of a regular sawn joist as part of the structure supporting the inserted stair. Five of the nine floor joists to the south of the axial beam have scribed carpenter's marks at their northern ends. However, these are no longer in numerical sequence, numbering, north to south VI, VIII, III, V, blank, II, blank, blank, blank (so missing I, IV, VII and IX) (**Figures 12 and 15**). There was no evidence visible for carpentry marks on the joists to the north side.

6.7.4 A small niche, now fitted shelves, built into the north end of the eastern wall, is a former doorway, later blocked and converted (**Figure 12; Plate 14**). It would suggest that the present door opening into (G2) is not original unless there were two separate door openings into this room from (G1). The two doors into (G2) and (G3) are simple, lightweight four panel doors of a 19th century date, while the part glazed door to the stair dates to the 20th century.

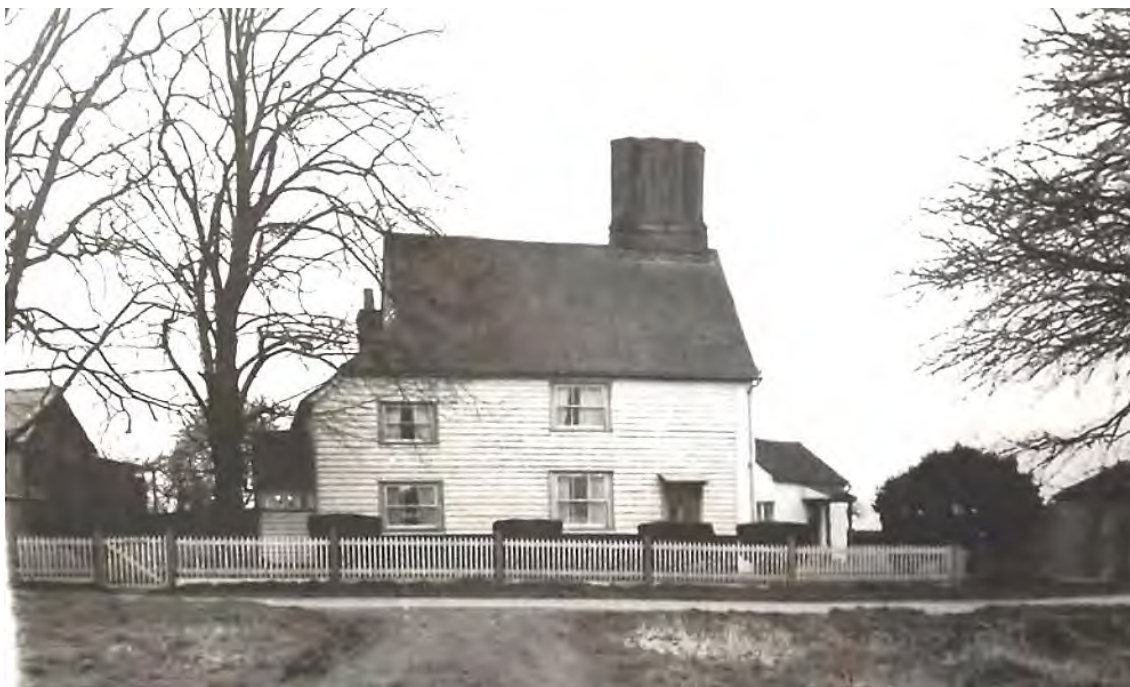
Historical Plate 2 Mentley Lane Elevation, 1975

- 6.2.1 The southern road facing elevation has been re-clad in softwood ship-lap weatherboarding fixed using common steel round nails (**Figure 18**; **Plates 1** and **2**). The four windows, two lighting the ground and first floors of the hall (east side) and two (west side) lighting the equivalent storeys in the cross wing, are modern (later 20th century), larger, replacement casements built with 'traditional' small panes of either six or eight lights per casement (**Plate 10**). A photograph of Spring Cottage taken c.1975 shows a former arrangement of three over three sash windows (**Historical Plate 2**).

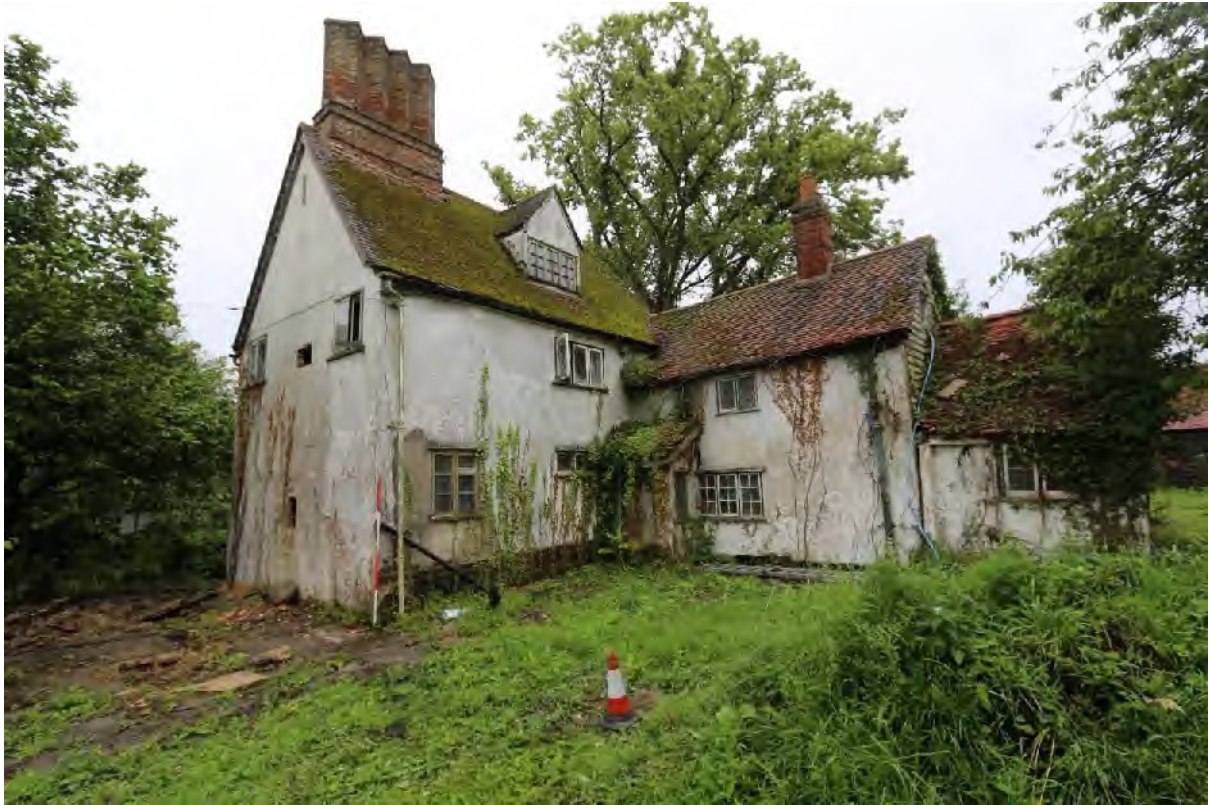
Plate 3 Eastern and northern elevations, looking south-west

- 6.3.1 The eastern elevation comprises the rebuilt end gable wall of the hall and the east facing flank elevation of the cross wing (**Figure 18**; **Plate 3**). The former, which represents the closing wall built after the loss of the eastern part of the hall, is constructed using Fletton brickwork, half a brick thick and rendered over. It incorporated two simple casement first floor windows on each side of the chimneystack. Small exploratory openings broken through the Fletton wall at ground

- 6.3.2 The eastern elevation of the cross-wing comprised two elements: a timber-framed two-storey wing and single storey in-line extension, added to its northern end (**Figure 18**; **Plate 3**). The cross wing is rendered and incorporates a large, inserted casement of three lights with small glass panes at ground floor (**Plate 11**) and a much smaller casement to first floor with fake lead-light glazing (**Plate 3**). A porched entrance, with a mono-pitch tiled roof, lies at the junction of the hall and cross-wing (**Plate 11**). It has an 'archaic' oak, plank and batten door with an arched head and a simple latch, which, along with the porch is a modern addition.

- 6.5.1 The north elevation represents the north rear wall of the hall and the corresponding gable walls of the cross-wing and extension (**Figure 18**; **Plates 3, 4 and 6**). The former is rendered and includes three modern casement windows, two at ground floor and one to the first floor (**Plate 3**). A large gable dormer, lighting the attic room, lies roughly central to the hall roof. It also has modern fenestration. A dwarf wall or plinth, equivalent to that present along the south elevation, extends for the full length of the hall.

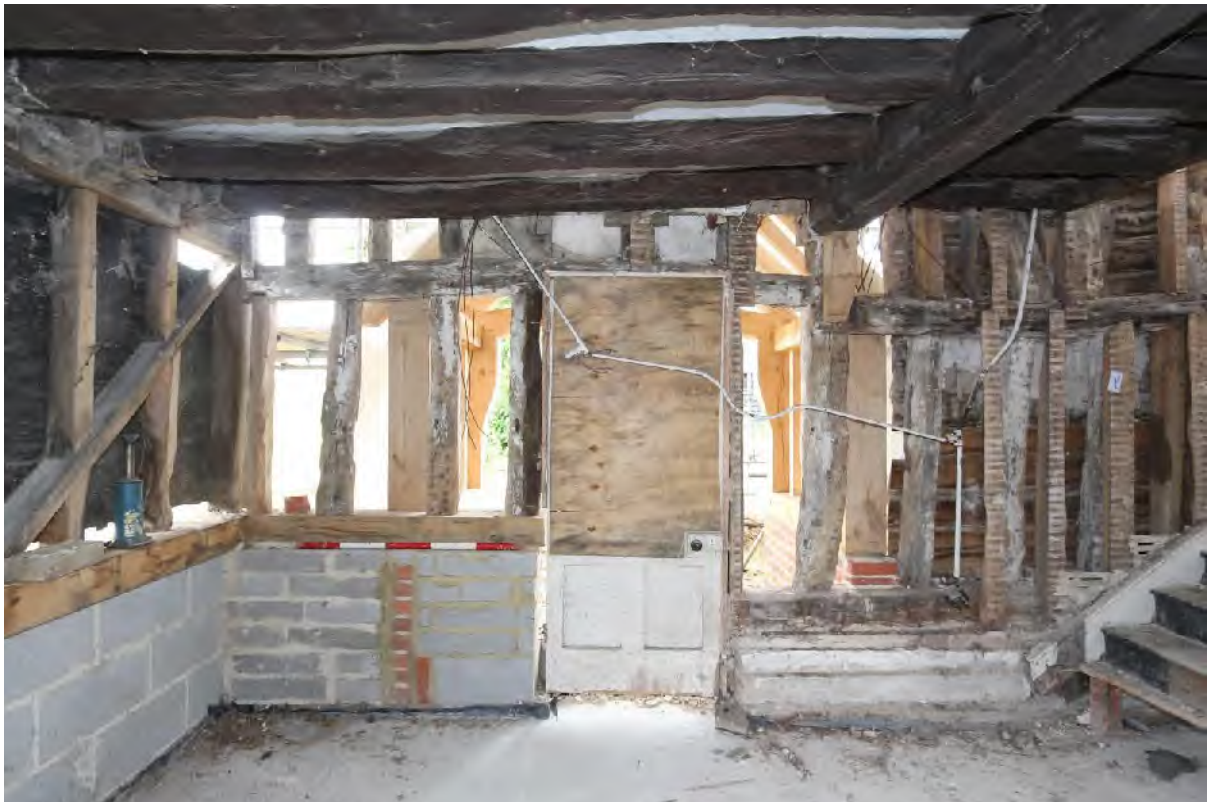
Plate 50 Room (G1), western flank wall

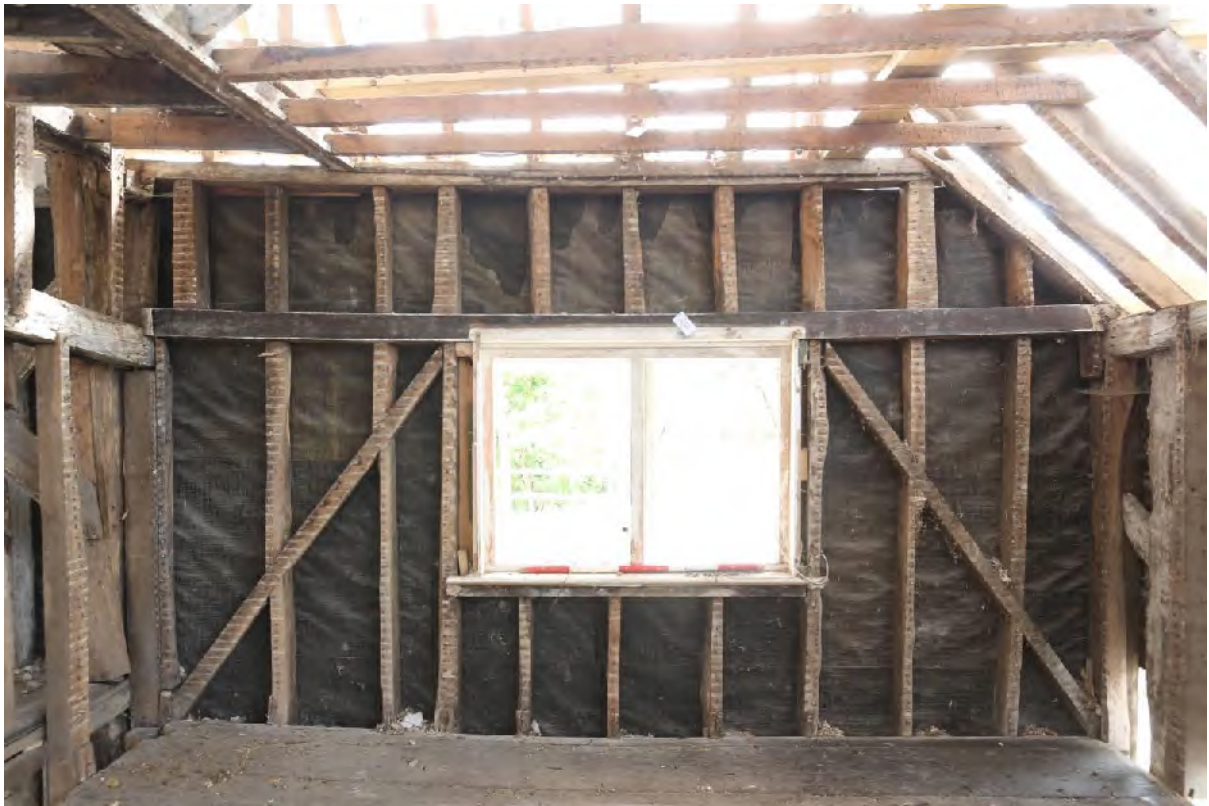
6.13.3 The southern wall, like its corresponding wall at ground floor, is primary braced (**Plate 68**). The tie-beam is similarly lapped over the top of the two top plates of the cross-wing, although the southern ends of both top plates are both now supported by later, storey posts, contemporary with the primary bracing.

Plate 68 Southern primary braced wall of (F1)

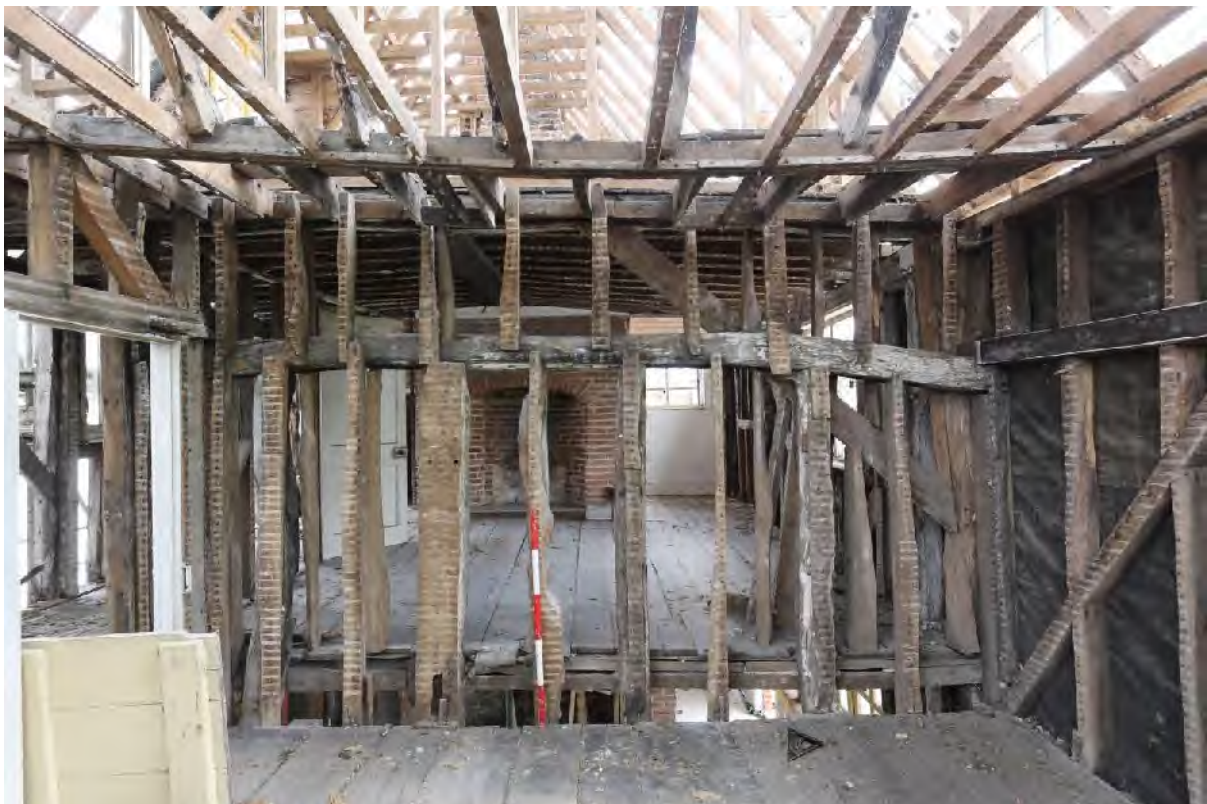
had its jowled head hacked back flush with the top plate/wall (**Plate 72**). The wall retains three original, stout (6x4ins) studs, each pegged in and retaining evidence, in the form of opposing holes and grooves for staves along with a V-trench cut into the soffit of the top plate. The head of the storey post has empty mortices in its north and south sides, which formerly received the top of tension braces, while the two studs to each side both have empty trenches cut across their backs, into which the tension braces were housed, demonstrating that they were once internal braces (to the hall) (**Plate 73**). The top plate (6x6ins) was slightly cambered/deformed and had been cut away at its north end to enable unrestricted passage from the stair into passage (F4). Its northern cut end now butting up against a hard wood post which was part of the later stairwell insertion phase.

Plate 72 Eastern wall of (F1) showing original storey post and top plate, looking east

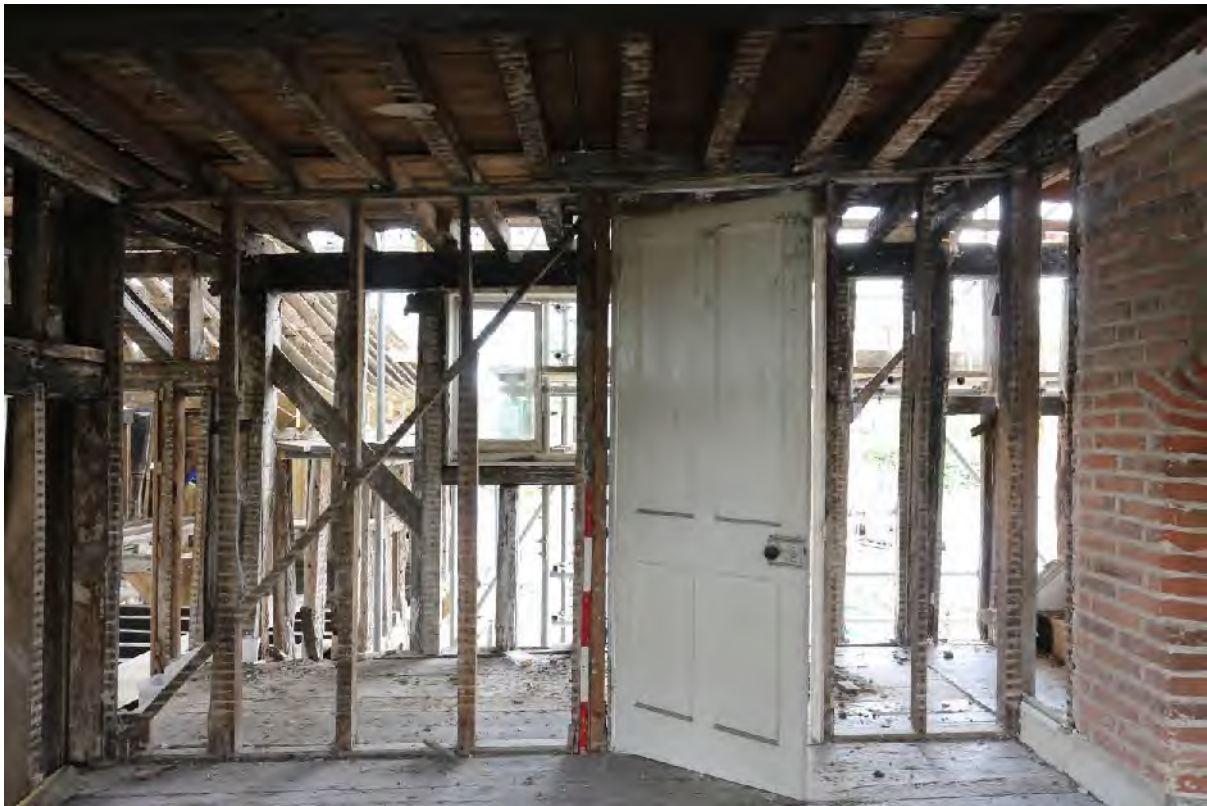
6.14.6 The north wall to (F2) or south wall to passage (F4) is typically formed from hard wood primary braced walling (**Plate 76**), but also includes some softwood studs, one example with a Baltic timber mark.

Plate 76 Northern primary braced stud wall to (F2)

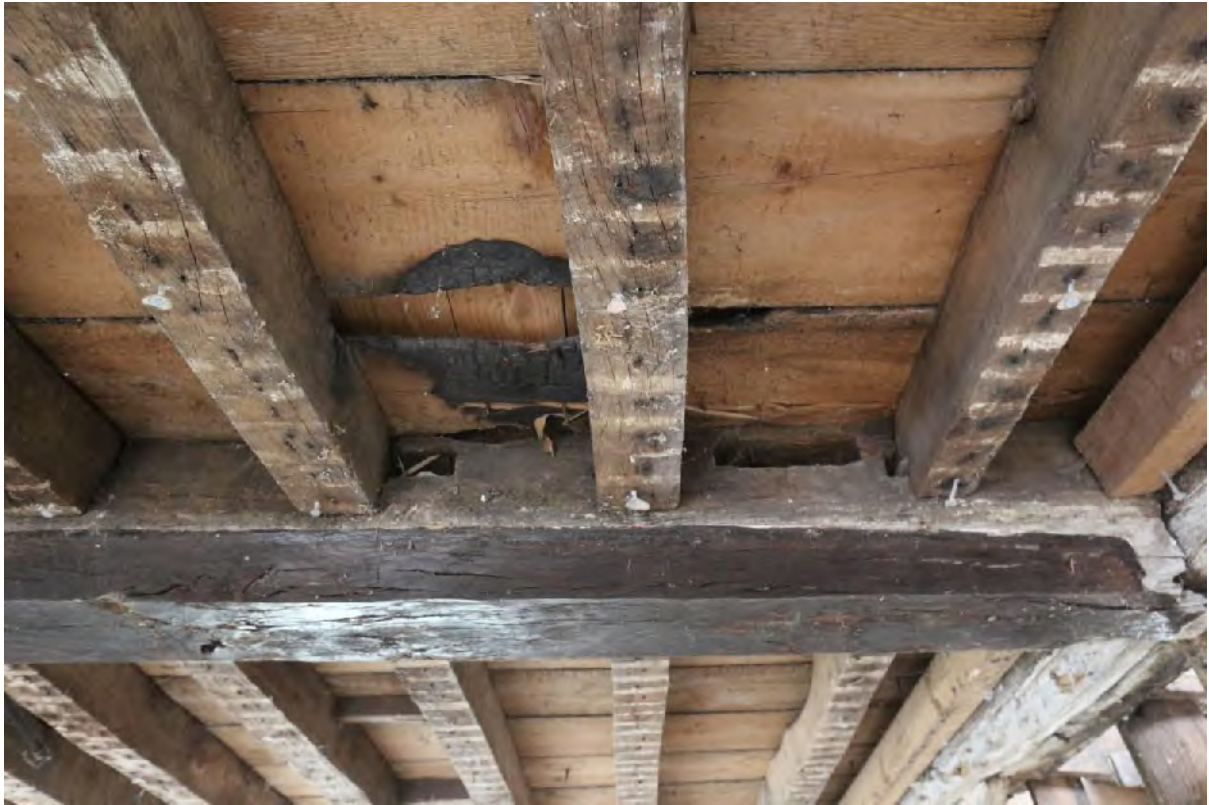
- 6.14.8 The ceiling structure over (F2) is 17th century, comprising a large chamfered axial bridging beam with no stops and a series of common joists. The latter appear to not fit correctly into the bridging beam, whose mortices are mainly larger, suggesting that this beam was re-used (**Plate 79**). The ceiling joists are all hard wood and relatively regular at 4x3ins. They are scribed marked using Roman numerals on the east side of each second joist (ranging from I to V) and are tagged to the north side (**Plate 80**). The joists fit into the axial beam using a mid-tenon with what appears to be a diminished haunch; their outer ends simply laid over the top plates. They are directly overlain by 8-inch boards which form the floor to the attic storey, although these floorboards have in turn been overlain by narrower, modern softwood boards, post fire.

Plate 79 Empty mortices in re-used bridging beam (F2)

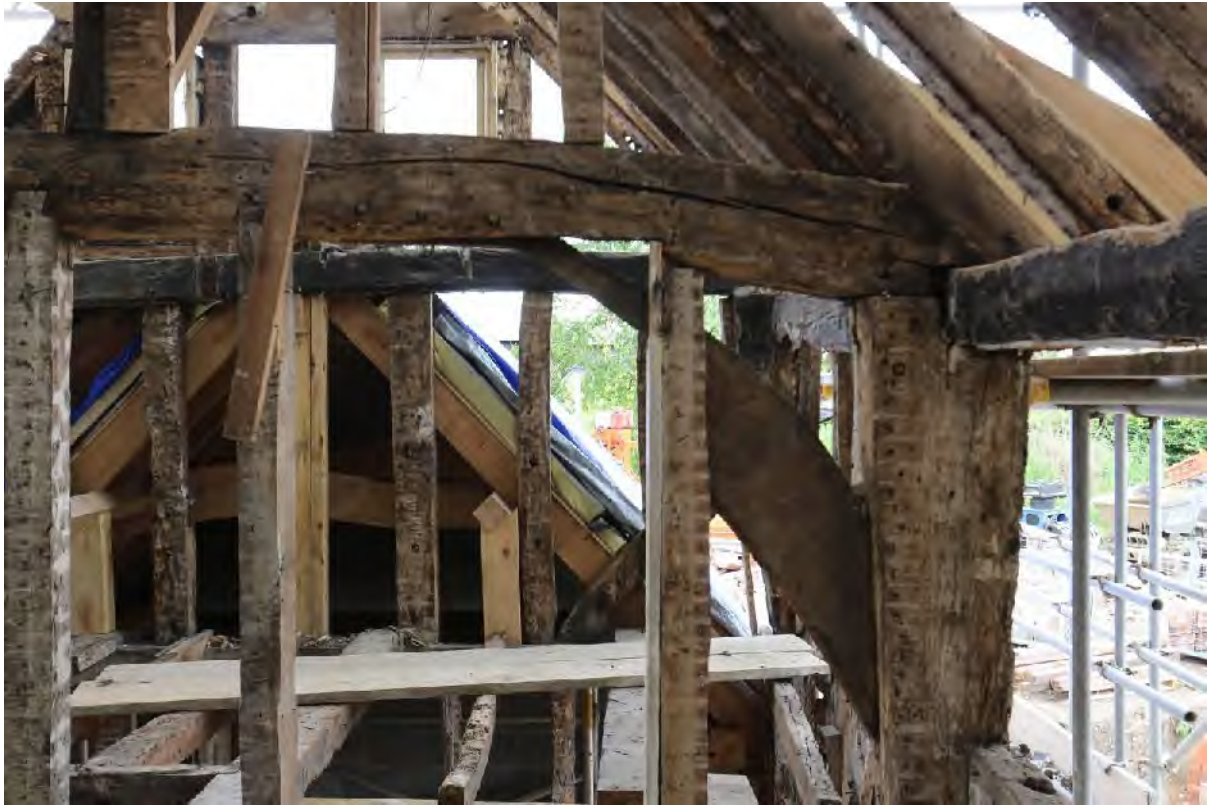
Plate 85 Eastern arch brace cut away to form door opening

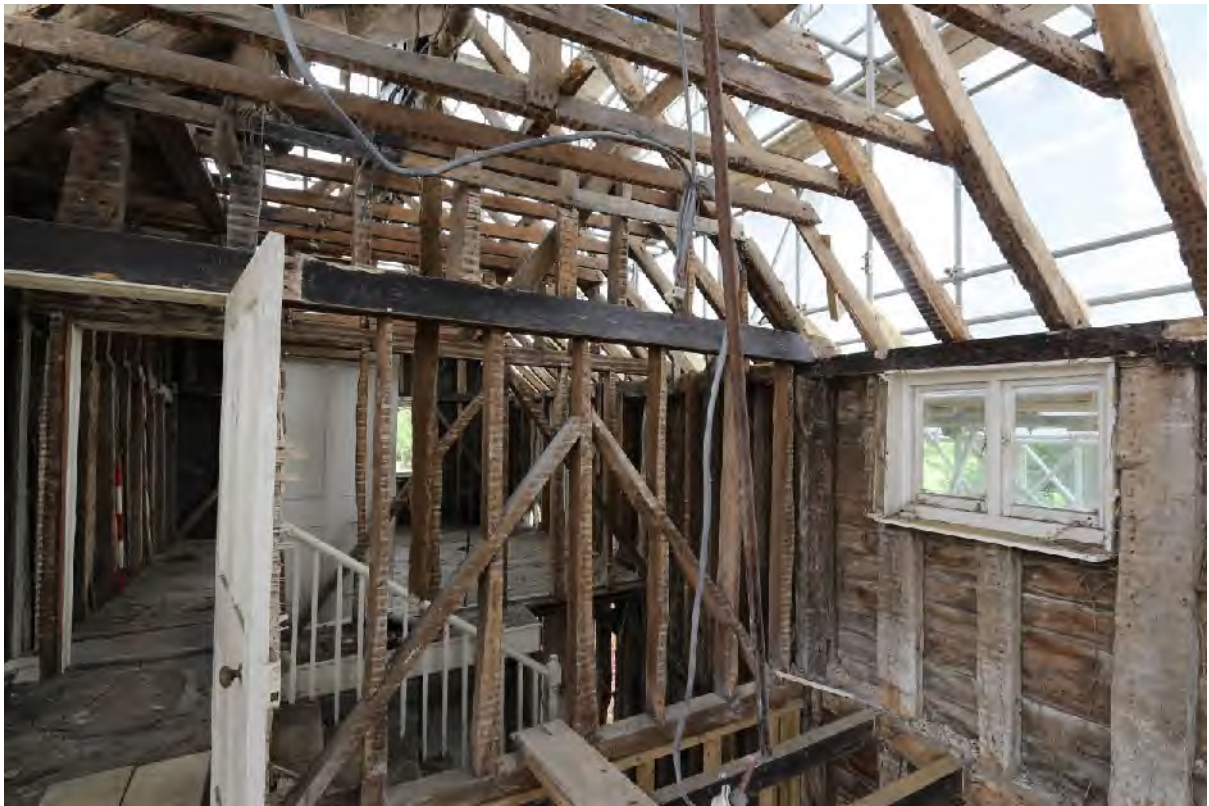
6.15.4 The northern wall to (F6) is formed by a series of light weight, inserted waney edged studs, the lower studs set between the first-floor transverse beam and the tie beam and the upper, from the tie beam to an inserted ceiling joist. They are typically lapped and nailed into the horizontal beams. A pair of later softwood raking struts rise from the top of the tie beam to support the side purlins along both sides of the roof. Most notable is the presence of two curving arch braces, to which the later studs are trenched around, which rise from the heads of the jowled storey posts to the underside of cambered tie beam. They are double pegged into the post and triple pegged into the tie beam (**Plate 84**). Part of the eastern arch brace has been cut away for a doorway between (F6) and (F7) (**Plate 85**). This doorway also entailed the removal of a section of the first-floor transverse beam and the southern end of the adjacent floor joists in (F7). The southern wall between (F6) and the stairwell (F3) is hard wood and primary braced (**Plate 86**).

Plate 86 Primary braced south wall to (F6)

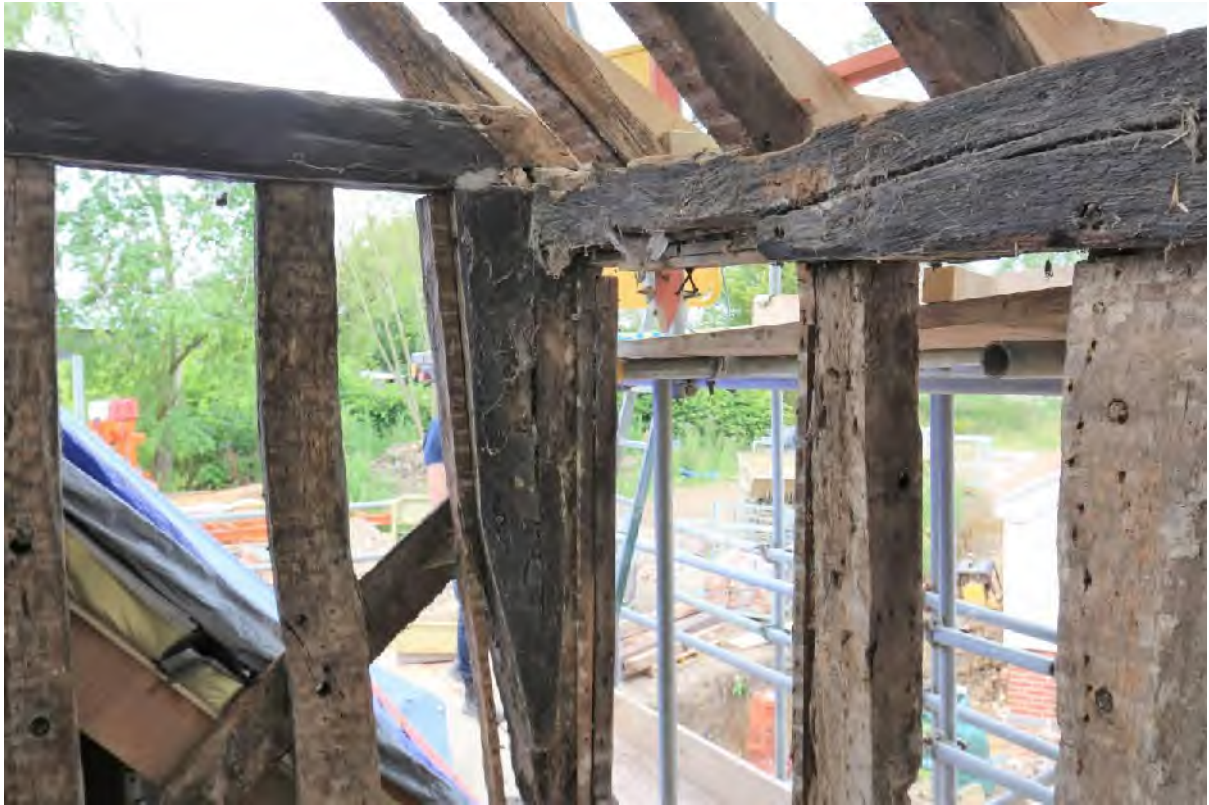
6.16.3 The removal of the floorboards in (F7) revealed the underlying floor joists. They were a mix of waney edged joists and four, stout (6 x 4 inch) joists, flat laid and simply halved over the transverse beams (**Plate 65**). Both of the eastern and western walls to (F7) retained curved downward internal tension braces (**Plates 87 and 88**), set at the southern end of the bay and trenched and nailed into the inner faces of the studs, while an external curving downward tension brace was present on the northern (outside) of the north-eastern storey post (**Plate 89**). Its equivalent on the north-western storey post had however been removed.

the north-eastern corner storey post (**Plate 89**). Its positioning, next to a storey post, is consistent with the other historic window openings (identified) across the first floor. The studding along the east, north and west walls is stout, regularly spaced and pegged into the top plate or tie beam. The west wall is perhaps the most interesting as it retains what appears to be original wall infill, comprising wide (up to 3 inch) riven vertical-set withies, wedged between and tied to the horizontal staves using lengths of creeper, such as honeysuckle (**Plates 90 and 91**). This is overlaid by a hair tempered daub with lime, laid flush with the inner face of the studs and presumably the outer faces, the latter not visible due to the later weatherboarding.

Plate 89 External brace and former window opening, south of north-eastern storey post

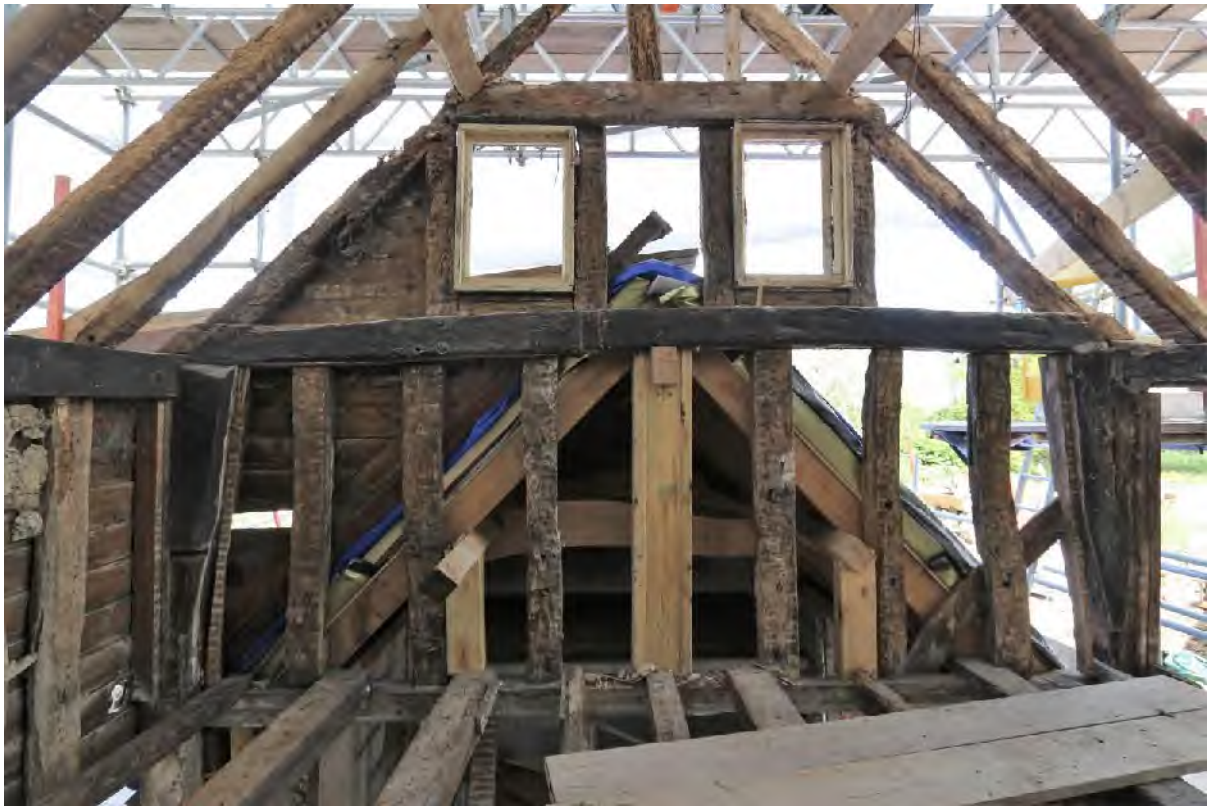
6.16.5 The northern gable wall above the slightly cambered tie-beam survives mainly intact below a later collar nailed into the principal rafters (**Plate 92**). The four studs below the collar are correctly pegged in (to the tie-beam) and now enclose two modern casements. The two inner studs are halved and nailed around the back of the later collar, while the single stud above the collar is a later addition. The latter is nailed into the principal rafter, although a trench which held one end of the original collar can be seen along the west side. The soffits of the principal rafters above the collar level show a series of circular holes drilled to receive vertical staves (**Plate 93**) for an infill wall.

Plate 92 Northern end wall to (F7)

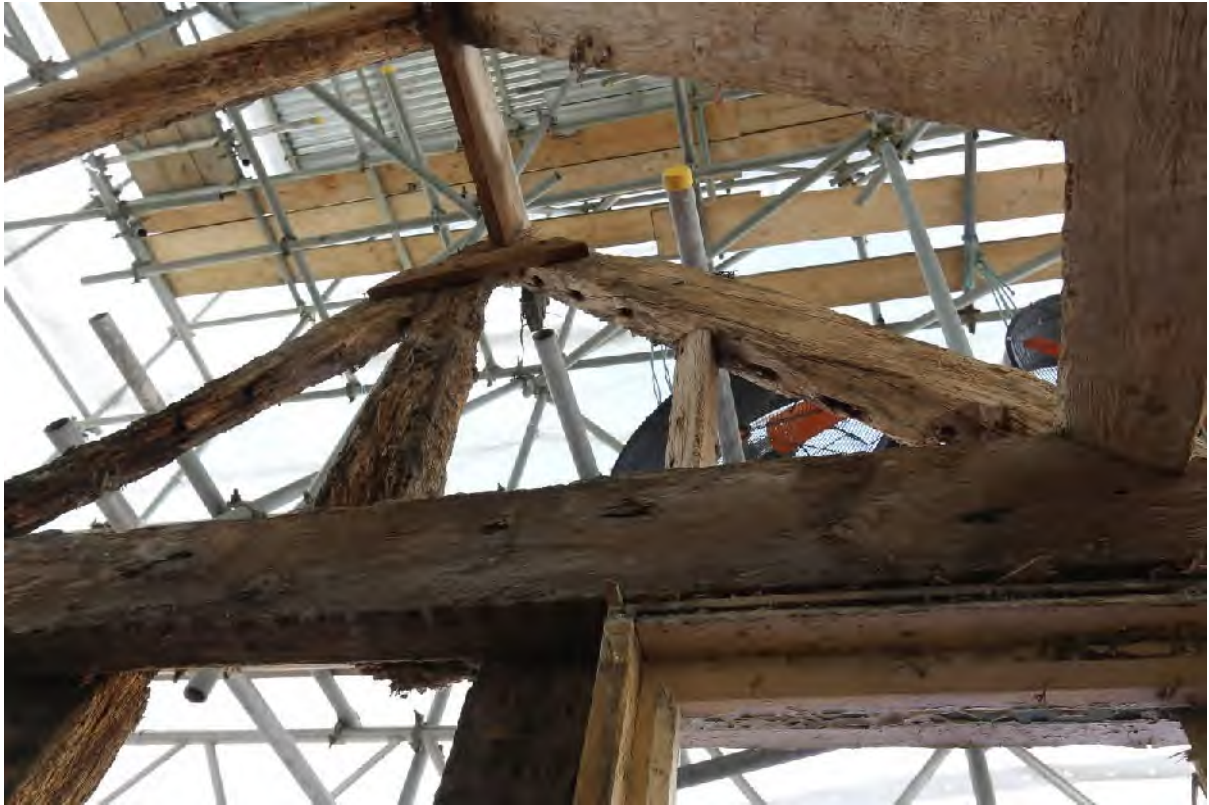
Plate 93 Stave holes in soffit of principal rafters, northern end of cross wing

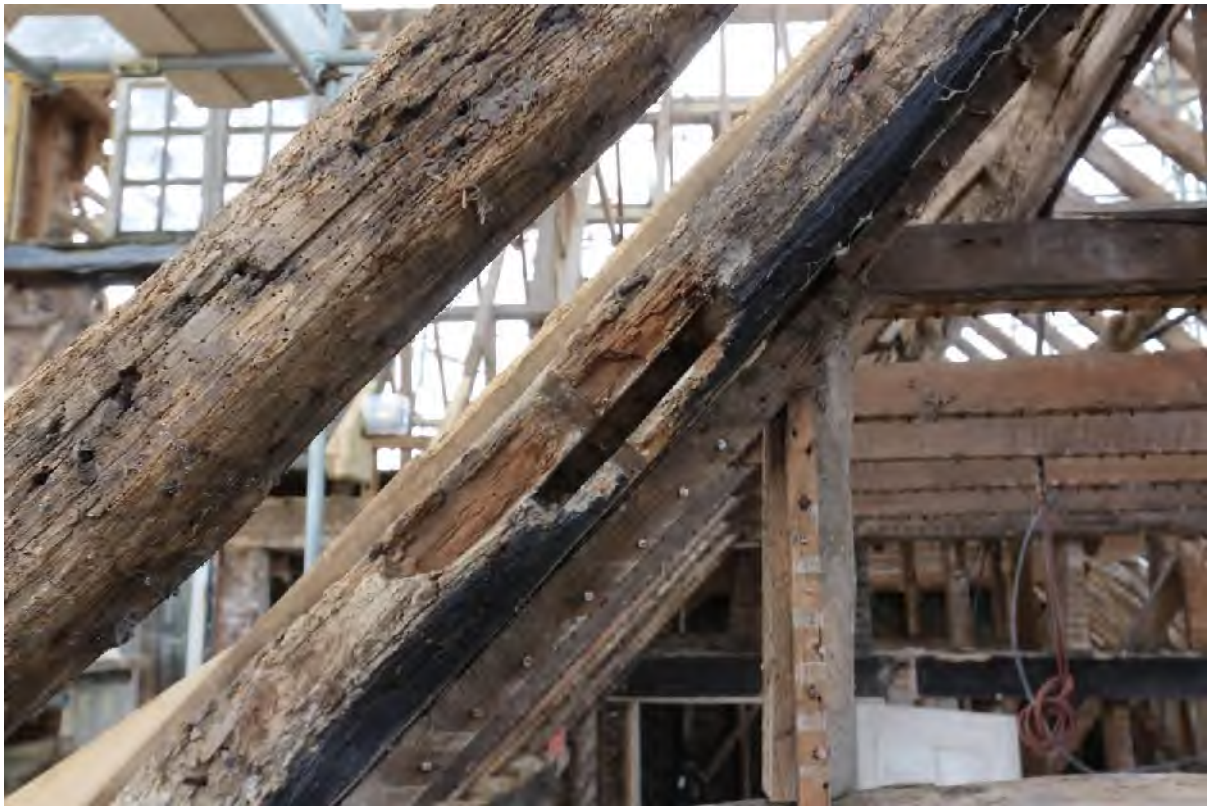
6.16.6 Narrow slit like mortices (**Plate 94**) present in the inward face of the northernmost principal rafter and corresponding slit mortices in the north face of the opposite (F6/F7) principal rafter show that the roof in this end bay (at least) was visible and embellished with paired wind braces. Given that the tie-beam between (F6) and (F7) showed no evidence for studwork and therefore an internal wall, it appears that together (F6 and F7) and perhaps (G3 and G4), formed one single (two bay) chamber which was open to the rafters.

Plate 94 Narrow mortise for a wind brace cut into principal rafter

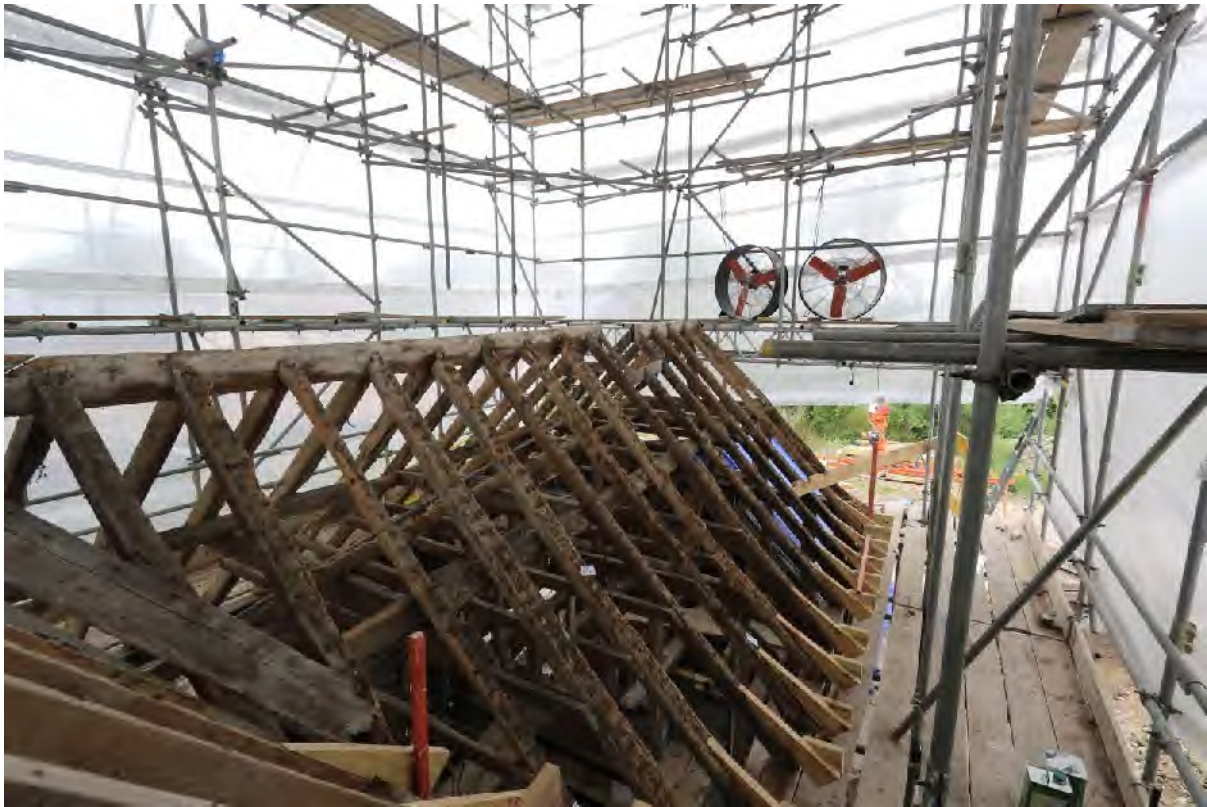
Plate 95 Northern and central bays of roof over cross wing

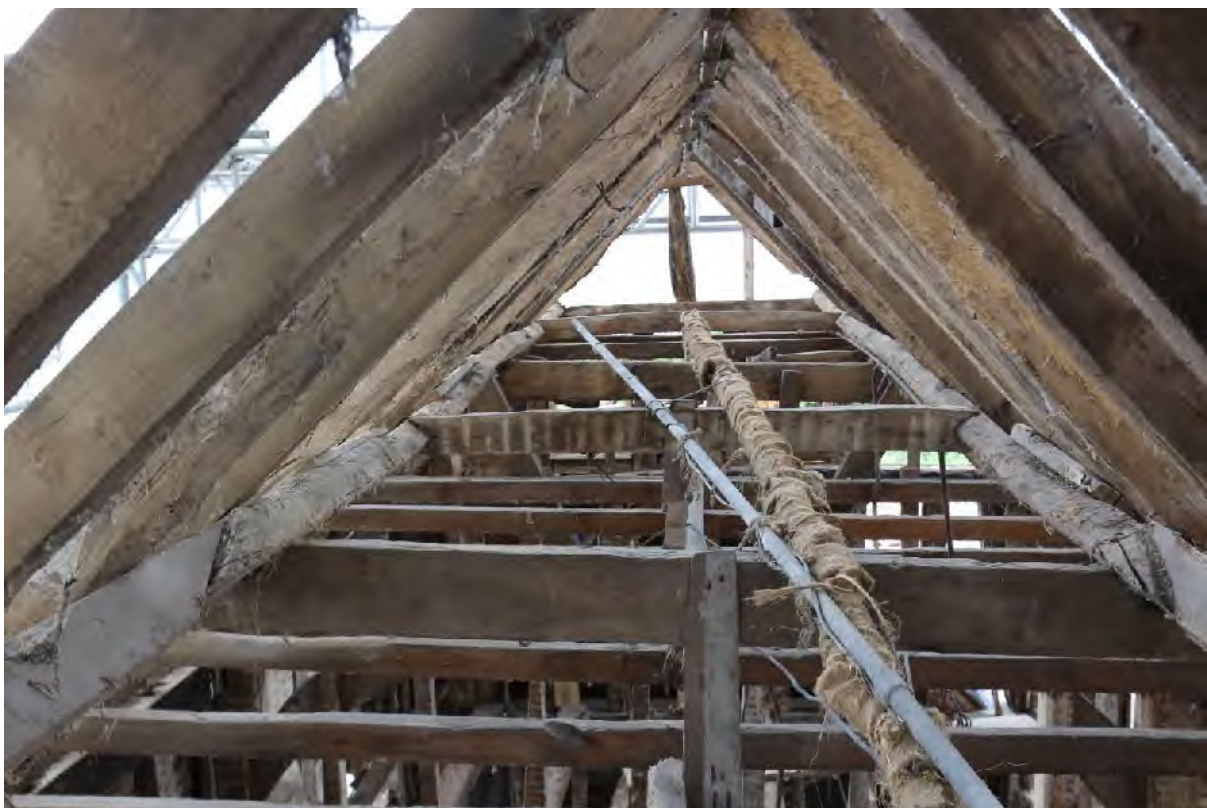
Plate 96 Roof showing clasped purlins and intermediate collars

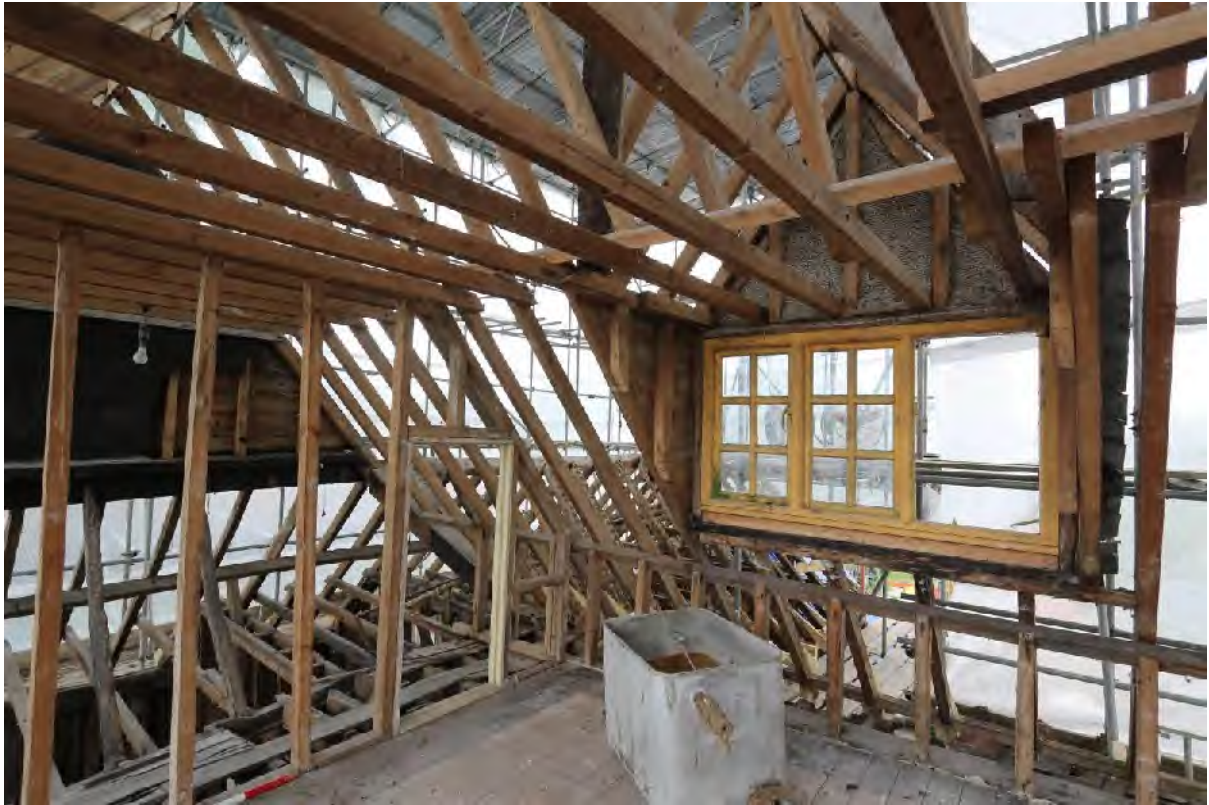
6.17.3 The northern part of the roof over the cross wing is an historic roof but is not the original. The common rafters include some re-used wide and flat laid original rafters, alongside later additions. The former show evidence of halving where they were formerly pegged together at the ridge, prior to the insertion of the ridge board. The roof is a clasped side purlin form using collars pegged into the principal rafters and intermediate collars positioned at half bay widths (**Plates 95 and 96**). The rafters pinch a narrow ridge board, suggesting that these northern bays had been reworked, probably when the southern part of the cross wing, which uses regular machine cut timber, was rebuilt during the 19th century. The roof structure over the front (south) bays (above F1 & F2) is all post-fire (**Plates 97 and 98**).

Plate 97 Post fire roof structure and dormer to attic room over (F1 and F2)
