**HISTORIC BUILDING RECORDING
OF THE FARMHOUSE AND BOTHY,
SPRING GRANGE,
WOOD END,
ARDELEY,
HERTFORDSHIRE,
SG2 7BB**

PCA REPORT NO: R15208

NOVEMBER 2022

Historic Building Recording

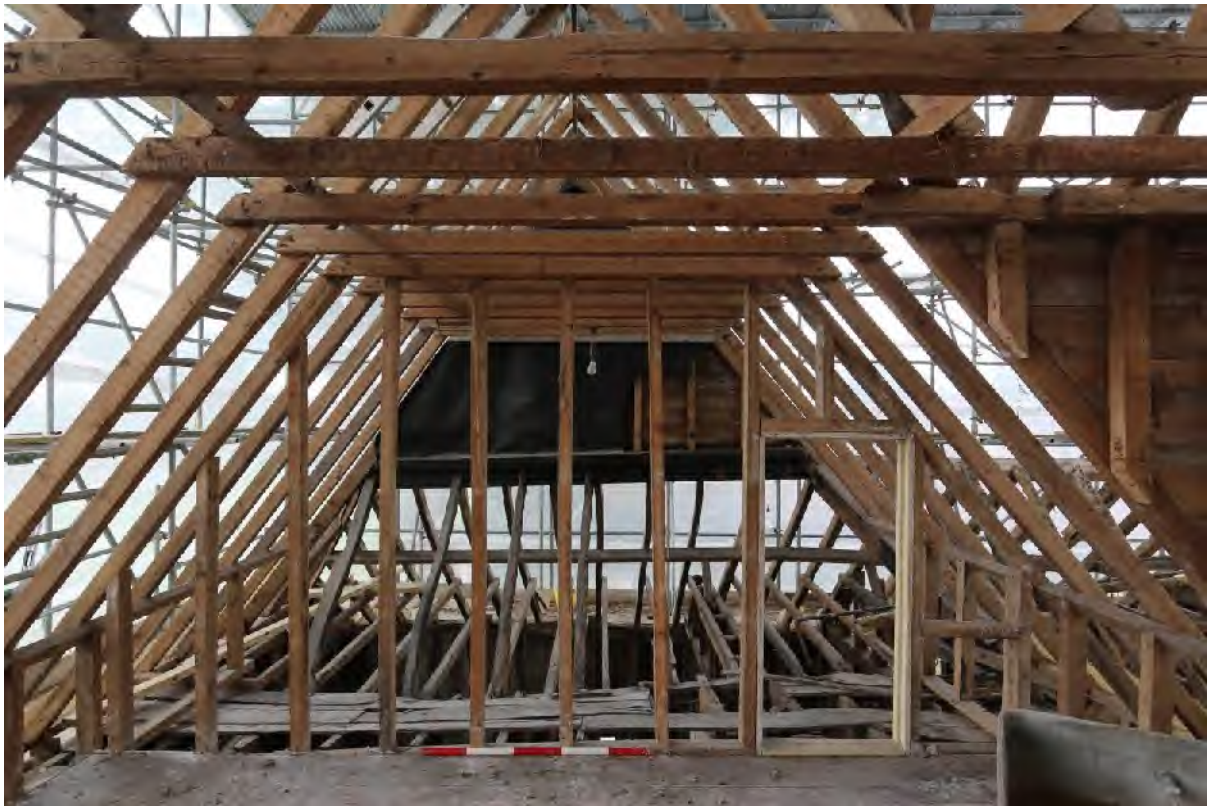
6.17.3 The northern part of the roof over the cross wing is an historic roof but is not the original. The common rafters include some re-used wide and flat laid original rafters, alongside later additions. The former show evidence of halving where they were formerly pegged together at the ridge, prior to the insertion of the ridge board. The roof is a clasped side purlin form using collars pegged into the principal rafters and intermediate collars positioned at half bay widths (**Plates 95 and 96**). The rafters pinch a narrow ridge board, suggesting that these northern bays had been reworked, probably when the southern part of the cross wing, which uses regular machine cut timber, was rebuilt during the 19th century. The roof structure over the front (south) bays (above F1 & F2) is all post-fire (**Plates 97 and 98**).

Plate 98 Post fire roof and stud wall in attic

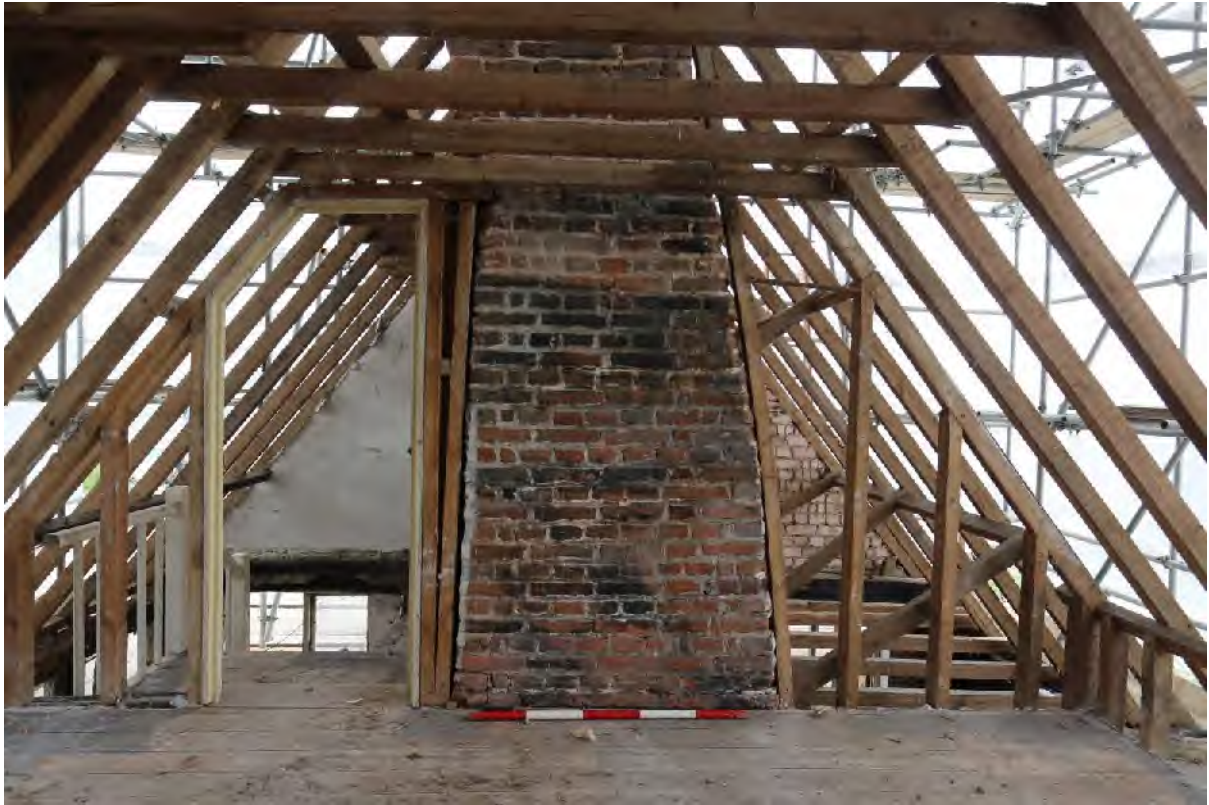
Plate 99 Attic room and brick stack, looking east

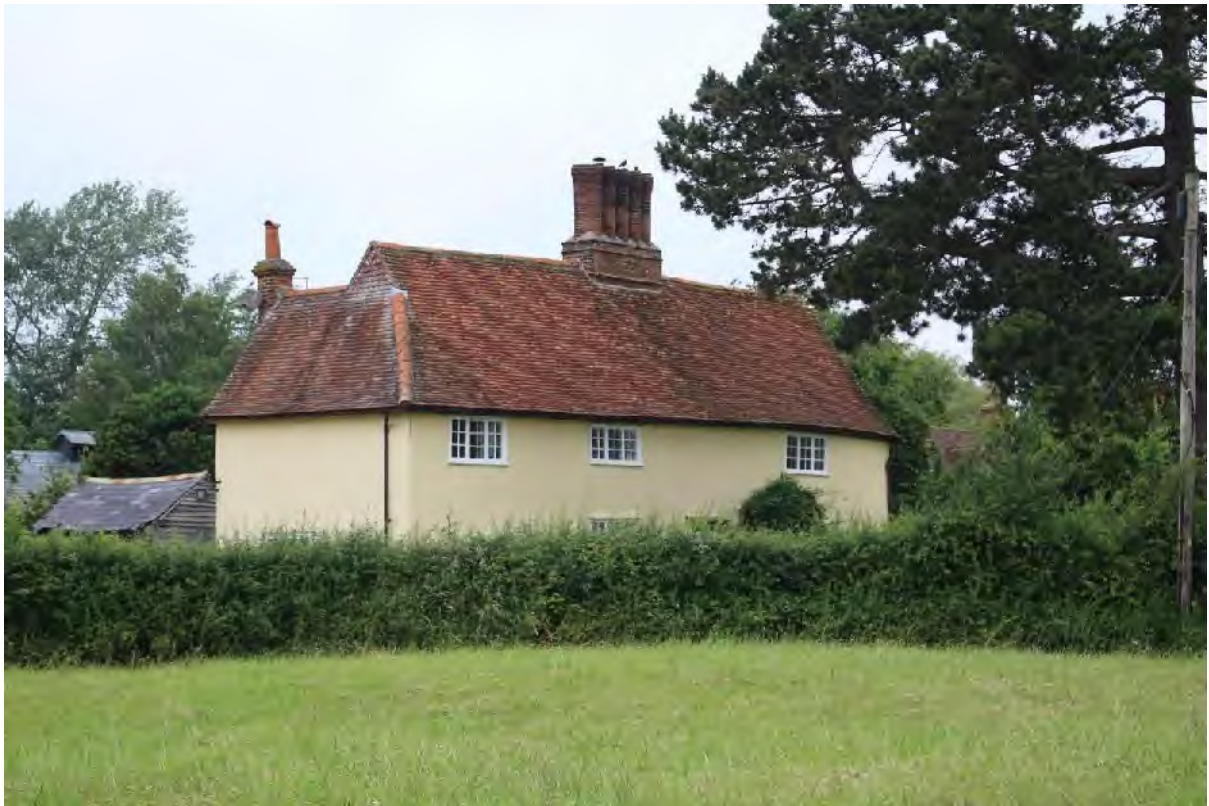
2.2.5 Spring Cottage (Grange) due to its long-term disuse and deteriorating condition, appears on the East Herts DC Heritage at Risk register 2019/20 (ref 1174428). It lies within the Wood End Conservation Area which also includes a number of historic farmhouses and associated farms. Notably the former Cherry Farm, lying at a short distance to the south-west (Figure 2), incorporates an almost identical chimney stack with in-line diagonal shafts, so presumably shares a 17th century phase contemporary with Spring Grange (Plate 100). Its list description reads:

Plate 100 Adjacent Grade II listed Cherry Farmhouse built with a comparable chimney stack
