St Martin Church, Belper, England	EXISTING SOUTH DOOR
Mar 23	
Ref - 22CHURCHINTERIORS07

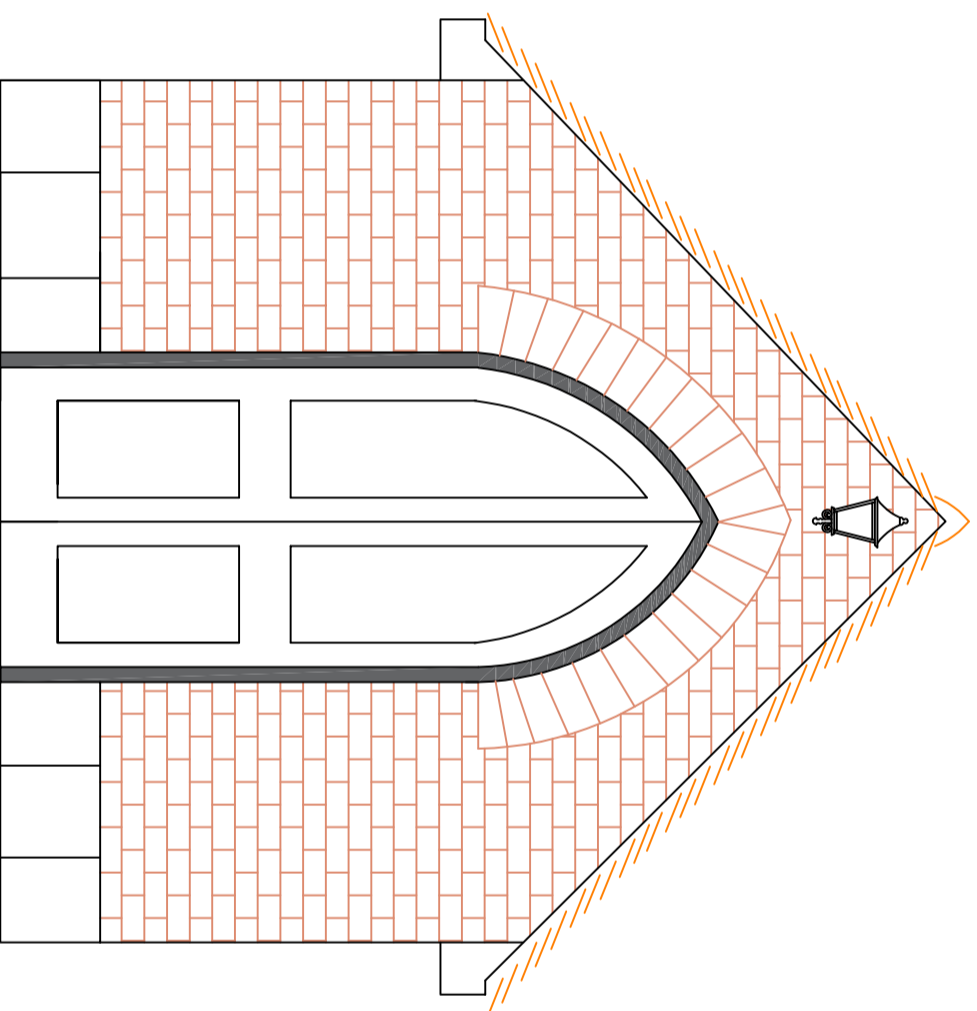
Existing Doors formed from plywood and in poor condition. Doors are not original (ply), so a repair would not be ideal. Door is rotten. Replace with solid timber doors and new glazing (double to match existing), painted black. New door handle and locks. New ironmongery.
