PROPOSED ENTRANCE - NORTH ELEVATION
SCALE 1:50 @ A3

St Martin Church	PROPOSED NORTH DOOR
Mar 23	
Ref - 22CHURCHRENEWALS06

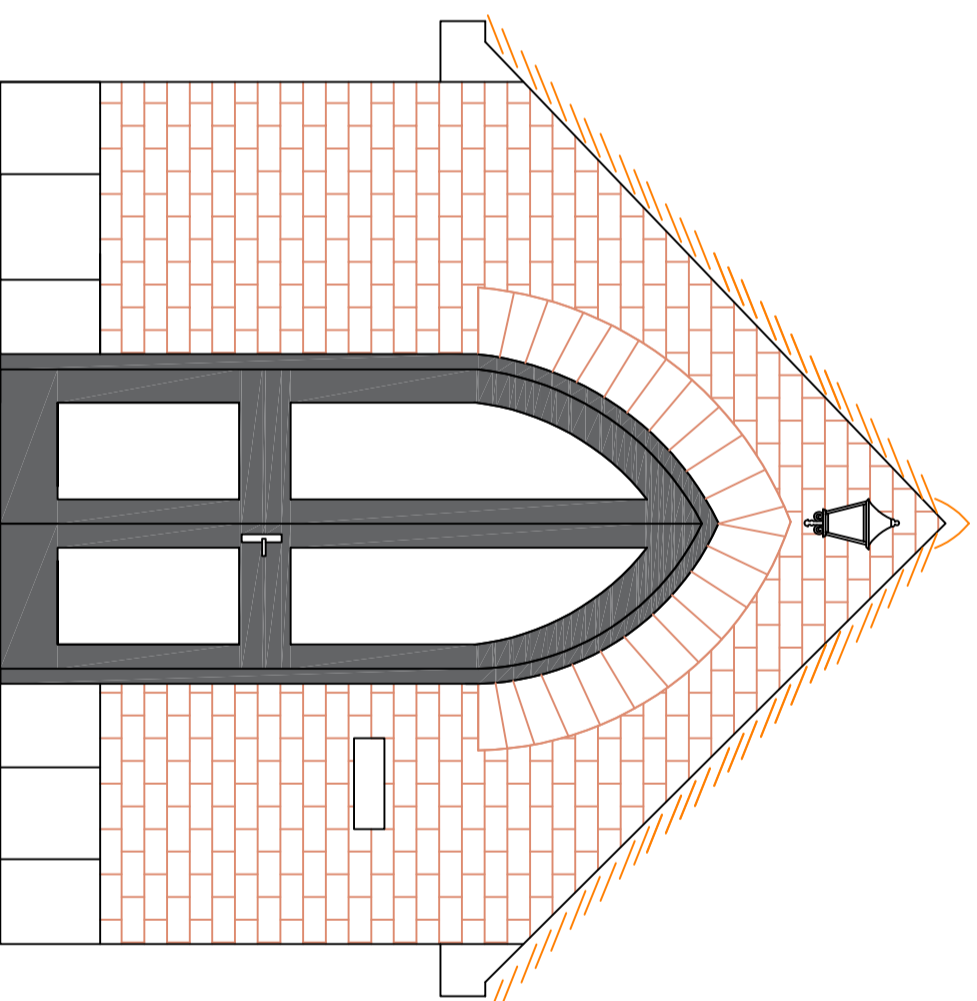
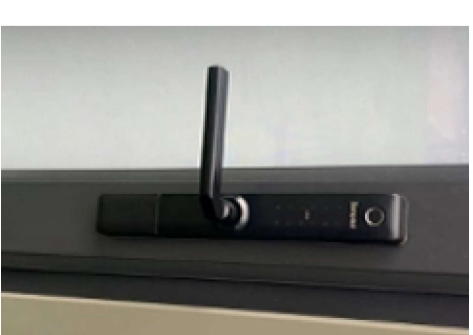
Existing Doors formed from plywood and in poor condition. Doors are not original (ply), so a repair would not be ideal. Replace with solid timber doors and new glazing (double to match existing), painted black. New door handle and locks. New black ironmongery to match existing.
