GFW02 W02

Project: Whitfield Farmhouse, Hungerford Lane, Shurlock Row, RG10 0NY Drawing: GFW02 W02

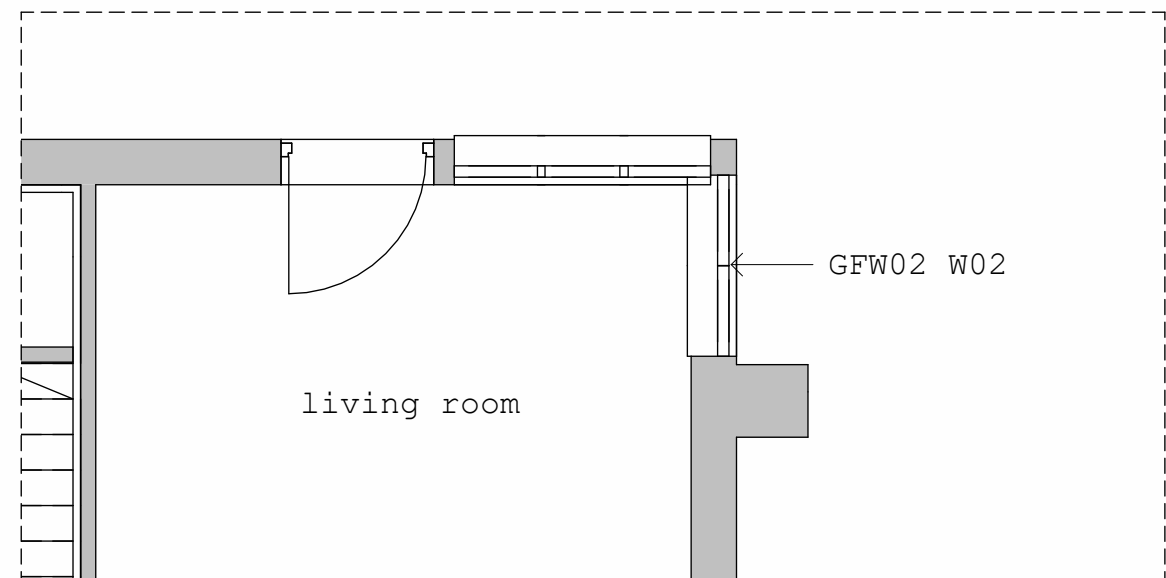
elevation - 1:20

current condition:

estimated early C20 casement window

painted shut, unable to easily open

window has a poor thermal construction, and has therefore been fitted with internal secondary glazing

images show the windows have previously had internal glazing bars removed (highlighted with adjacent dashed red linework)

proposed replacement unit:

2 light 1 window unit to be replaced with like for like timber unit

replacement unit to contain leadwork to match existing

slimline double glazing to remove the need for any further secondary glazing
