GFW04 W04

Mar 24 planning Drawn By:

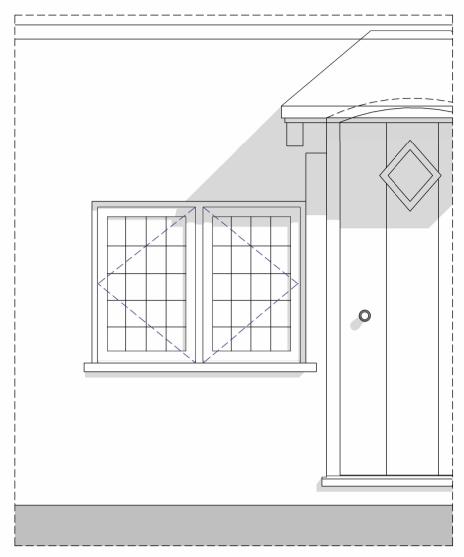
front elevation - 1:20

estimated late C20 casement window painted shut, unable to easily open LHS of external cill rotten

3 light 1 window unit to be replaced with like for like timber unit

replacement unit to contain leadwork to match existing

slimline double glazing to remove the need for any further secondary glazing
