**GFW01 W01**

Project: Whitfield Farmhouse, Hungerford Lane, Shurlock Row, RG10 0NY Drawing: GFW01 W01		RIBA Chartered Practice
	Collaborating with: Linda Behan	Date: Mar 24	
Job: 997	Drawing: 10-00	Revision:	Drawn By: JB Checked By: EM
Colony Architects Ltd. The Wine Store, Brewery Court, Theale, Reading, RG7 5AJ +44 (0)118 380 0328 hello@colonyarchitects.com colonyarchitects.com

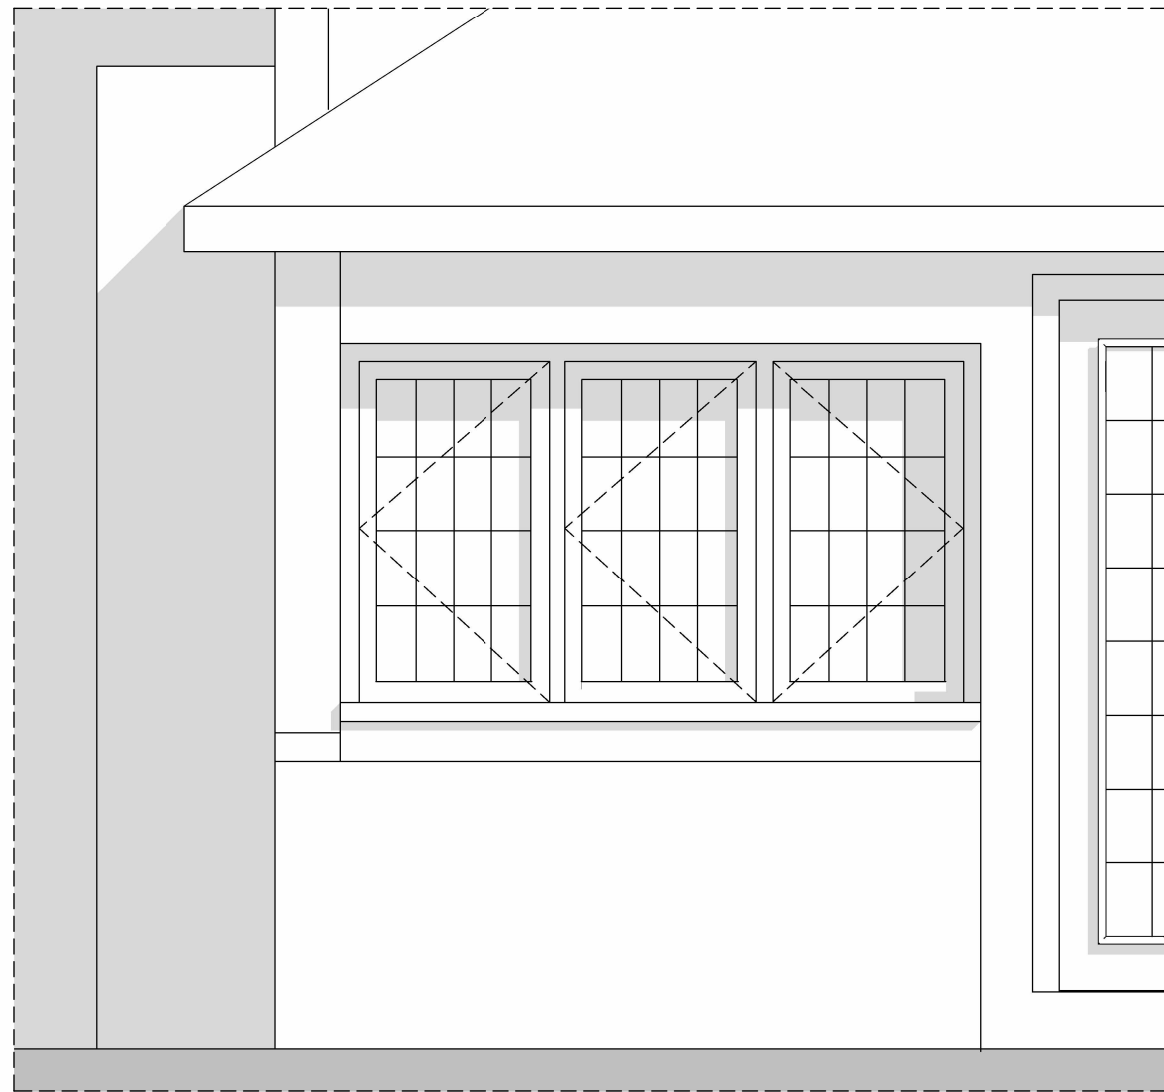
elevation - 1:20

current condition:

estimated early C20 casement window  
 painted shut, unable to easily open

window has a poor thermal construction, and has therefore been fitted with internal secondary glazing

images show the windows have previously had internal glazing bars removed (highlighted with adjacent dashed red linework)

proposed replacement unit:

3 light 1 window unit to be replaced with like for like timber unit

replacement unit to contain leadwork to match existing

slimline double glazing to remove the need for any further secondary glazing
