28th November, 2023
Our Ref: AR/4090-L4/jq

Woodbury, 28 Sandhurst Road, Crowthorne, Berkshire RG45 7HS
Re-positioned garage - BFC Ref: 21/00249/FUL

Site Plan - Proposed Garage and Drive Extension

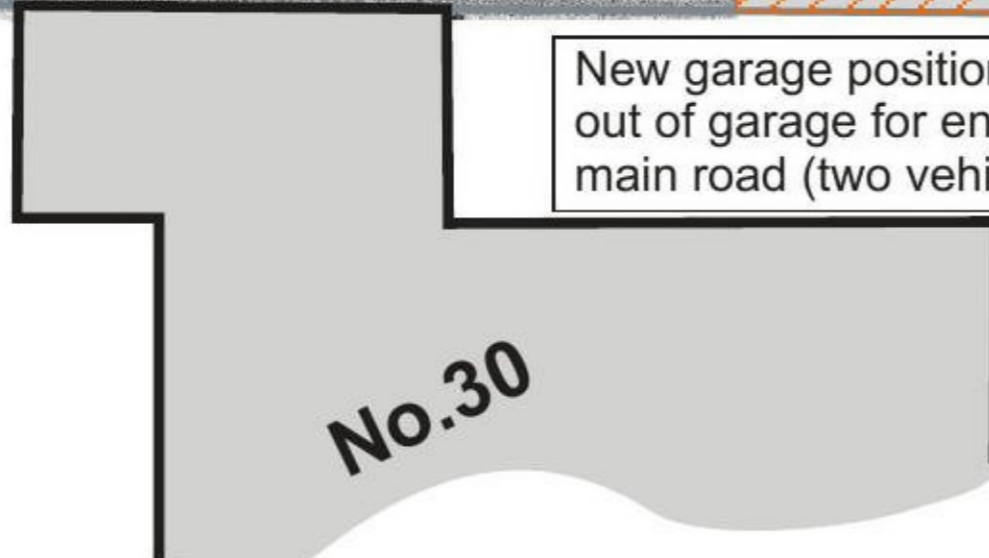
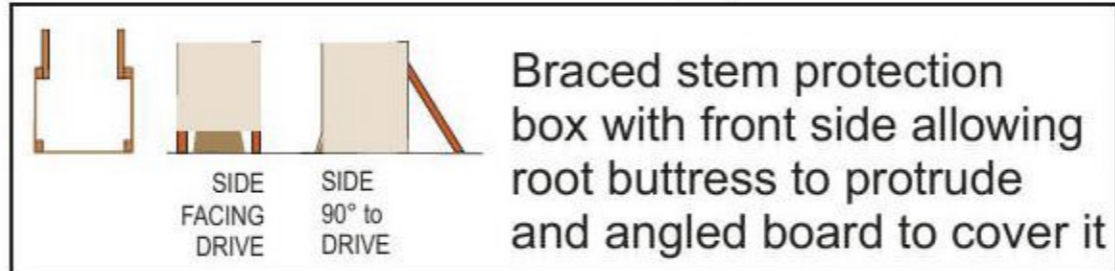
Steel bollard with luminous top to protect the oak

Braced stem protection box with front side allowing root buttress to protrude and angled board to cover it
