**EDGECOMBE GARAGE
Abson Road,
Abson, Wick, Bristol BS30 5TT**

**STRUCTURAL REPORT
ON
GARAGE BUILDING**

Date of inspection

28th November 2023

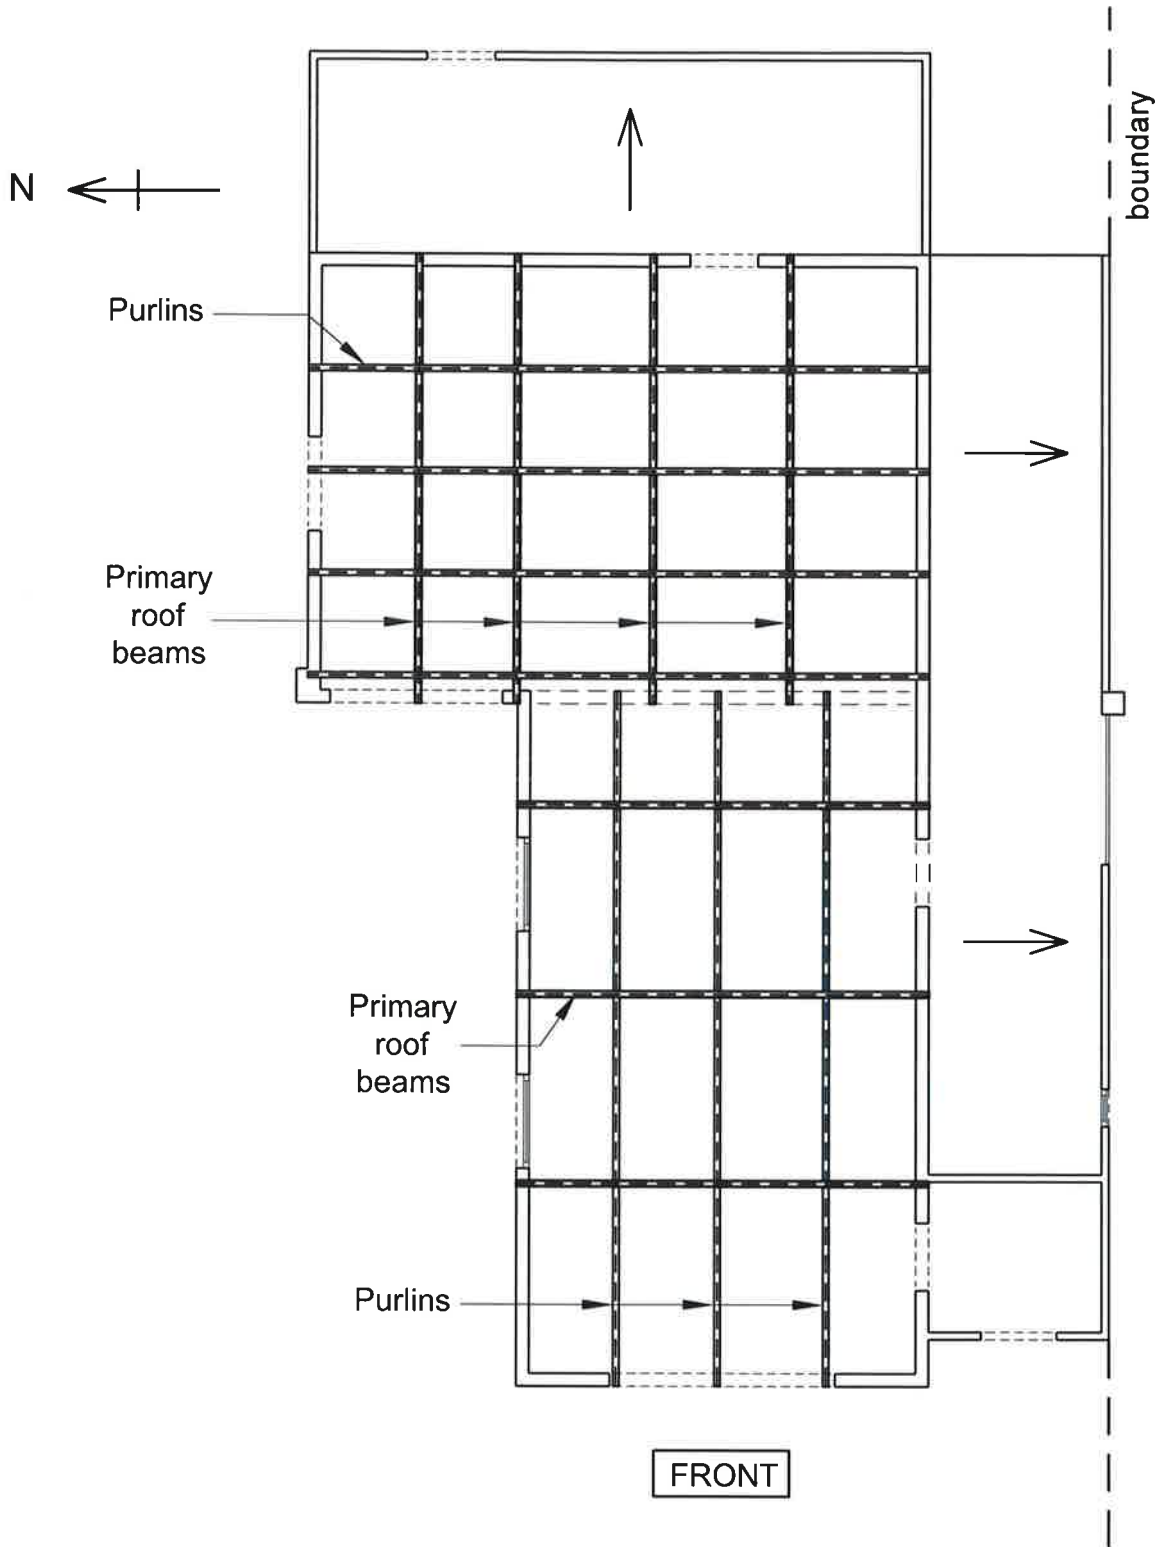
Plan on Garage Roof Structure

The front workshop roof sheeting is carried directly on longitudinal timber purlins, 80mm wide x 60mm deep. These are supported on the end walls plus a set of three inclined timber roof beams. These beams measure 230mm deep x 80mm wide and span across the 5.5m width of the workshop. Most of the connections between purlin and roof beam have been made using metal joist hangers. Both the purlins and roof beams appear to be in good condition throughout, showing no visual evidence of decay, structural distress or excessive deflection.

The back workshop roof has 125mm deep x 75mm wide timber purlins equally spaced at approximately 1.35m. Intermediate roof support is provided by a series of four timber raking beams. These measure 230mm deep x 75mm wide and are set a varying spacings from 1.3m to 1.8m. In this workshop the purlins run over the top of the intermediate beams, leaving the latter unnotched which is structurally advantageous. Similar to the front workshop, all roof timbers appear to be in good condition, free of decay, structural distress and excessive deflection.
