# CONSULTING ENGINEERS

## RE: MOORBRIDGE FARM

### 1.0 Introduction

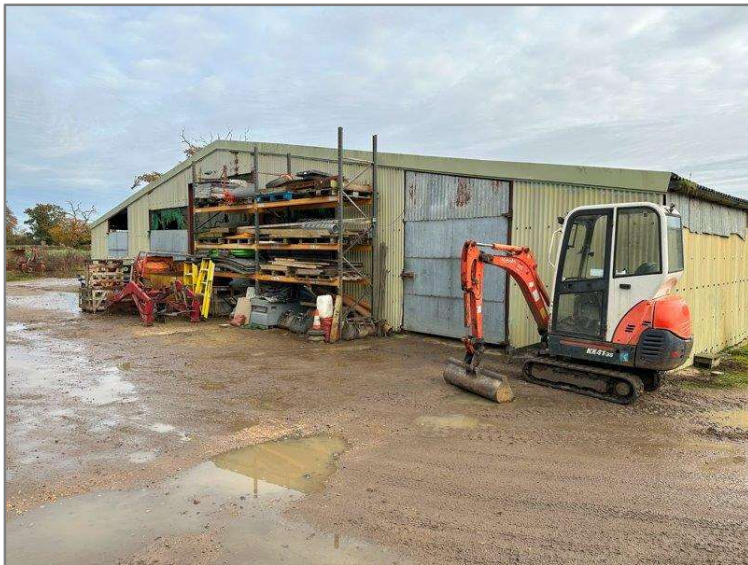
Photo 16

This barn is a steel framed structure with corrugated metal cladding to the sides and corrugated cement sheeting with plastic roof lights to the roof. The structure of the building is formed by a central series of steel portal frames at 4.57m centres with a span of around 10.35m and appears to have been extended to either side by around 6.5m with a steel mono pitch lean to formed of rectangular posts and beams to give an overall size of approximately 54.8m x 23.35m, Photos 15 – 17 show the external elevations and 18 – 19 the internal view.
