LEVEL 3

Your survey report

5A Northgate
CHICHESTER
PO19 1BA

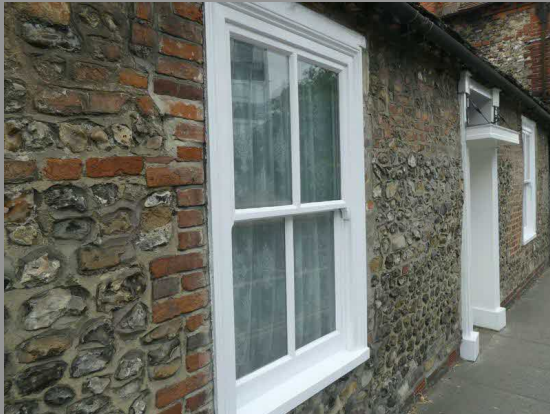
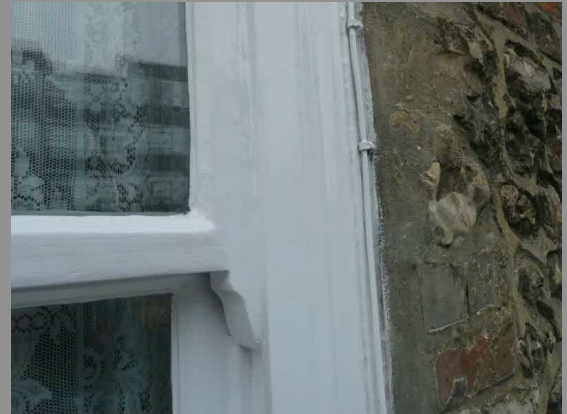
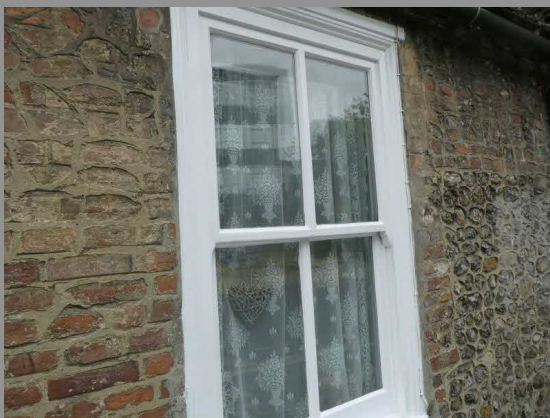
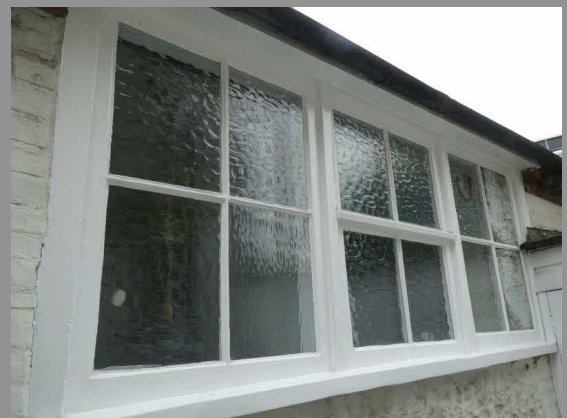
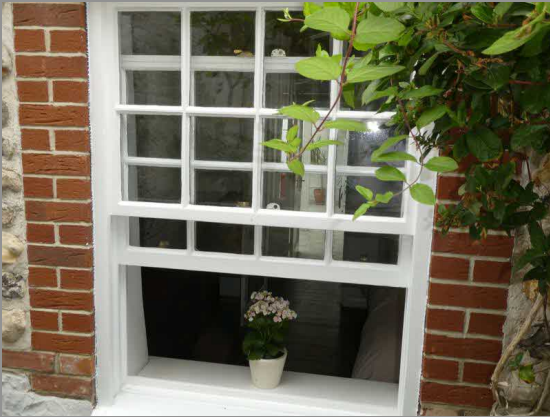
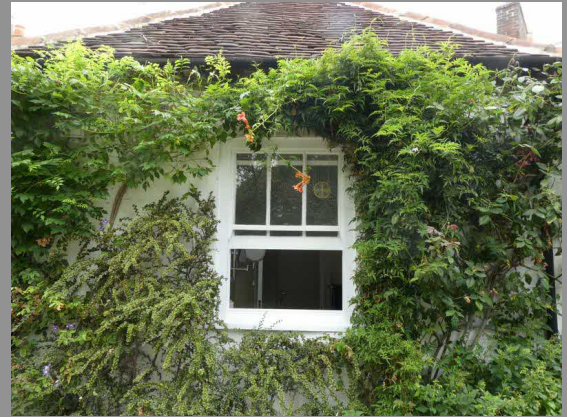
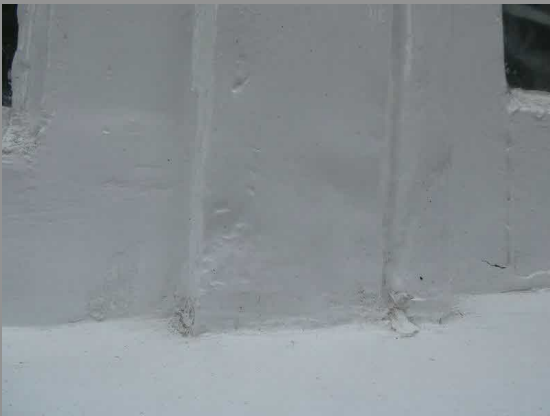
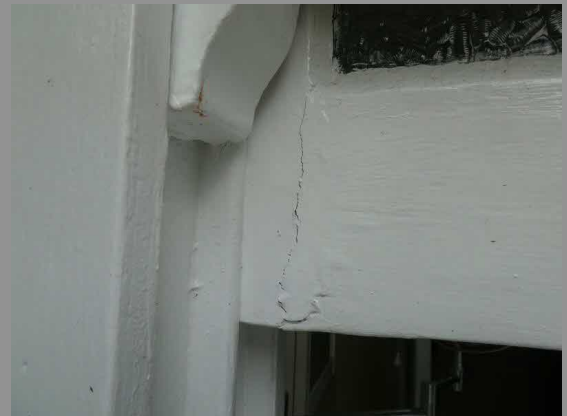
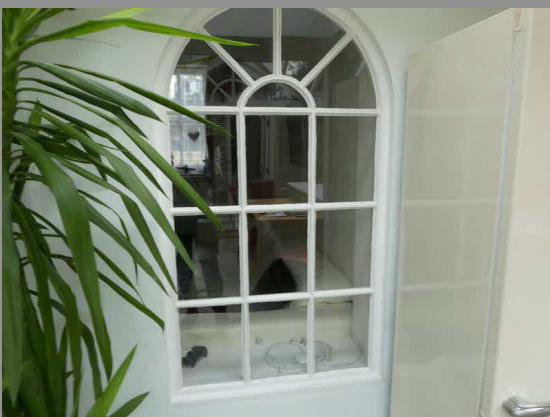
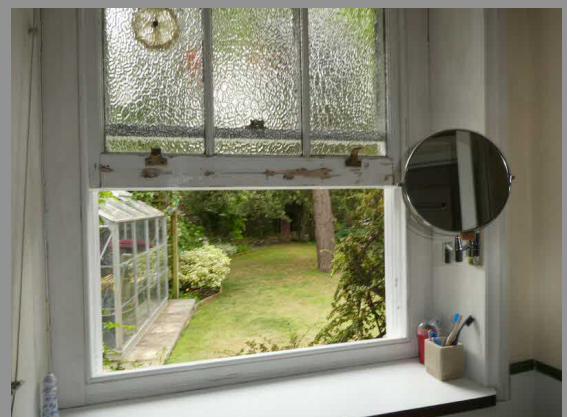
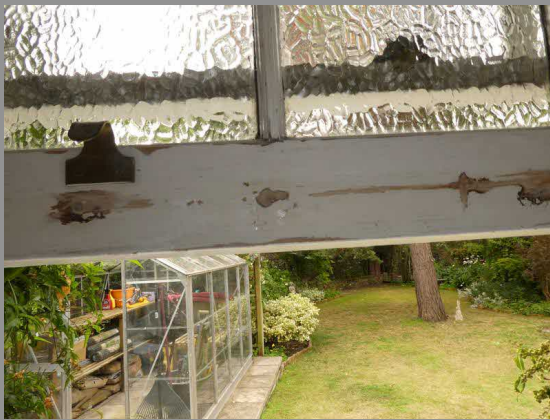
The junction between the window and door frames and surrounding wall is frequently a source of water penetration, particularly during severe weather conditions. It is important that the sealing material that protects these joints is regularly checked and maintained in good condition.

Condition rating 2. These works / investigations should be carried out soon.

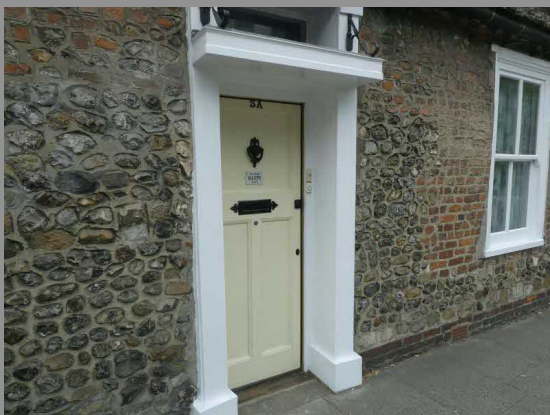
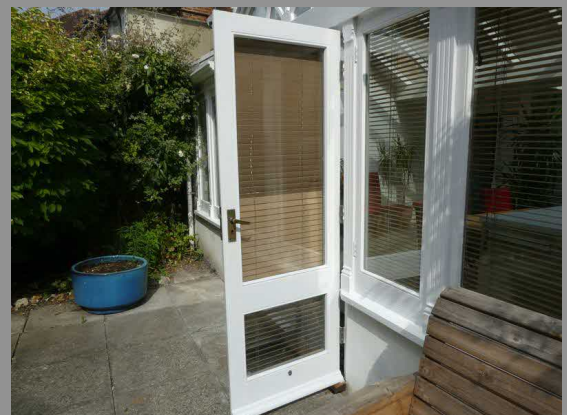
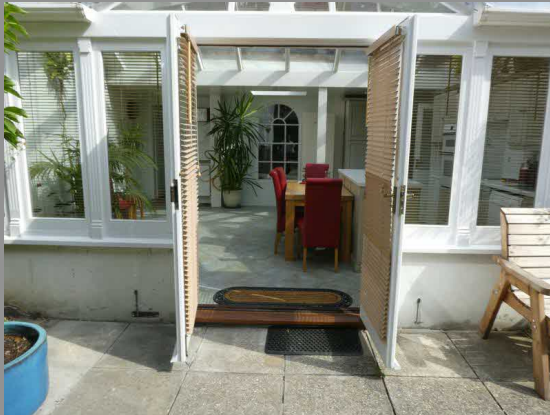
See our comments above in respect of timber generally, the durability of sealed double glazed units and sealants to door/wall junctions.

Condition rating 1. No repair is currently needed. The property must be maintained in the normal way.

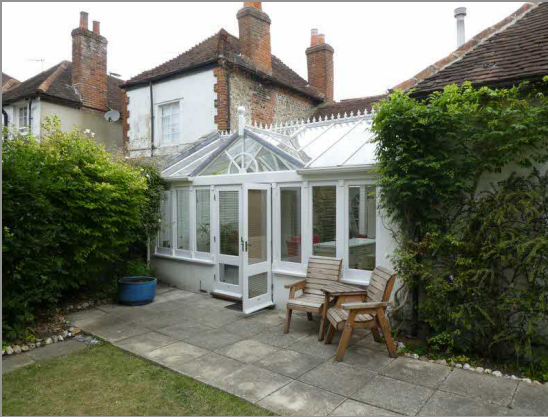
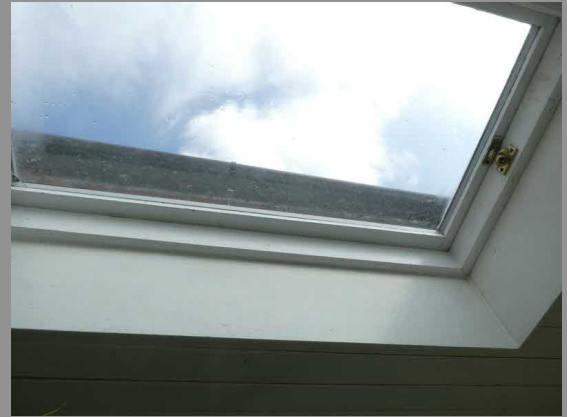
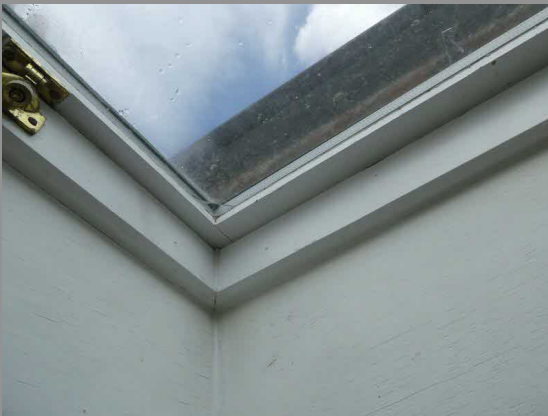
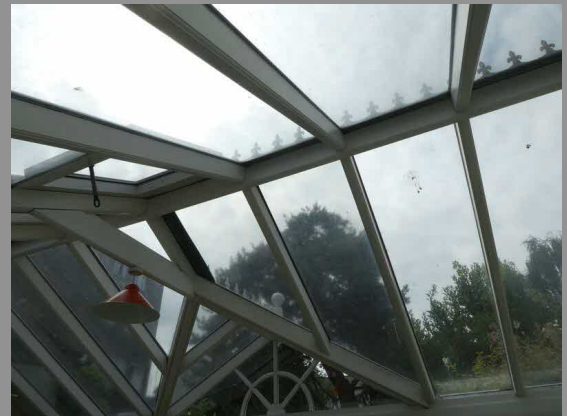
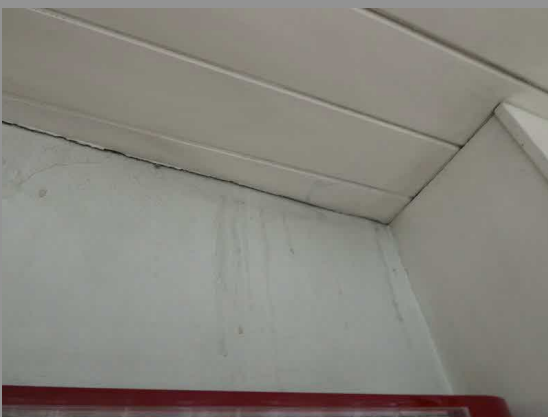
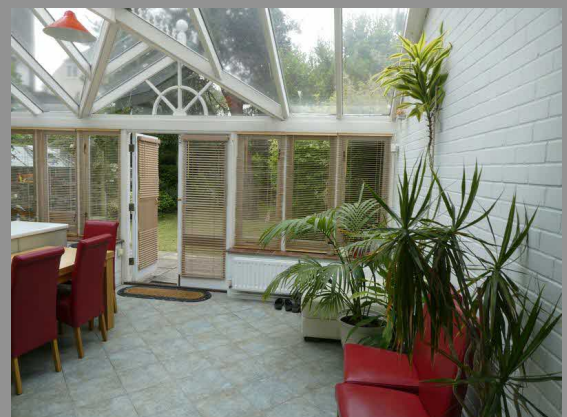
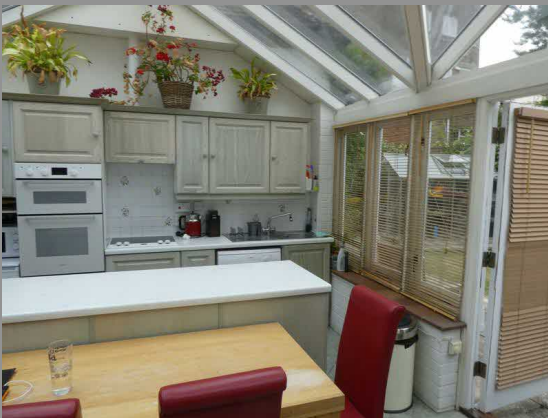
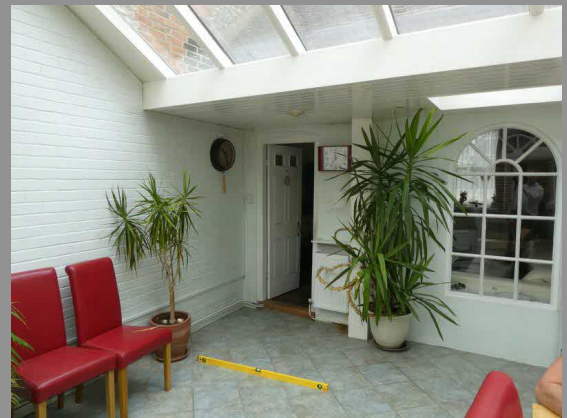
See our comments in section D2 regarding the flat roof area.

Condition rating 3. These investigations should be carried out immediately.

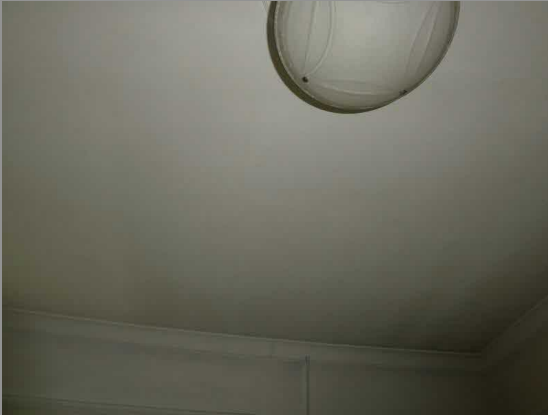
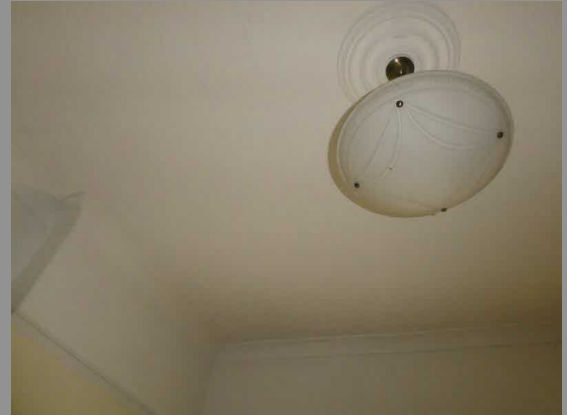
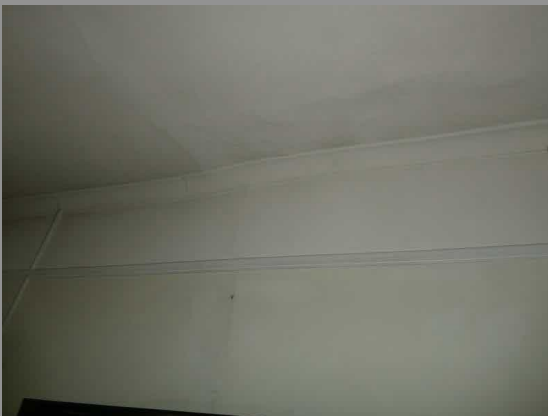
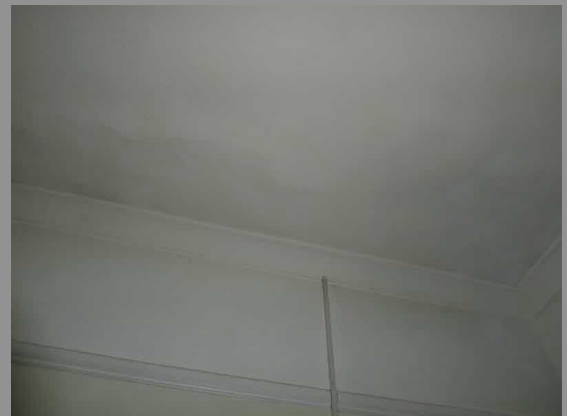
Many of the ceilings within the property are concealed by paper linings. Although no significant defects were noted, there are areas of unevenness which suggests loss of key. Whilst serviceable at present, should you remove the lining it is likely that areas of plaster will become detached and that localised repairs will then be required.

Condition rating 2. These works should be carried out soon.

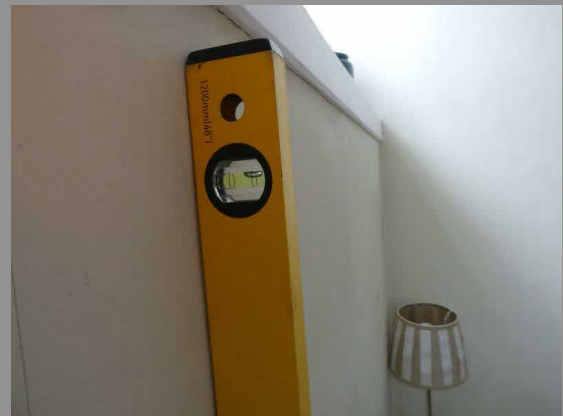
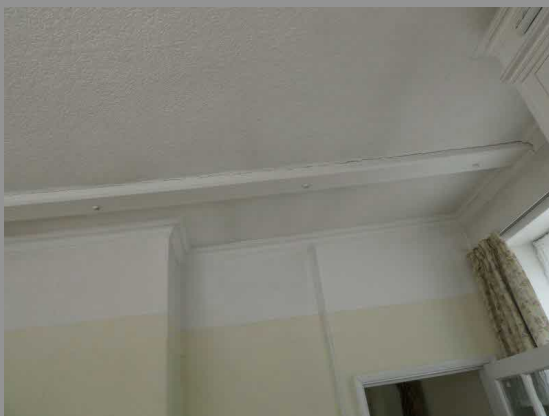
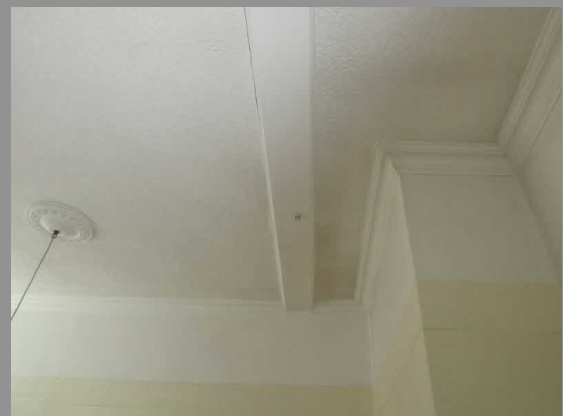
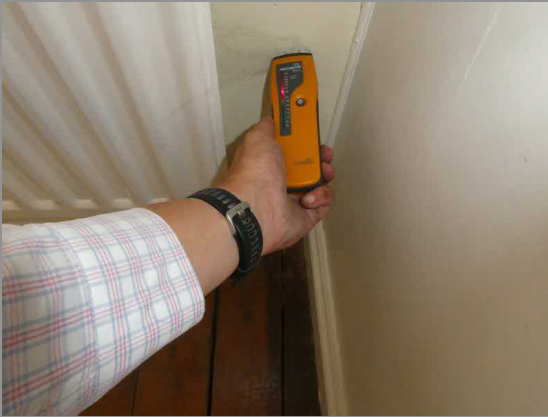
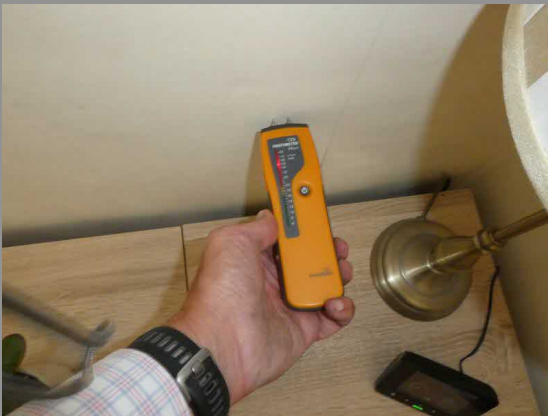
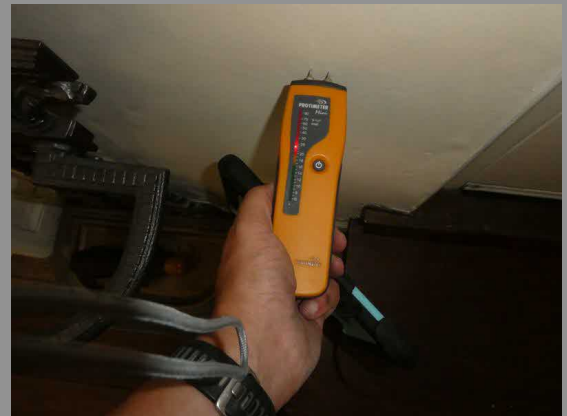
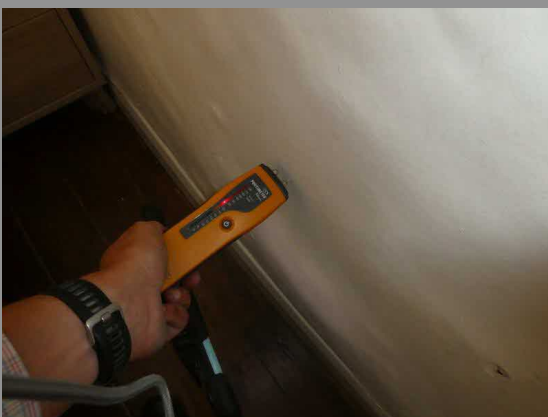
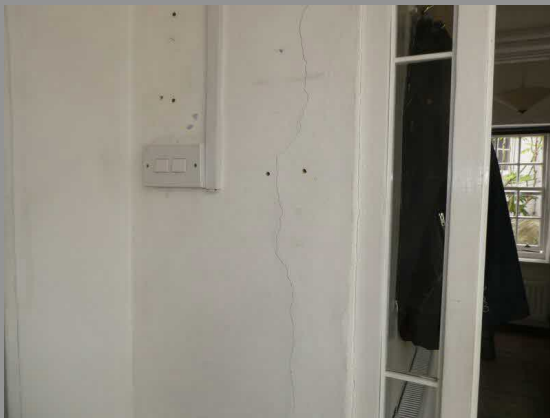
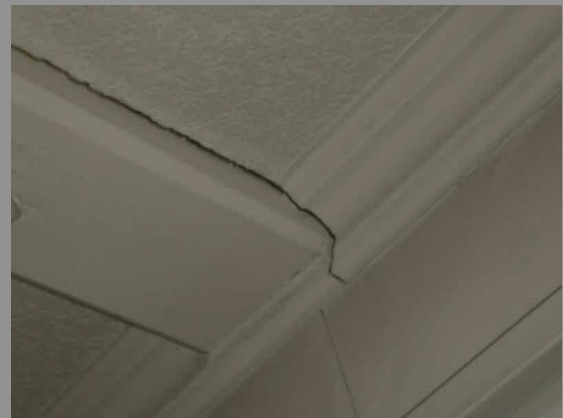
Many of the walls are concealed by paper linings. Although no significant defects were noted, there are areas of minor cracking and unevenness, which suggests loss of key. Whilst serviceable at present, should you remove the lining, it is likely that areas of plaster will become detached and that localised repairs will then be required.

Dampness was detected at low level to the main walls and further specialist investigation to the whole property is required prior to exchange of contracts. Any structural floor timbers which are in contact with damp masonry are at risk from decay and you should instruct your specialist firm to check the sub floor timbers for defects and again carry out appropriate remedial treatment as required.

There is also some minor hairline cracking in several locations, notably at the junctions of walls and ceilings. The cracking is the likely result of some drying out and resulting shrinkage of the plaster. The cracking is common, is of little cause for concern, and can be dealt with in a cycle of decoration.

There are timber lintels in both bedrooms which may have been where a load bearing walls have previously been removed. The lintel are deflecting and there are gaps in the lining paper along the side the of lintels, suggesting recent movement. This is probably due to inadequate support being provided. This may be serious and you should now obtain a report from a Structural Engineer which should include a detailed analysis of the cause of the defect, and the works that are required to remedy the problem and associated costs. This investigation should be carried out prior to the commitment to purchase.

Condition rating 3. These investigations should be carried out immediately.

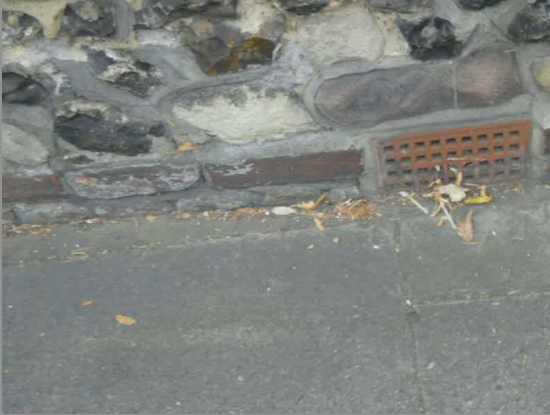
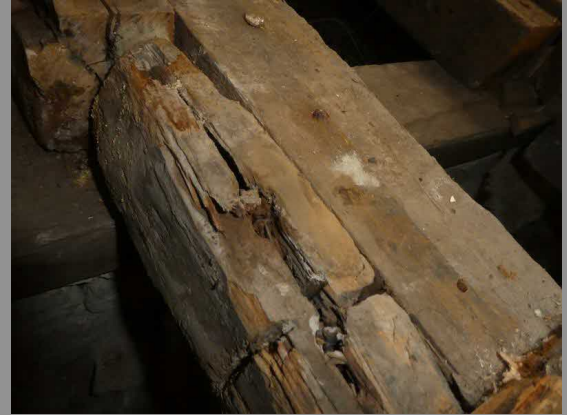
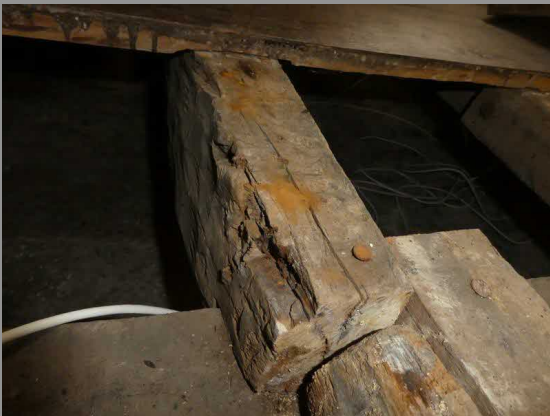
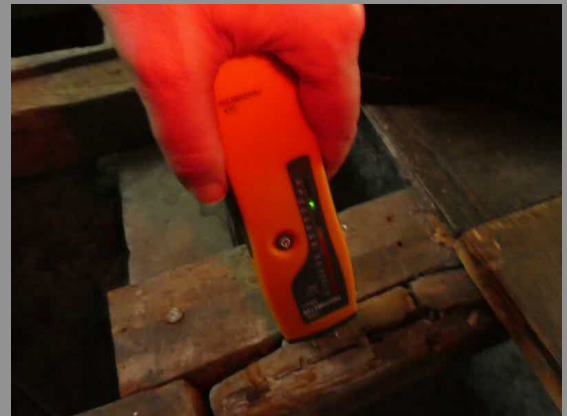
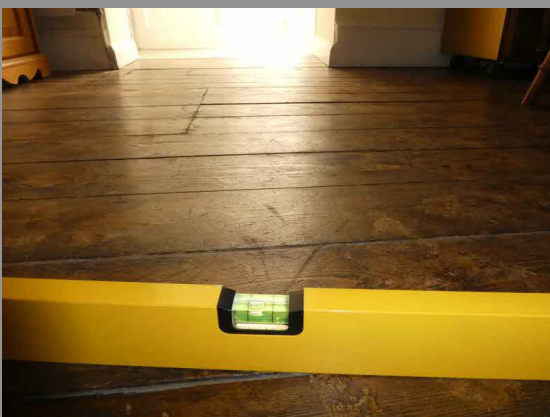
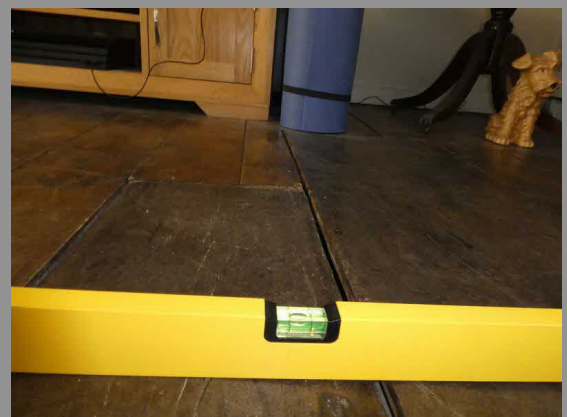
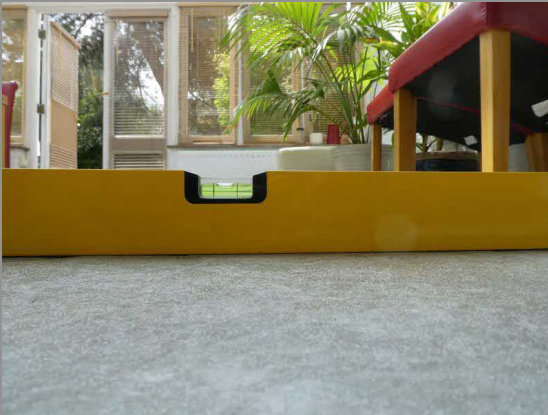
Floor finishes included tiling and carpeting. Many of the floors have exposed timber floorboards which are uneven in places and there is a loose panel in the sitting room. This is common with floors of this age and these should be repaired soon. The exposed timber floors are likely to be cold and draughty in the winter.

The loose panel was raised and the timber visible appears to have suffered from some decay but was dry at the time of our inspection. The timber inspection recommended in section E1 should include the subfloor where possible.

The floors are of suspended timber construction. The timber floors are in generally satisfactory condition with no signs of significant deflection or distortion. They were found to have minor spring and unevenness, but no repairs are needed at present. Due to the age of the building the distortion evident is greater than would be considered acceptable in a modern property. However, it is not of structural significance and can be accepted as the floor forms part of the inherent character of the property. Re-forming the floors can be undertaken, but is very disruptive and costly.

Condition rating 3. These investigations should be carried out immediately.

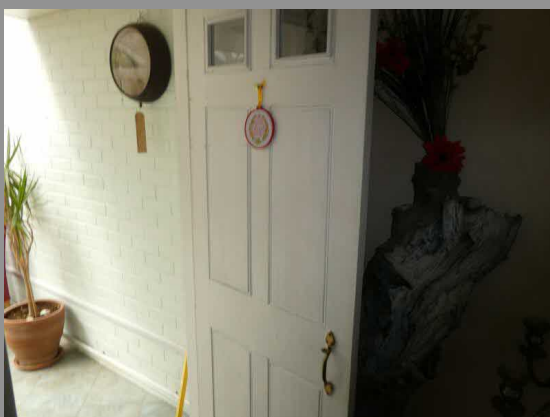
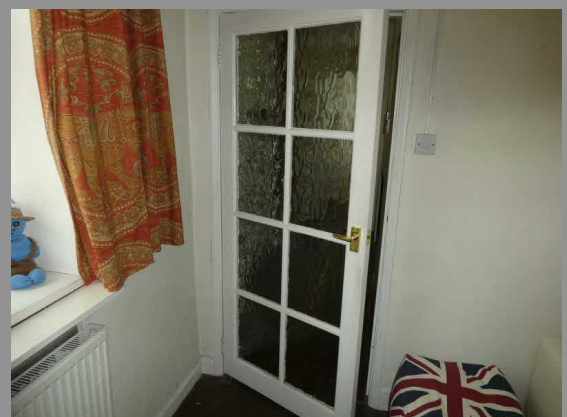
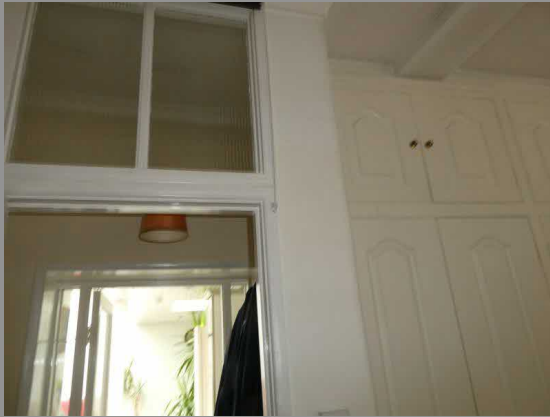
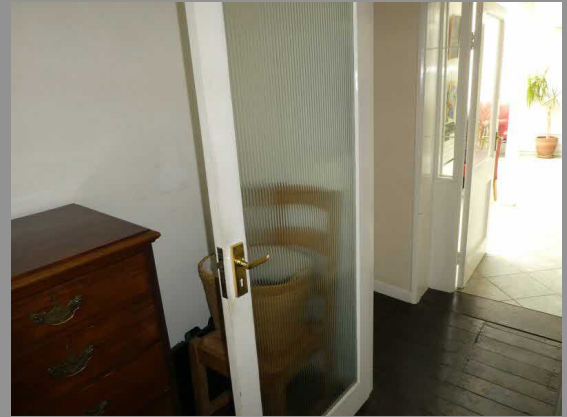
This comprises the internal joinery including doors, frames, skirtings, staircases, etc. These are adequately presented, subject to some general wear and tear and some of the doors need to be eased and adjusted.

Given the age of the property some paint may contain lead. Removal of lead based paint can pose a health risk unless correct procedures are followed. Urgent action is not required, but before paint is removed advice should be obtained from the Health and Safety Executive - <https://www.gov.uk/search?q=lead+paint>.

Condition rating 2. These works should be carried out soon.

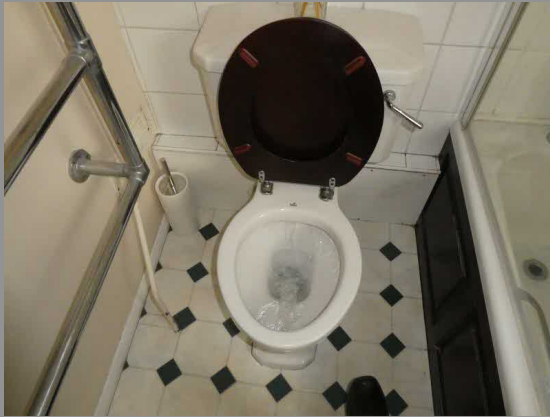
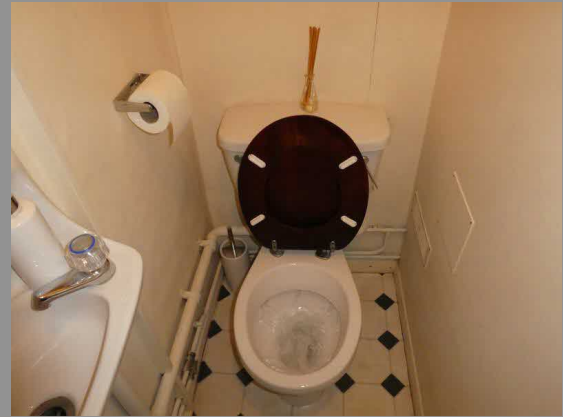
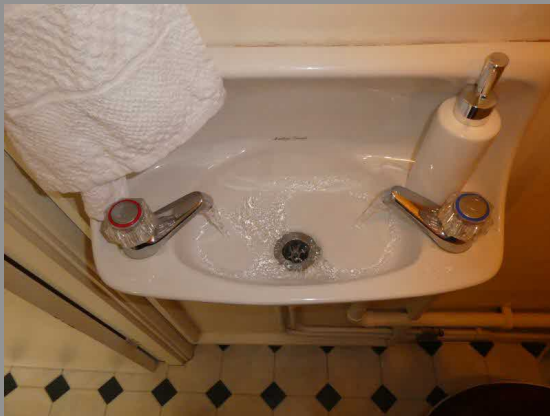
The property has a bathroom and separate WC. The sanitary fittings are dated and we assume you will be renewing them in the near future. We noted that there are missing plugs in the both basin and bath. 2

It should be noted that there is no mechanical extract fan in the bathroom, and the installation of a fan is advised to prevent a build up of moisture in the atmosphere.

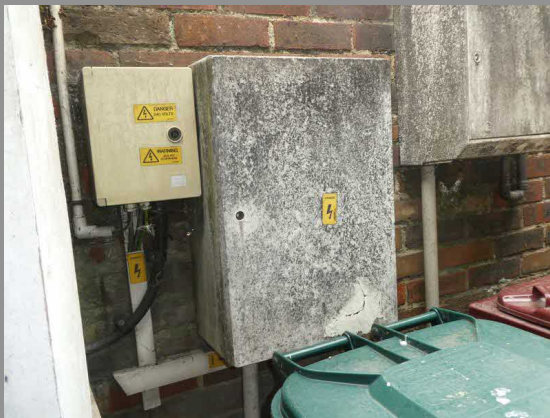
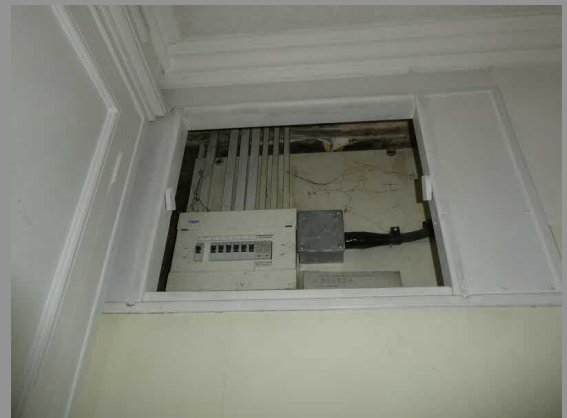
No electrical testing was undertaken and we can only advise that the electrical installation appears to be in working order with no significant defects or deficiencies. However, if it were formally tested it may not be found to comply with current requirements. Therefore, and in accordance with the information above, as the property is now changing ownership you should obtain a test report before you exchange contracts to confirm compliance.

Condition rating 3. These investigations should be carried out immediately.

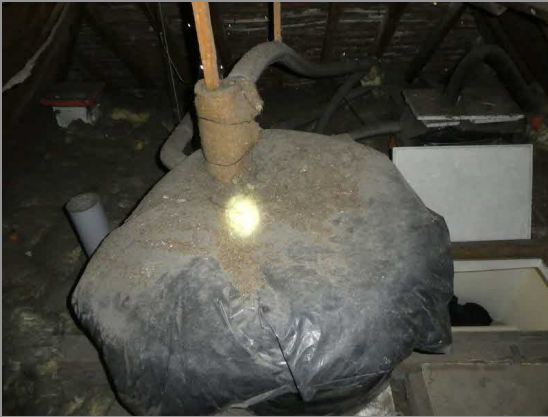
Photo - 116

Where visible, the pipework is in generally satisfactory condition and no leaks or other serious defects were noted. However, much of the pipework is concealed and it is, therefore, possible that defects could exist in unseen areas.

In view of the age of the property there may be older metal pipes present including lead. We recommend that any lead, steel or cast iron pipes should be now replaced.

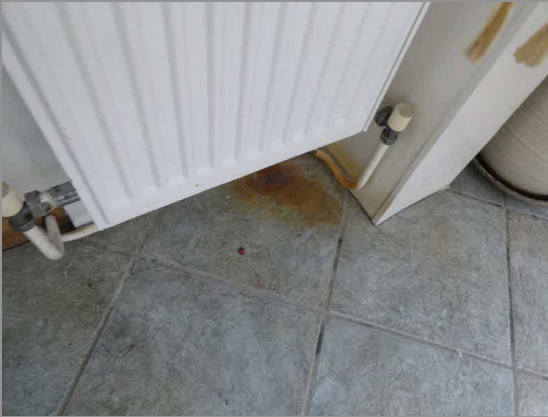
Photo - 119

Parts of the heating system are dated and should be regarded as approaching the end of their useful life. Replacement should be anticipated and we recommend you budget for renewal.

The radiator in the kitchen/dining room appears to be leaking and needs repair.

The system was not activated at the time of our inspection so we could not check its basic operation and we cannot confirm that the system meets current standards. As a matter of safety you should now arrange for a Gas Safe engineer to check and test the system prior to exchange of contracts.

Condition rating 3. These investigations should be carried out immediately.

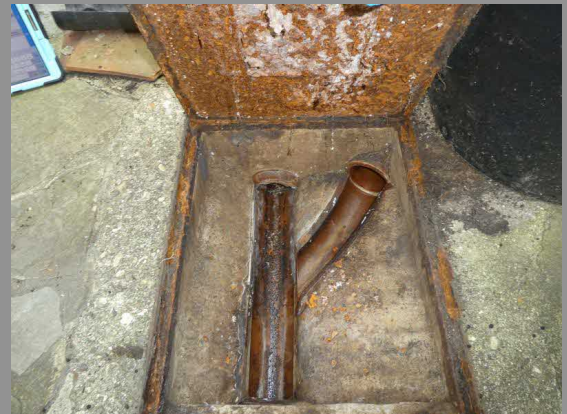
Photo - 123

The only cover on site was raised and the drains appear to be coming from the neighbouring property, sloping towards the subject property. The drains appear to run underneath the building. This will make access for repair and maintenance more difficult and expensive. With this in mind and in view of the age of the property, it is probable that the drainage system will have some defects that have developed unseen. Our limited inspection of accessible inspection chambers cannot confirm that the system is free from defects. As a precaution you should have the installation checked and tested prior to exchange of contracts.

Condition rating 3. These investigations should be carried out immediately.

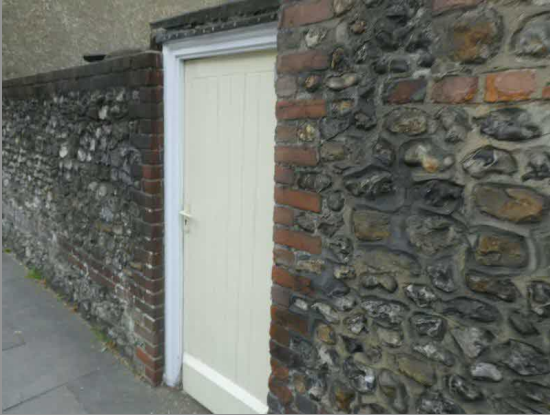
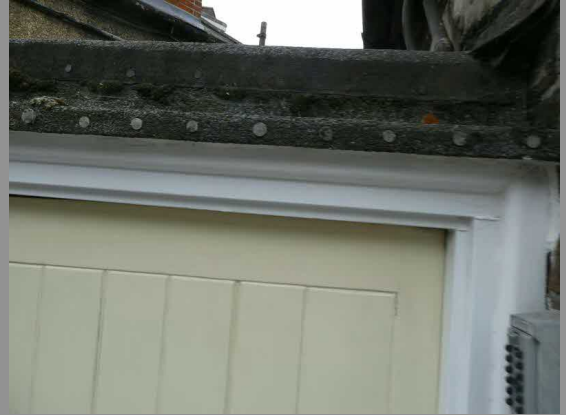
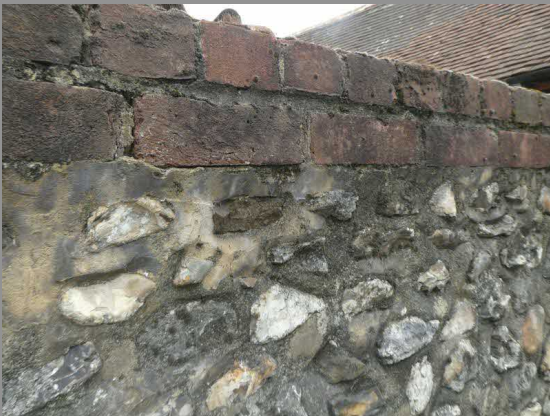
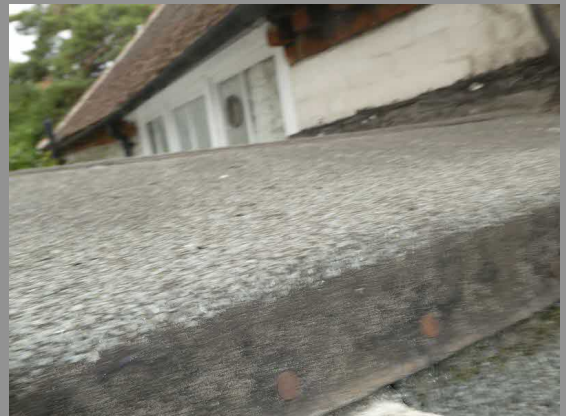
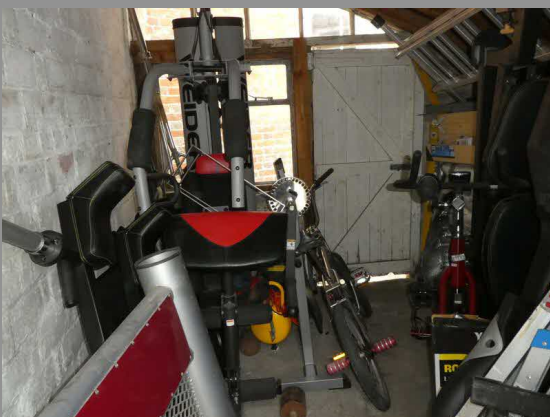
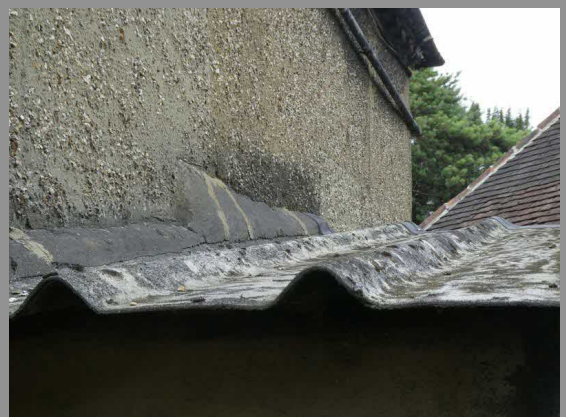
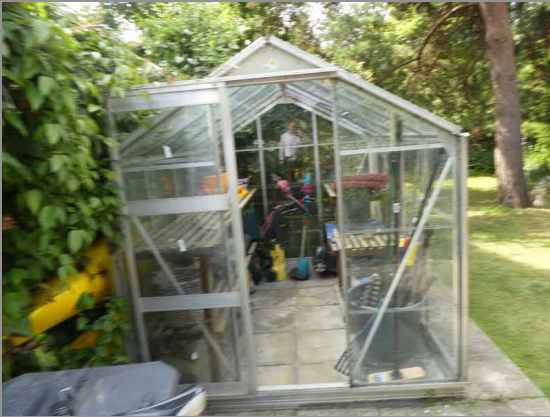
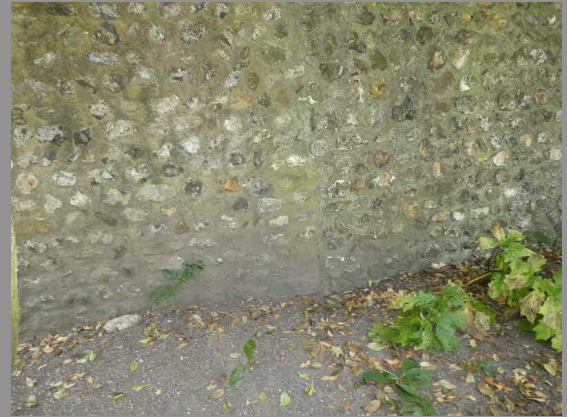
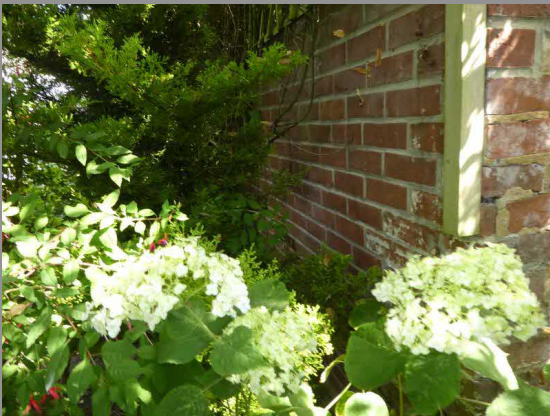
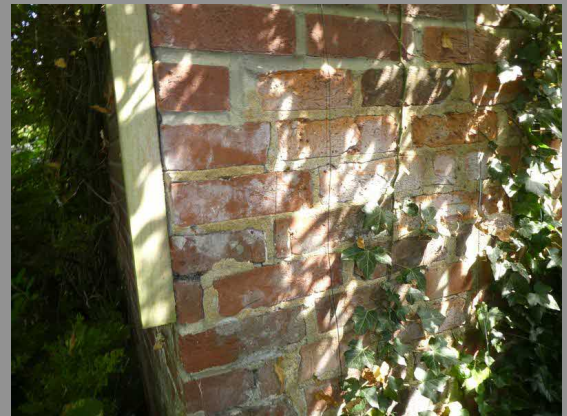
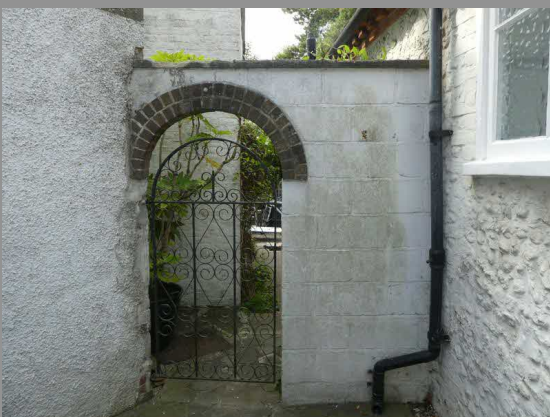
The brick and flint wall along the front boundary is in reasonable condition but some repointing is required. The wall just inside the courtyard with the metal gate is cracked in places and there are frost damaged coping stones on the top which need repairs.

The rear garden is enclosed by a mixture of brick wall and "Listed" stone wall, both were noted to be in need of repairs including cracking and leaning slightly. Ownership of the boundaries should be confirmed by your legal adviser so you are aware of which boundaries are your responsibility. Repairs to the listed wall are likely to be very costly if they are your responsibility.

The side gate and canopy are timber and in reasonable condition but the canopy will require preparation and redecoration in the near future. The felt roof covering is of some age and likely to have a limited life.

The small store is of rendered masonry under an asbestos cement roof covering with a part glazed timber door. The larger store is of brick and timber construction under a felt covered roof with metal and timber windows and doors. Both stores are in reasonable condition but require some repairs. The store doors are not fitted with safety glass. See our comments in section E9 regarding asbestos.

The greenhouse appears to be in reasonable condition but is unlikely to be fitted with safety glass and could be a hazard.

Condition rating 2. These works should be carried out soon.

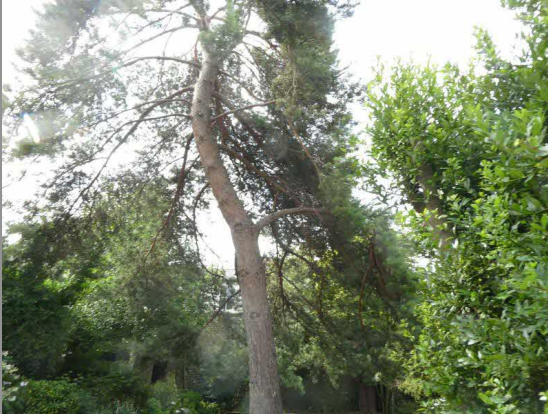
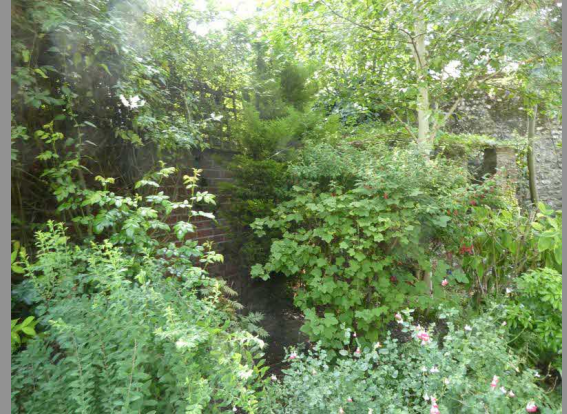
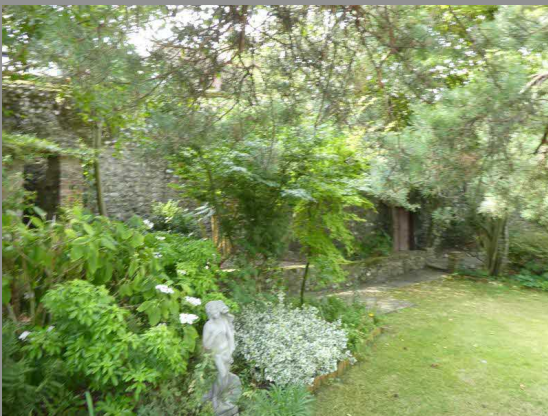
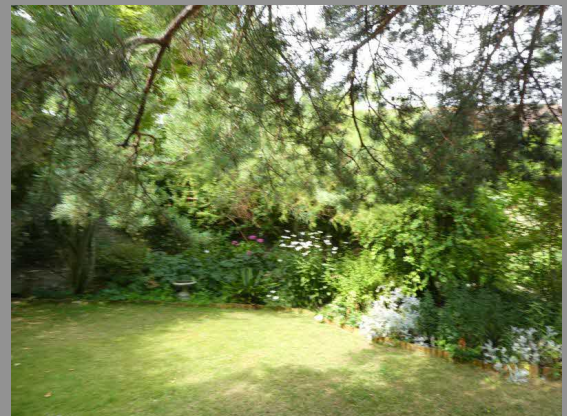
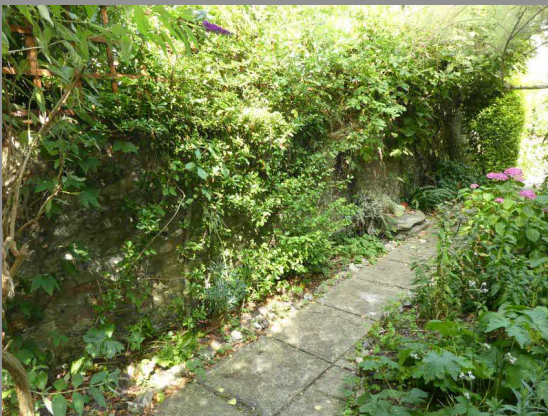
There is a large tree in the centre of the rear garden. Arrangements should be made for the trees to be kept regularly pruned to prevent them from increasing in size.

Condition rating 1. No repair is currently needed. The property must be maintained in the normal way.
