QUINQUENNIAL INSPECTION REPORT
of

SAWBRIDGEWORTH EVANGELICAL CONGREGATIONAL CHURCH

Date of Inspection: 22nd November 2023

MC/cp/ss/C328/1
15th December 2023

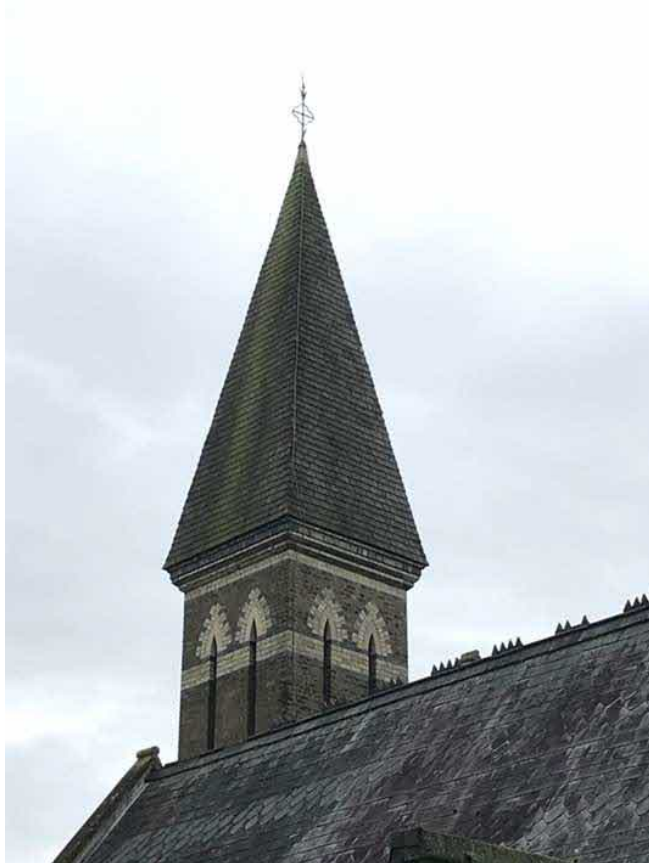
2.1 **Tower:** a steep pitched pyramid-form roof, finished on all four sides with cedar shingles, with a lead dressing at the top, a lightning conductor spike projecting through and the remains of a weathervane.

Condition: the cedar shingles appear to be largely in sound condition. Some have curled out towards the corners but nothing of any concern. No significant defects evident here.

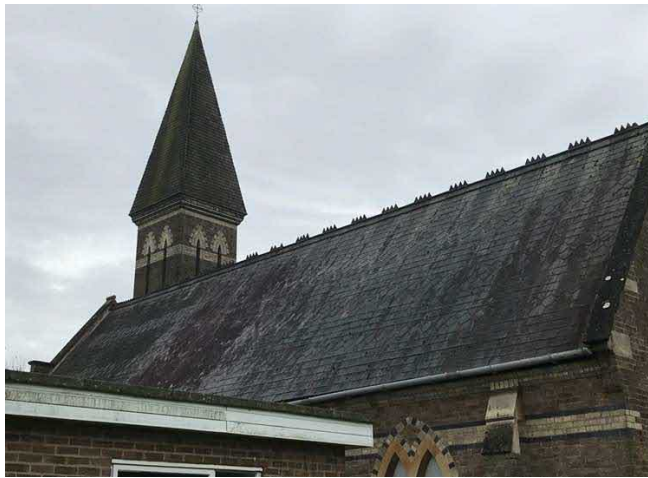
- 2.9 **North aisle north slope:** of natural slate with Staffordshire blue ridges and lead flashings at abutments to the parapet at each end. There are three bands of diamond slates across the roof finish.

Condition: all appear to be in good order.

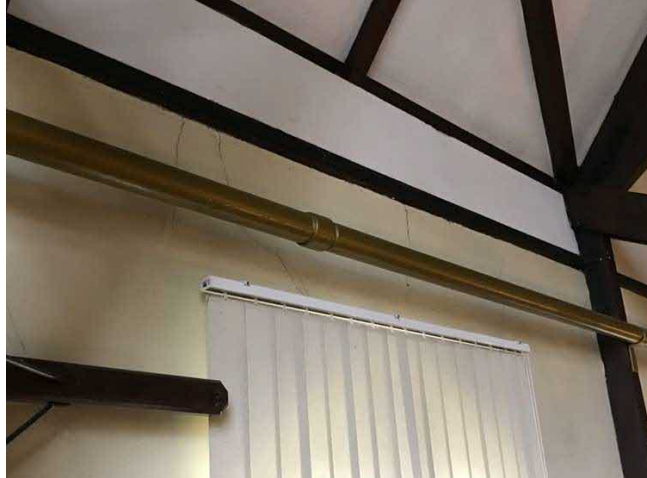
- 8.7 **Main chapel:** suspended timber floor, plastered and emulsion painted walls, a full set of original softwood pews.

Condition: largely in sound condition. There are some fractures to the west end around the organ apse. These are generally only fine cracks and indicate a small amount of movement of the gable end but nothing of any great significance. There are also some cracks to the southeast corner, as noted in the previous inspection report. These have been filled and the cracks have reappeared. Again, these are only fine cracks and indicate some movement in this corner which is currently not to a significant degree.

Repairs needed: monitor the hairline cracks to the south wall and, if they develop further, allow for structural opening-up and further investigations into the external conditions, including the drainage to this corner.

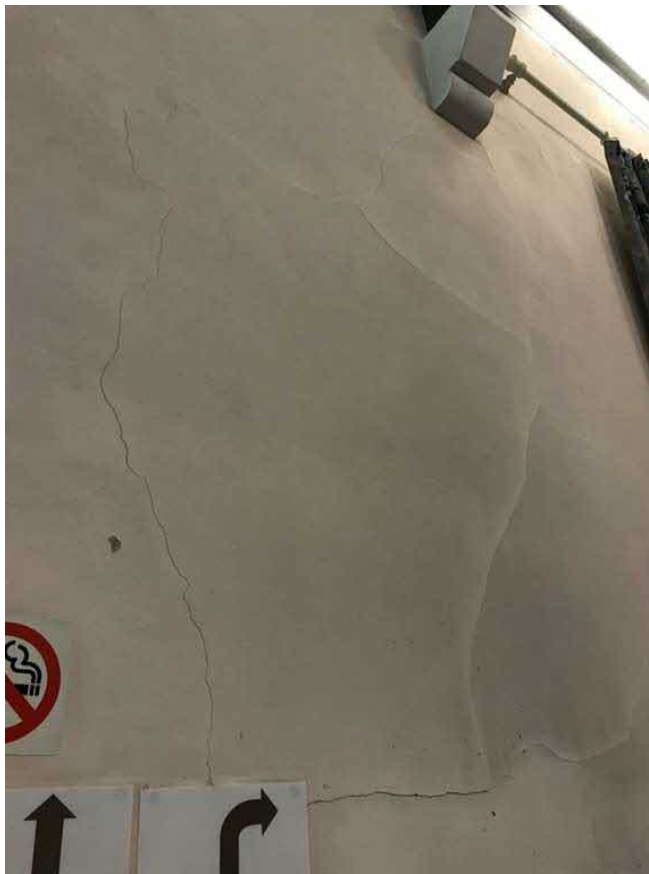
- 8.16 **North aisle hall:** solid concrete floor with sheet vinyl finish, gloss painted plastered walls with plasterboarded skim coated ceiling between a series of five exposed timber trusses supporting the roof. The rest of the roof structure is concealed from view above the ceiling. It would appear to be of purlins over the trusses supporting common rafters. There is a series of large timber boarded sliding doors between this wall and the main chapel.

Condition: I understand that the former suspended timber floor has been replaced in recent years with the current concrete floor and that the dado panelling has also been removed, with the wall at low level plastered. This wall is generally in good condition. There is some cracking along the line of the junction between the modern plaster and the older plaster finish above. There are also several hollow patches and random surface cracks to the modern plaster. This is currently not to the point where any repairs are required. However, repairs are likely to be needed in the next few years. The modern plaster is failing to adhere to the brick backing sufficiently well because of general moisture within the wall resulting in the plaster being blown off the face. I recommend that when repairs are carried out that a lime plaster be used to allow this wall to breathe adequately and be flexible enough to take any natural movement within the structure.

Repairs needed: carry out low level plaster repairs.
