QUINQUENNIAL INSPECTION REPORT
of

SAWBRIDGEWORTH EVANGELICAL CONGREGATIONAL CHURCH

Date of Inspection: 22nd November 2023

**QUINQUENNIAL INSPECTION REPORT 2023
SAWBRIDGEWORTH EVANGELICAL CONGREGATIONAL CHURCH**

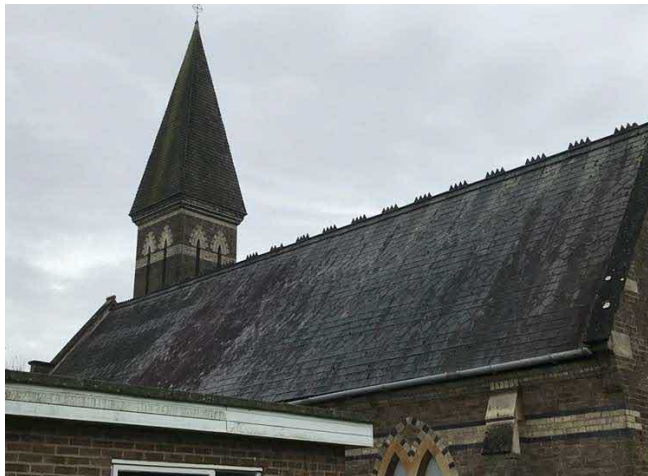
- 2.9 **North aisle north slope:** of natural slate with Staffordshire blue ridges and lead flashings at abutments to the parapet at each end. There are three bands of diamond slates across the roof finish.

Condition: all appear to be in good order.

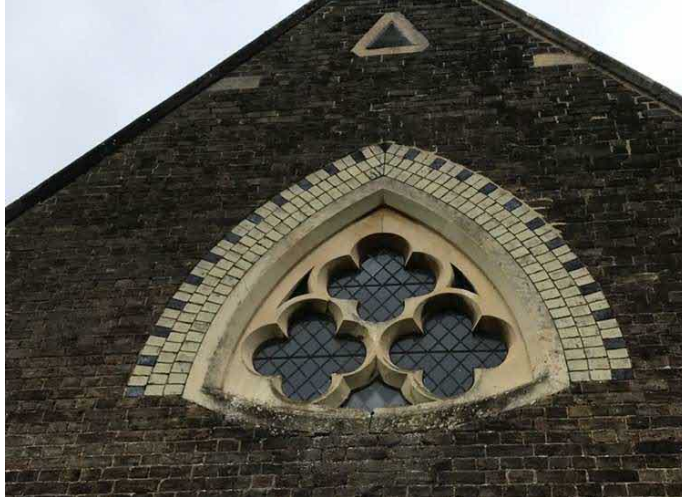
5.13 **Window 14 (triple quatrefoil):** this window to the western gable of the north wall is of triple quatrefoil set in a Bath stone surround with diamond leaded lights.

Condition: all in satisfactory condition.

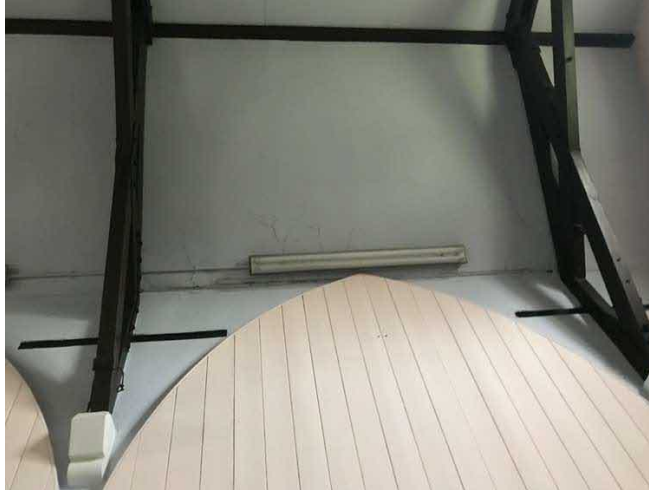
7.2 **North aisle roof structure:** a series of five high pitched timber roof trusses largely exposed. There is a high level flat section of ceiling to the apex. All ceiling panels between timbers appear to be a plastered finish, presumably of lath and plaster. Close access to the roof structure is not possible.

Condition: the roof structure itself appears to be in good condition, with no evidence of significant movement or deterioration. There is a section to the west on the south slope which shows evidence of water ingress and deterioration to the plasterwork of the sloped ceiling. This is in the location of the valley gutter between the main chapel roof and this roof.

Repairs needed: closer inspection to the valley is required. However, allow to clear out and carry out any repairs to the lead valley gutter as required.

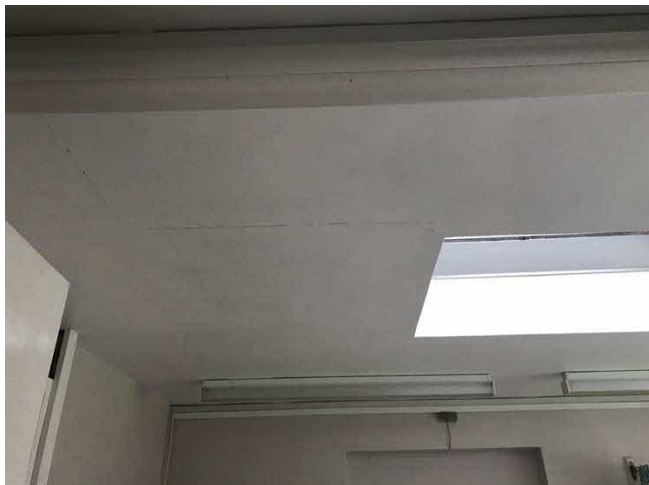
7.3 **Kitchen and toilet extension roof:** a flat roof structure likely of timber construction. However, there are no access panels available for direct inspection.

Condition: the underside appears in good condition throughout, indicating that there are no structural issues to the roof structure.

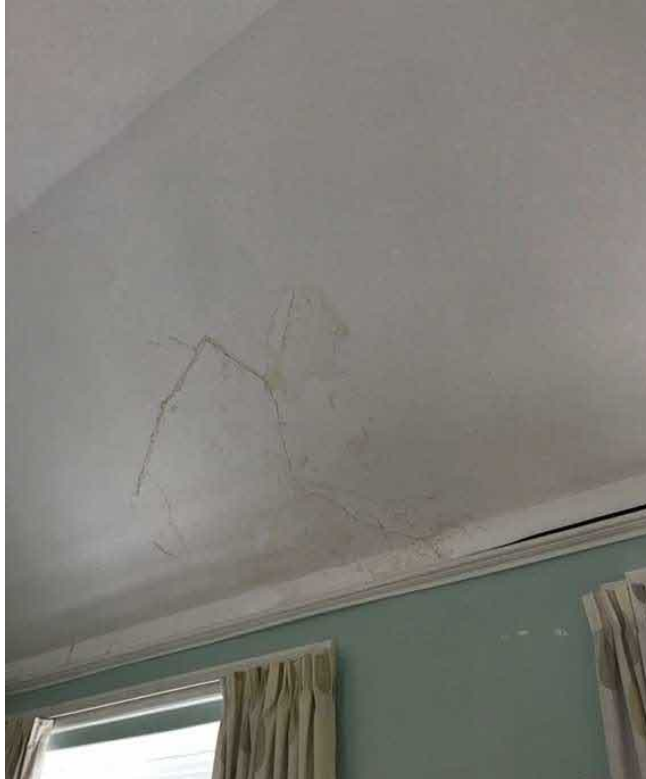
7.4 **Schoolhouse roof:** direct inspection was not possible due to the high ceiling level. However, it is assumed to be a timber-framed structure. It has a higher ceiling near the apex internally.

Condition: while there are no signs of structural issues to the roof structure, there are many areas internally to the sloped ceilings which show signs of major water ingress as there is not likely to be a felt present within the roof structure or a waterproofing membrane of any kind. The presence of penetrating moisture does create the risk that there could be rot and decay to the timber roof structure above.

Repairs needed: remove sections of ceiling and inspect the timber roof structure behind and gain access to the higher roof void for further closer inspection of the roof timbers and allow for a level of repair to the roof timbers and replacement if required.

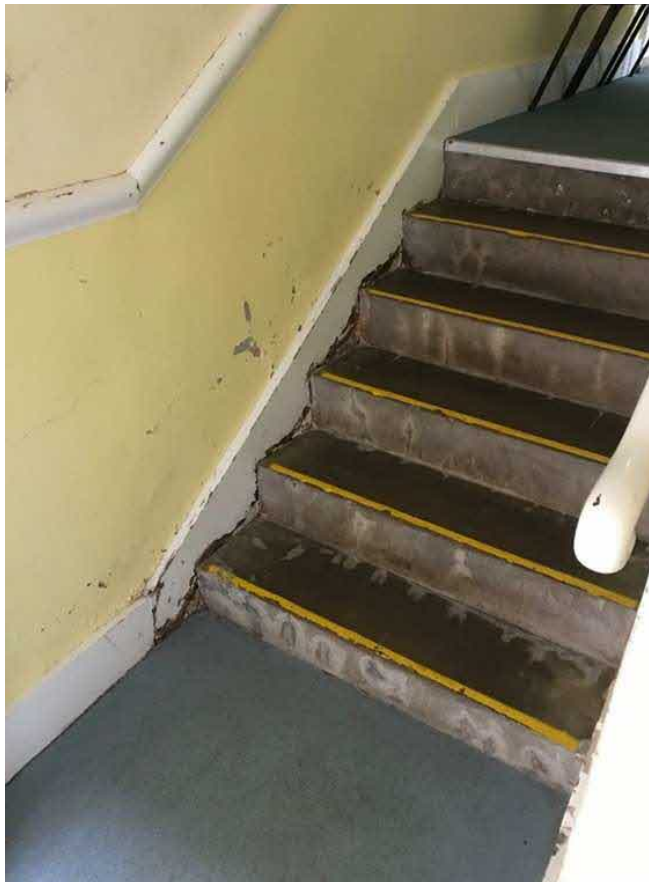
8.1 **School building entrance lobby:** concrete floor with vinyl finish, plastered and emulsion painted walls and ceiling, with a concrete staircase rising to the ground floor level.

Condition: there is a significant amount of dampness to the walls around the staircase and the staircase itself. This is resulting in deterioration to the plasterwork to the walls, with areas of salts leaching through, cracking to the plasterwork and deterioration to the timber skirtings. Solving this problem would be difficult. Injecting a damp proof course is likely to be of minimal effectiveness and stopping damp coming through the staircase would be very difficult. The only thing that can be done is cleaning back the face of the walls where deterioration has occurred and redecorating. This is likely to be a regular recurring maintenance activity. Permanently dealing with this is very difficult.

Repairs needed: clean back walls where surface deterioration has occurred and redecorate using a breathable paint.

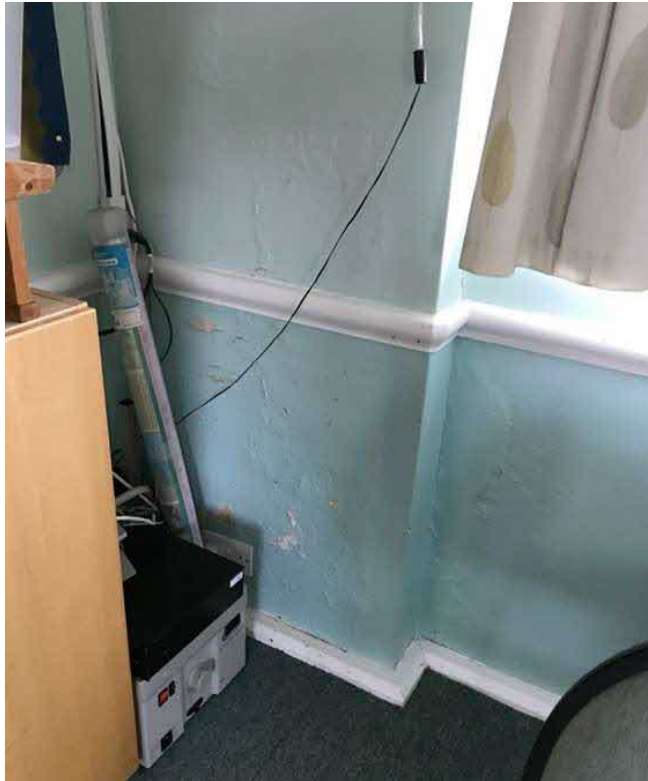
- 8.6 **First floor:** construction and finishes as for the other rooms. This is one large room with sliding folding acoustic partitions to divide it into smaller rooms as required.

Condition: there is some cracking and flaking paint due to dampness in the wall in the northeast corner. A small amount of movement does not appear to be of any significance. The dampness to the wall and the flaking paint are most likely the result of a combination of a leaky gutter joint above and the porous nature of the external brickwork. Some eroded mortar joints to this corner.

Repairs needed: as included in roof structure section, damp sections to the walls should have the plaster removed and replaced and redecoration carried out once the source of water externally has been removed and repaired.

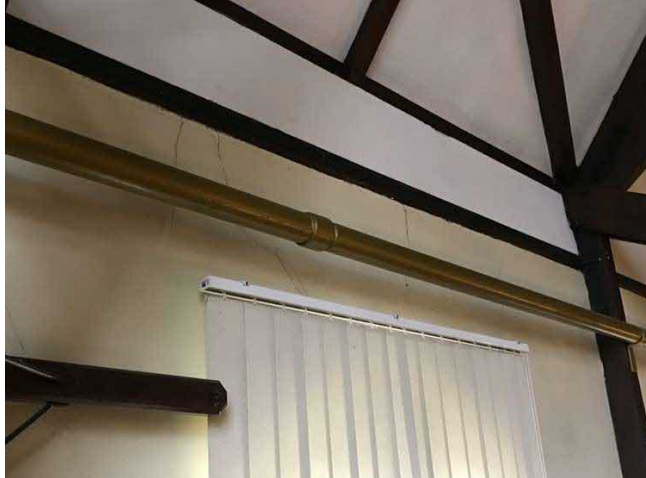
- 8.7 **Main chapel:** suspended timber floor, plastered and emulsion painted walls, a full set of original softwood pews.

Condition: largely in sound condition. There are some fractures to the west end around the organ apse. These are generally only fine cracks and indicate a small amount of movement of the gable end but nothing of any great significance. There are also some cracks to the southeast corner, as noted in the previous inspection report. These have been filled and the cracks have reappeared. Again, these are only fine cracks and indicate some movement in this corner which is currently not to a significant degree.

Repairs needed: monitor the hairline cracks to the south wall and, if they develop further, allow for structural opening-up and further investigations into the external conditions, including the drainage to this corner.

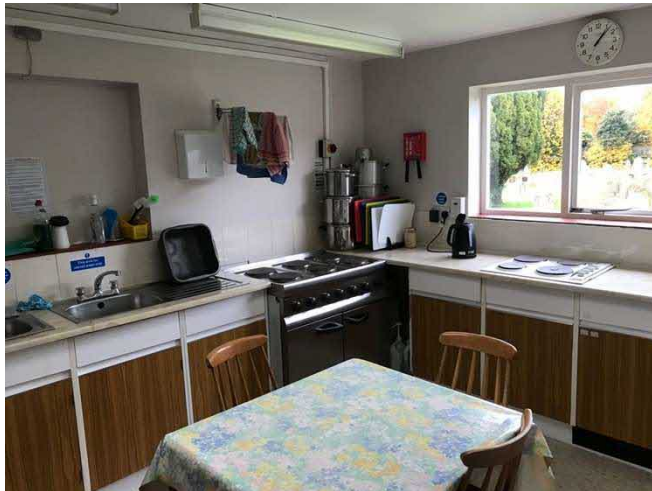
- 8.12 **Kitchen:** finishes as for the lobby, with a fully fitted kitchen with melamine faced worktops, cabinets and doors, a stainless steel electric cooker range and separate inset hob, two stainless steel inset sinks and a plumbed-in hot water cylinder in the corner under the worktop. There is a sliding up hatch from the kitchen into the lobby. No extract is present.

Condition: the kitchen cabinets are dated but generally still in fair condition. The rest of the finishes for this room are in good condition. I recommend consideration be given to installing an extract fan to help prevent the build-up of moisture during cooking. This should ideally be an extract hood over the cooker and the inset hob.

Repairs needed: consider installing extracts to the kitchen.

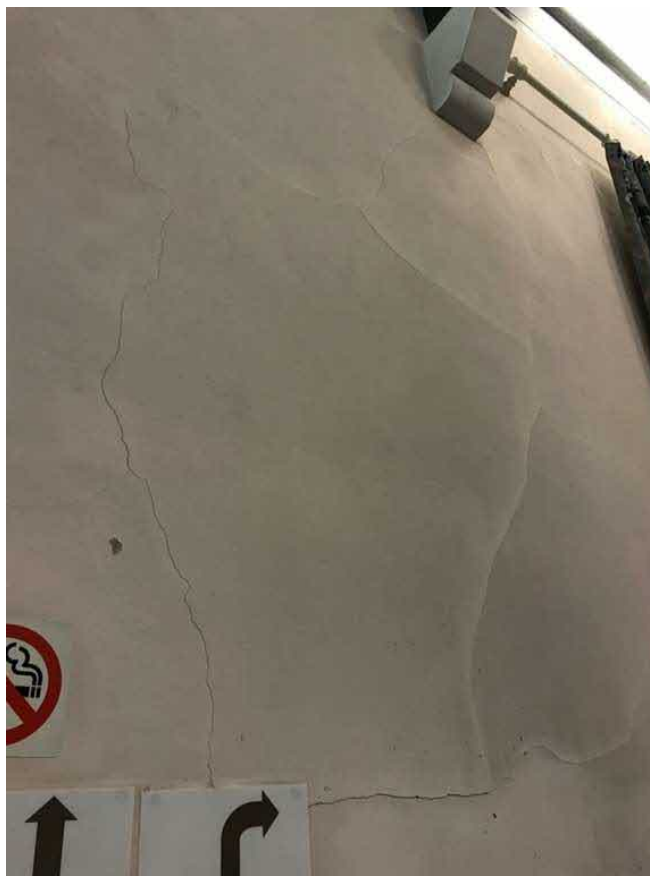
- 8.16 **North aisle hall:** solid concrete floor with sheet vinyl finish, gloss painted plastered walls with plasterboarded skim coated ceiling between a series of five exposed timber trusses supporting the roof. The rest of the roof structure is concealed from view above the ceiling. It would appear to be of purlins over the trusses supporting common rafters. There is a series of large timber boarded sliding doors between this wall and the main chapel.

Condition: I understand that the former suspended timber floor has been replaced in recent years with the current concrete floor and that the dado panelling has also been removed, with the wall at low level plastered. This wall is generally in good condition. There is some cracking along the line of the junction between the modern plaster and the older plaster finish above. There are also several hollow patches and random surface cracks to the modern plaster. This is currently not to the point where any repairs are required. However, repairs are likely to be needed in the next few years. The modern plaster is failing to adhere to the brick backing sufficiently well because of general moisture within the wall resulting in the plaster being blown off the face. I recommend that when repairs are carried out that a lime plaster be used to allow this wall to breathe adequately and be flexible enough to take any natural movement within the structure.

Repairs needed: carry out low level plaster repairs.

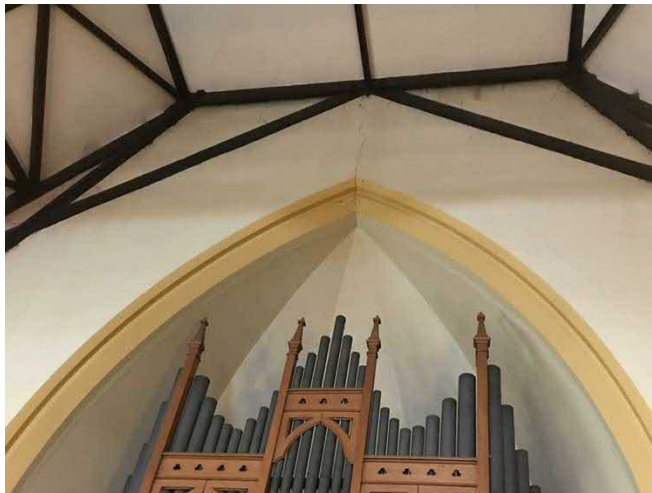
- 8.20 **The apse to the west end:** this apse contains the organ. A raised suspended timber floor platform area, with plastered and emulsion painted walls and vaulted ceiling.

Condition: there are several vertical cracks and some horizontal cracks in the plasterwork at high level as a result of general movement in the structure. This does not appear to be to a significant degree and all is generally in satisfactory condition.

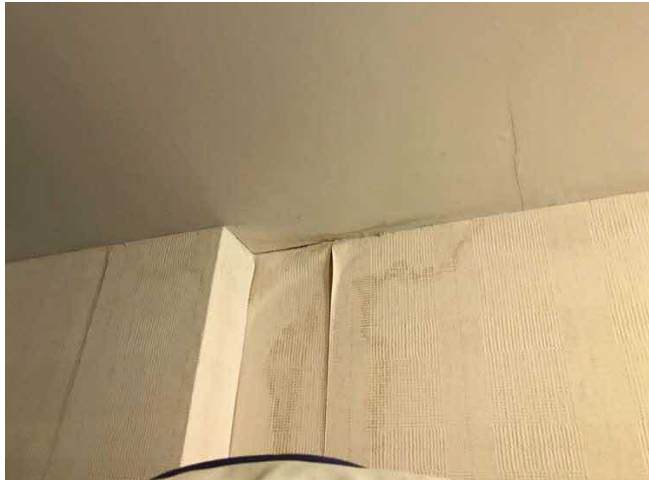
- 8.22 **Minister's vestry:** suspended timber floor, simple skirtings, wallpaper to the walls, plasterboard false ceiling. Lavatory off with covered floor, low level flush cistern, papered walls and plywood and lath and plaster ceiling.

Condition: there is water staining in various places in the vestry, including the east wall between the church and the vestry. This appears to relate to an old blockage in the valley gutter and is currently dry. There is also water staining on the south wall which is likely to be due to penetrating damp. Damp levels in this wall are not excessively high but are enough to cause some staining to the internal finishes. The toilet off the vestry generally has damp walls probably due to penetrating damp through the rather porous external solid brick walls. I recommend redecoration of the vestry be carried out. The roof coverings have been repaired recently and lead flashings redressed, which should mean the penetrating damp has been prevented.

Repairs needed: replace wallpaper to walls and toilet and allow to replaster where leaks have damaged prior to redecorating or reapplying wallpaper.

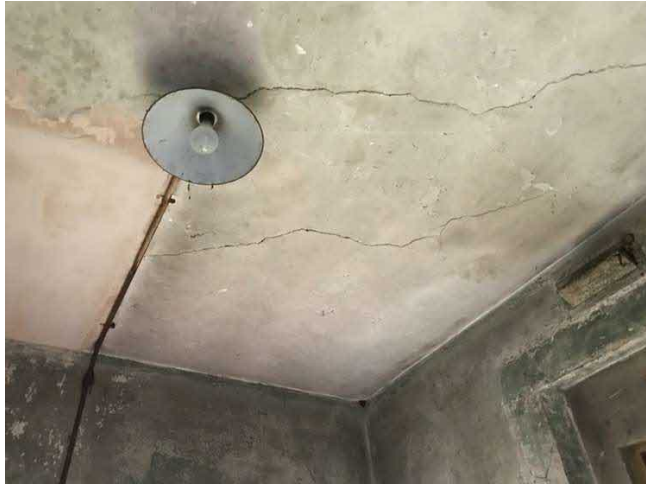
8.23 **Main boiler room:** concrete floor with plastered brick walls and plastered ceiling.

Condition: there are some diagonal cracks to the ceiling, currently this is still sound but should be monitored as further deterioration may require repair.

Repairs needed: monitor cracks.

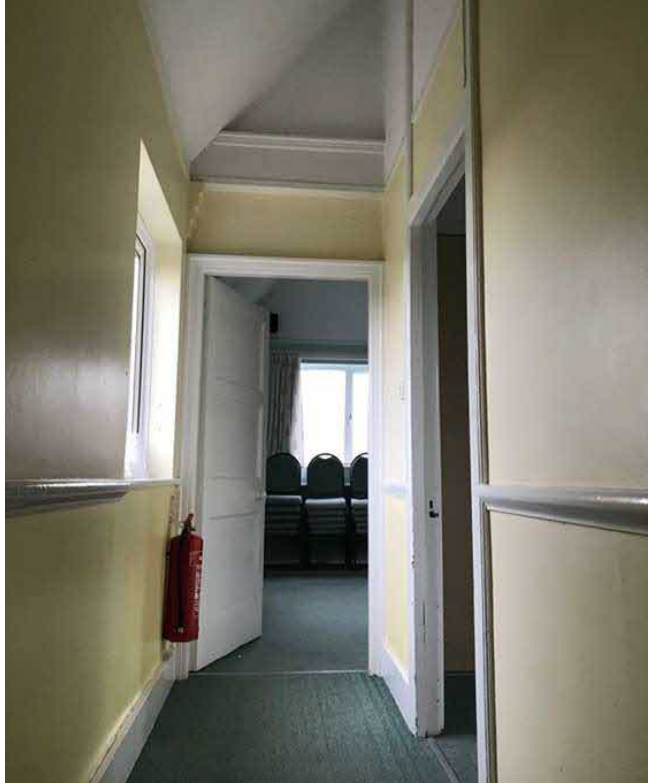
9.1 **Internal joinery to schoolhouse:** hardwood timber panelled doors, skirtings, handrails and architraves throughout and likely of original age to the building.

Condition: generally in acceptable and useable condition, however scuffed and damaged throughout due to general wear and tear.

Repairs needed: redecorate as needed and allow for minor timber repairs as required.

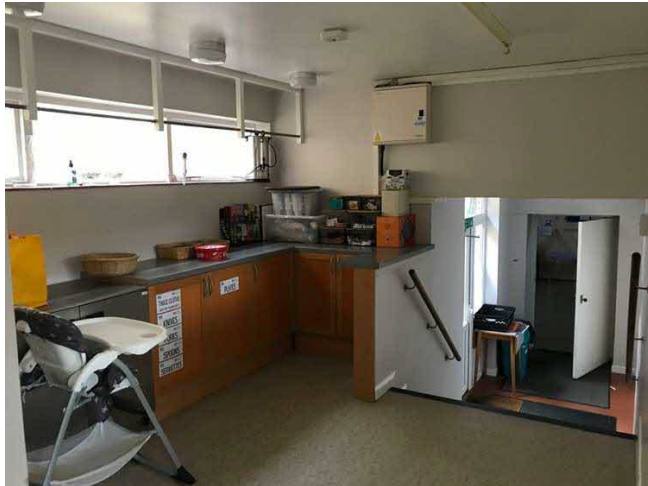
9.2 **Internal joinery to kitchen and toilet extension:** flush gloss painted doors with gloss painted frames, architraves and skirtings in softwood timber.

Condition: generally in acceptable condition, however scuffed and damaged through general wear and tear.

Repairs needed: redecorate as needed and allow for minor timber repairs as required.

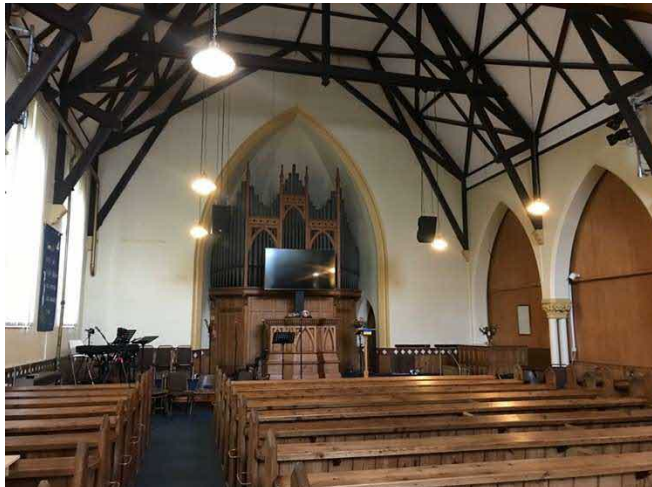
- 9.4 **Main chapel:** pine posts support the front edge of the gallery with pine gallows-style brackets and there is a decorative pine wainscot present across the external walls, with a series of pine pews present.

Condition: as noted in the previous inspection report, there is evidence that the corbel to the southern end has dropped. As previously mentioned, this is historic. There are currently no issues of concern. The timber wainscot is in acceptable condition. However, where it is against the wall to the southeast, it has come away due to the structural movement. However, it is in an acceptable condition. The pews are also in acceptable condition. The timber pulpit and timber organ are in good condition throughout.

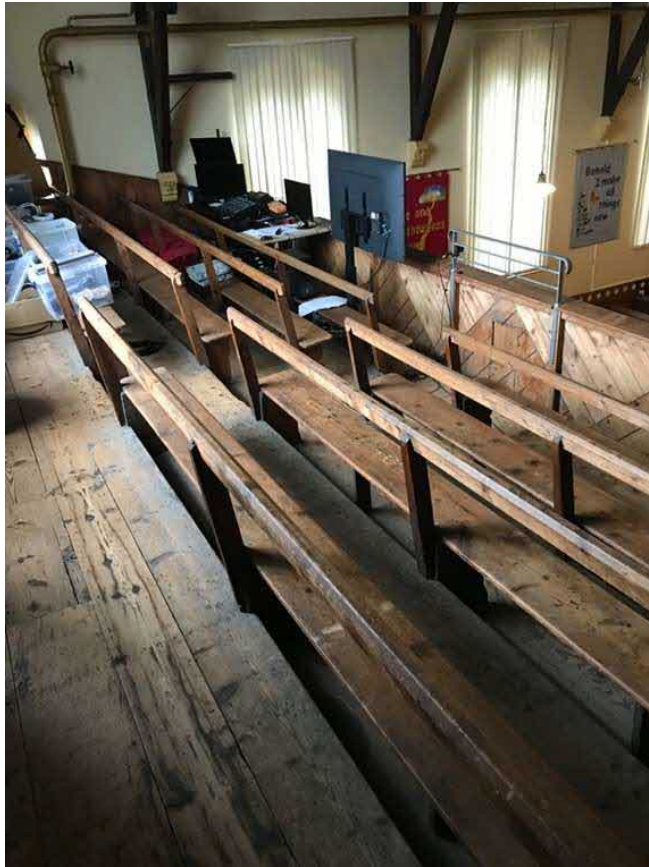
11.2 Gallery: tiered seating fixed to softwood boarding, with a timber gallery structure possibly on steel supports, with diagonally boarded gallery front. A metal handrail of the appropriate height has been placed at the base of the aisle leading from the stairs.

Condition: the current gallery rail is lower than is required for current safety regulations and in order to ensure the safety of the building occupants it would be necessary to raise the gallery rail height.

Repairs needed: increase gallery rail height.

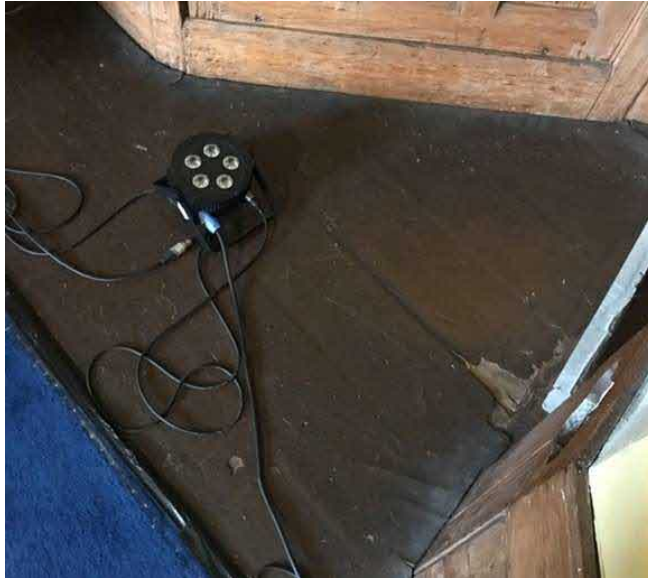
- 11.3 **Floor finish behind organ:** this is of traditional linoleum and has clearly been in place for many years.

Condition: in poor condition with deterioration to the edges, cracking and sections missing. I recommend this floor finish be either removed or replaced to prevent trip hazards occurring.

Repairs needed: remove or replace floor finish.

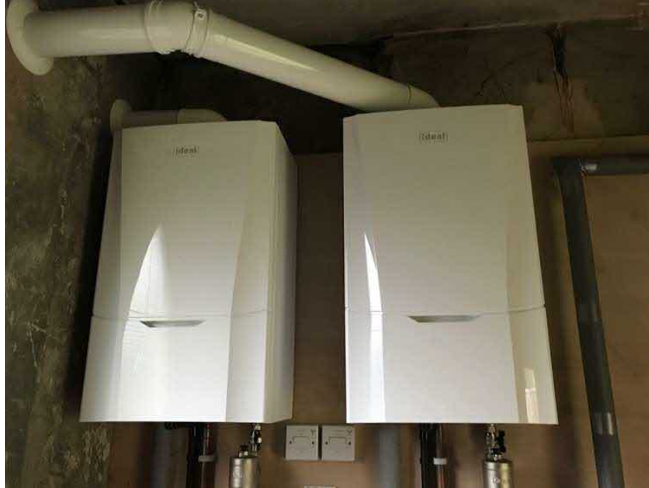
- 12.1 **Heating:** there are a variety of forms of heating for the buildings. A conventional wet system serves the chapel, with traditional style cast radiators and two fan assisted convector heaters. This system has large heating pipes that run around the perimeter of the room feeding the radiators. The boilers for this system are located in the boiler room and are gas-supplied.

Condition: the system and the boilers appear to be in good condition and are of a recent install and there is no evidence of significant defects.

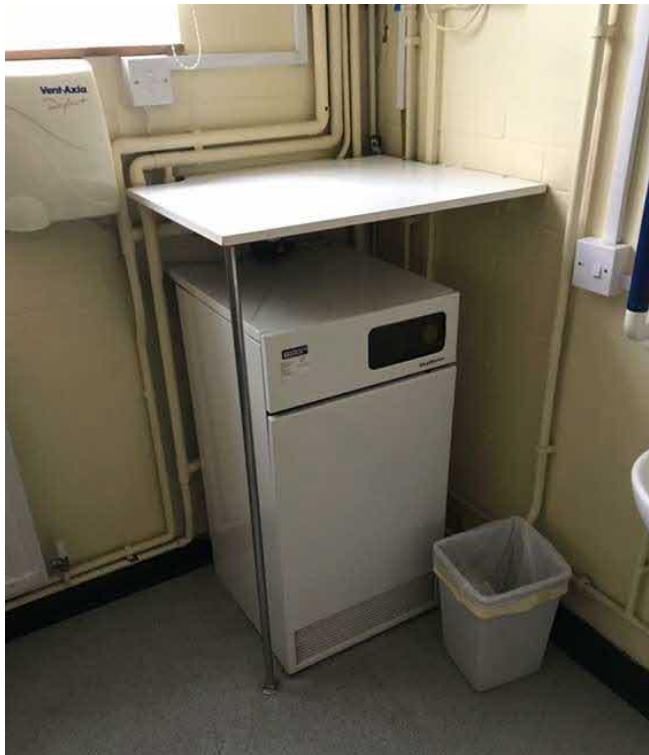
12.2 **Heating system for schoolhouse:** this is a conventional wet system, with the gas boiler located in the toilet cubicle on the ground floor, distributing heat around the building to steel panel radiators.

Condition: this gas boiler is serviced annually but is now quite old and likely near the end of its life. The system is in working order with no evidence of leaks or problems. The boiler should be replaced within the next five years.

Repairs needed: replace boiler.

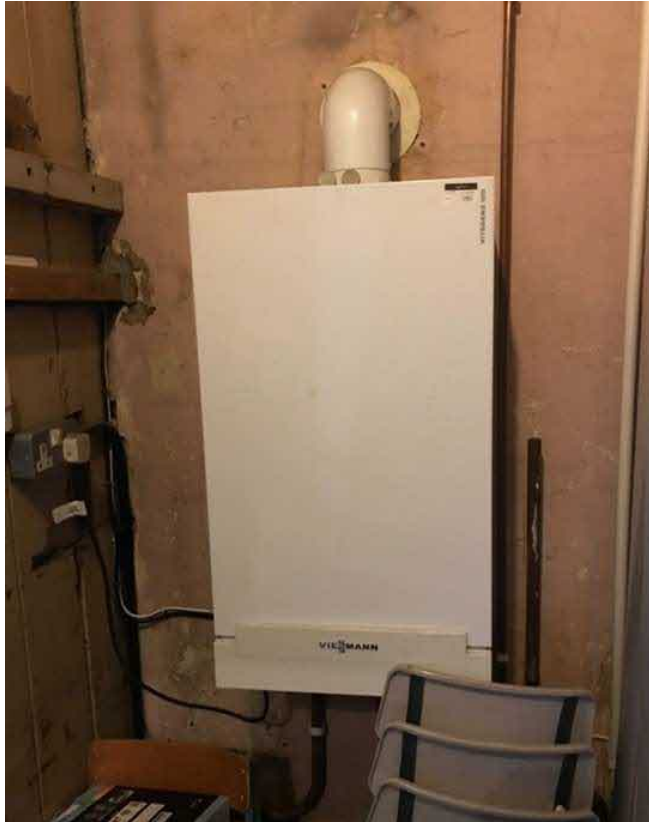
- 12.3 **Heating to the north hall:** heating to this part of the building is served by a gas boiler located within the staircase to the gallery. It is a combi boiler with a balanced flue distributing heat via radiators.

Condition: in good order.

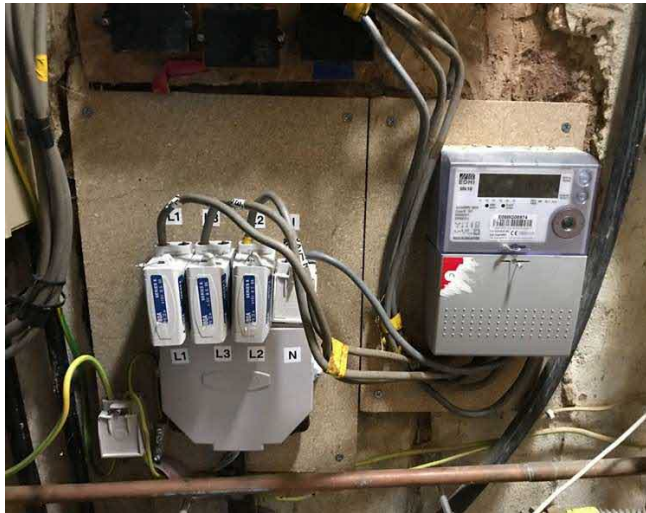
13.1 **Electricity supply:** the incoming supply meter and main fuse board are located below the stairs to the gallery. The fuse board and meter are of recent installation and have been recently tested within the past year. The presence of RCD fuses will provide a reasonably good level of protection to circuits.

Condition: the electrical system appears in good working order.

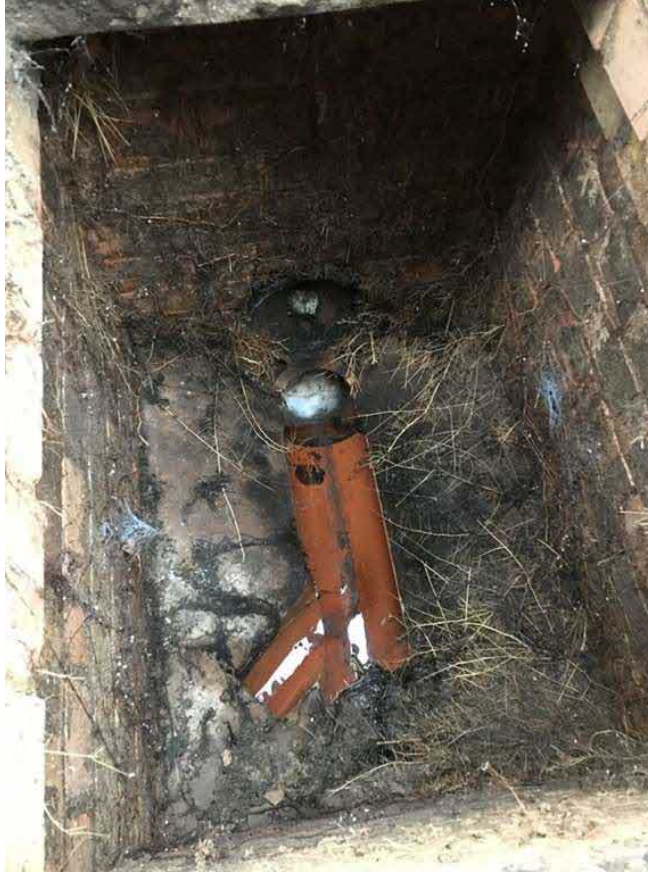
14.3 **Below ground drainage:** the foul drainage system appears to be a combined system which also picks up the surface water drainage within the manholes present around the buildings which discharge into the mains sewer in the main road to the east. The only manhole which was able to be lifted was to the southeast of the building. This manhole had a large number of roots present, which was holding debris, and there is a Victorian trap present in the invert.

Condition: there are heavy roots present within the drainage outfall to the southeast. However, due to the depth of the manhole, it was not possible to determine where these roots were coming from and they could possibly have been from a previously removed tree nearby. If this is the case, however, there is still a risk that the roots could cause blockages in the foul drainage system. Due to the location, this may also be contributing factor to the settlement of the main chapel in the southeast corner.

Repairs needed: clean through the foul drainage system and have a CCTV survey carried out to ensure it is in good condition and remove any roots within the manhole or drainage system.

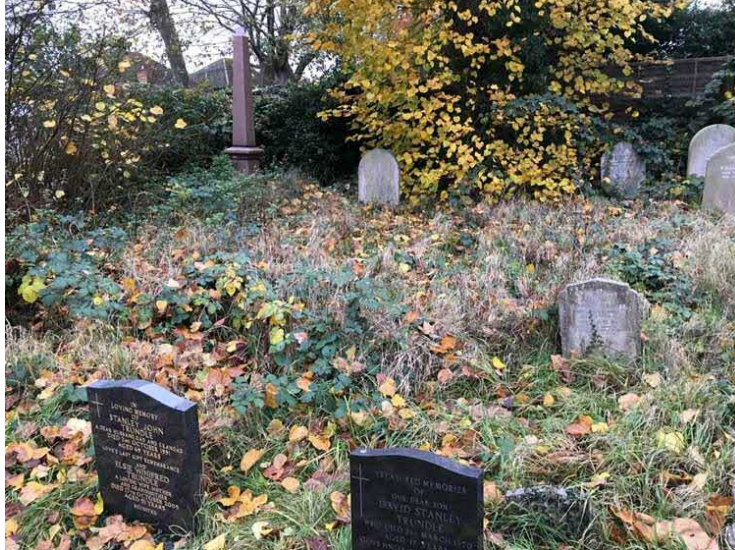
24.4 **Graves:** a number of graves are present to the west on the lawn.

Condition: while the graves are in acceptable condition, the surrounding grass is poorly kept and heavily overgrown to the western boundary.

Repairs needed: this area should be maintained and overgrown areas cut back.
