Mr and Mrs Perks

Y Felin, Efail Rhyd, Llanhraeadr Ym Mochnant SY10 0DU

Structural Inspection

Inspection Report for Planning Application Support

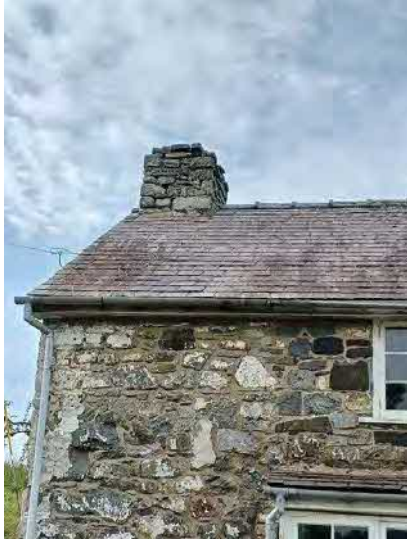
029

- 3.1.6 Pitched slated roof appears in reasonable condition although this does not appear to be original. Slight undulation to ridge tiles visible from ground level. Open mortar joints to ridge tile bedding (photo 29 – 32)
