ROTTERDAM WHARF

EXTRACT FROM PUBLISHED
GEOLOGICAL SURVEY MAP
(MINING INFORMATION)

INVASIVE WEEDS SURVEY

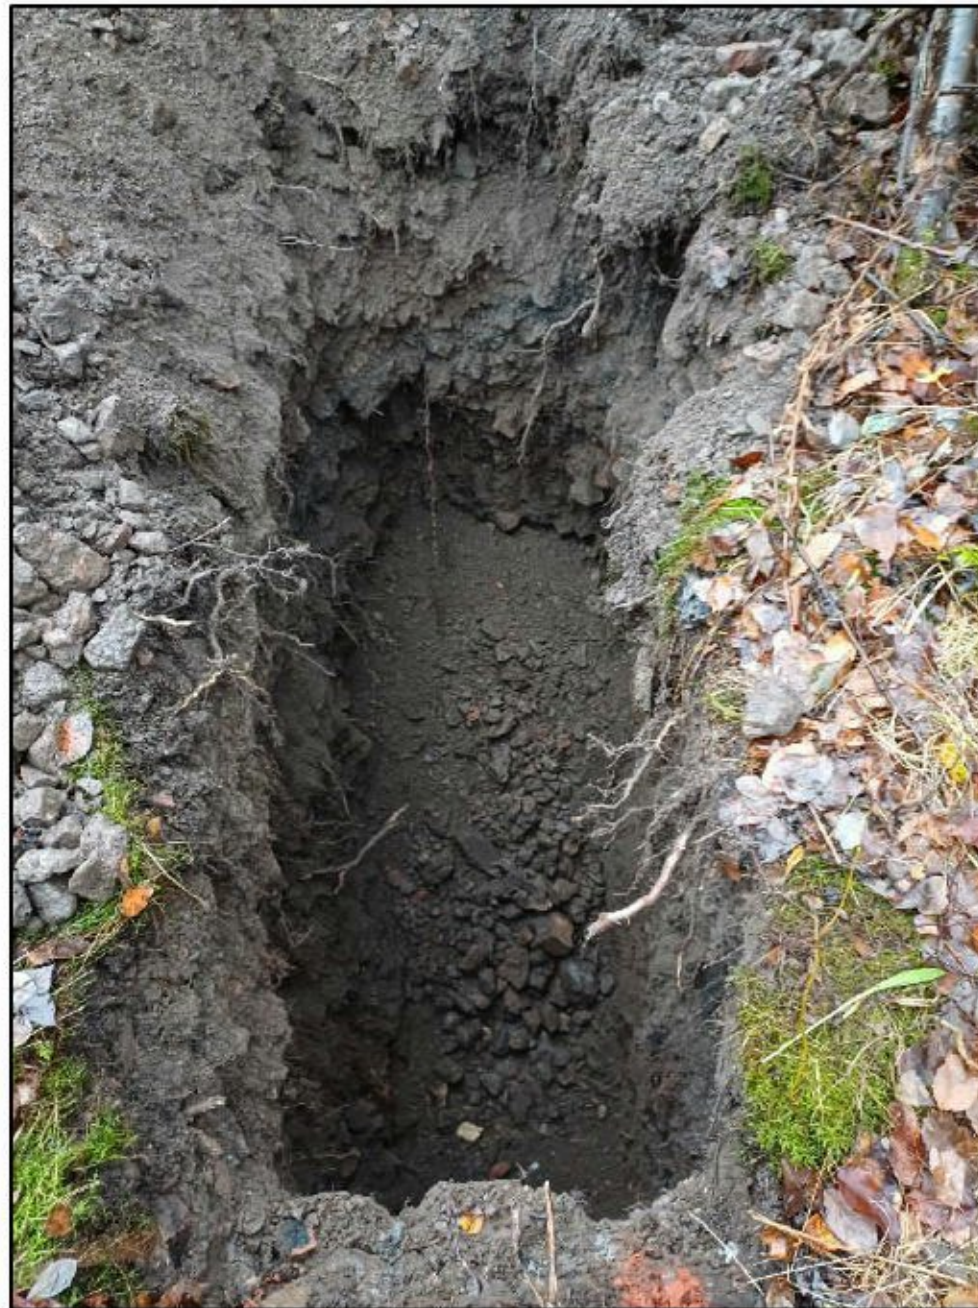
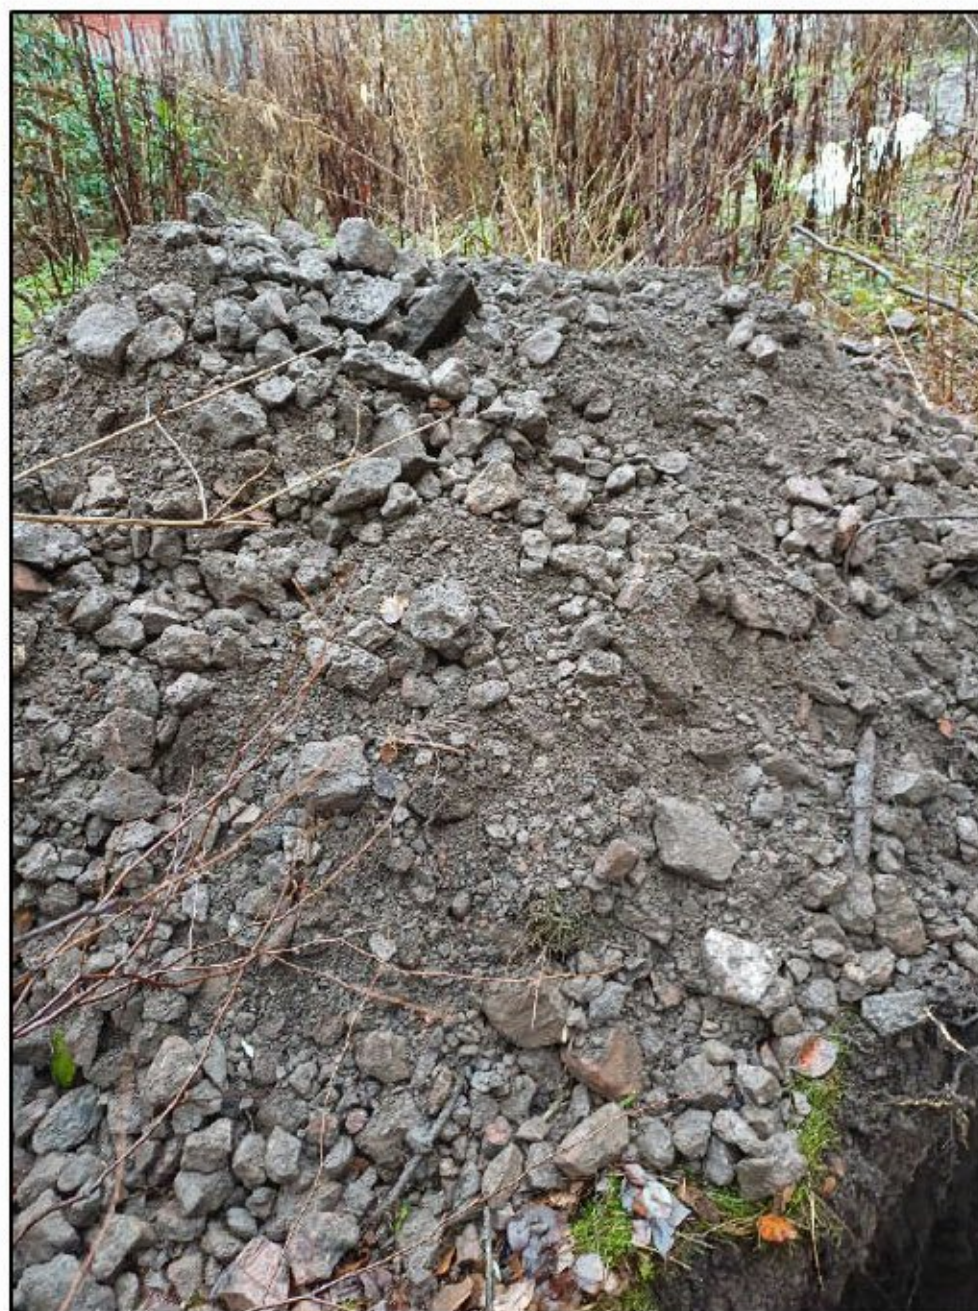
TP08

Remarks 1. Strength and characteristics assessed by onsite engineer only. 2. Pit terminated at 2.30 m due to concrete obstruction at base. 3. Pit was stable at termination. 4. No water ingress recorded. 5. No visual or offactory evidence of contamination.	Plan 	
	All dimensions in metres Scale 1:25	Logged By MF
