Fabric Repair & Downtaking

Fabric Repairs

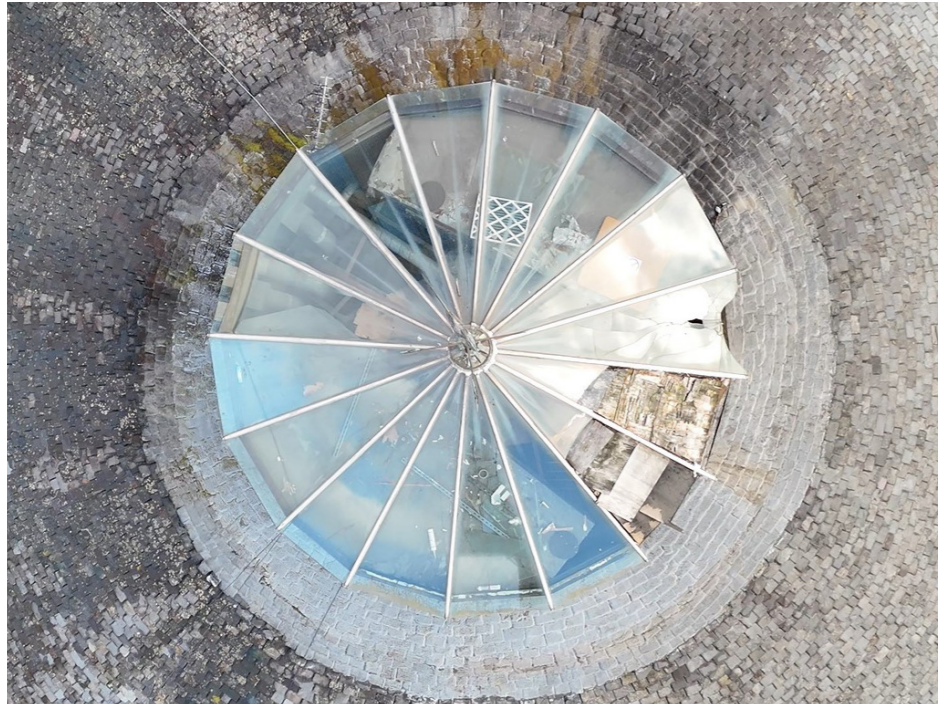
Image top left:
existing cupola
Image top right:
existing roof slates
Image bottom left:
existing roof structure
Image bottom right:
existing brickwork &
stonework

- Introduce new cupola/lantern

The replacement cupola is proposed to be entirely new (existing windvane to be assessed). complete with new leadwork pitched roof. It is proposed to incorporate high level automatic ventilators within the cupola.

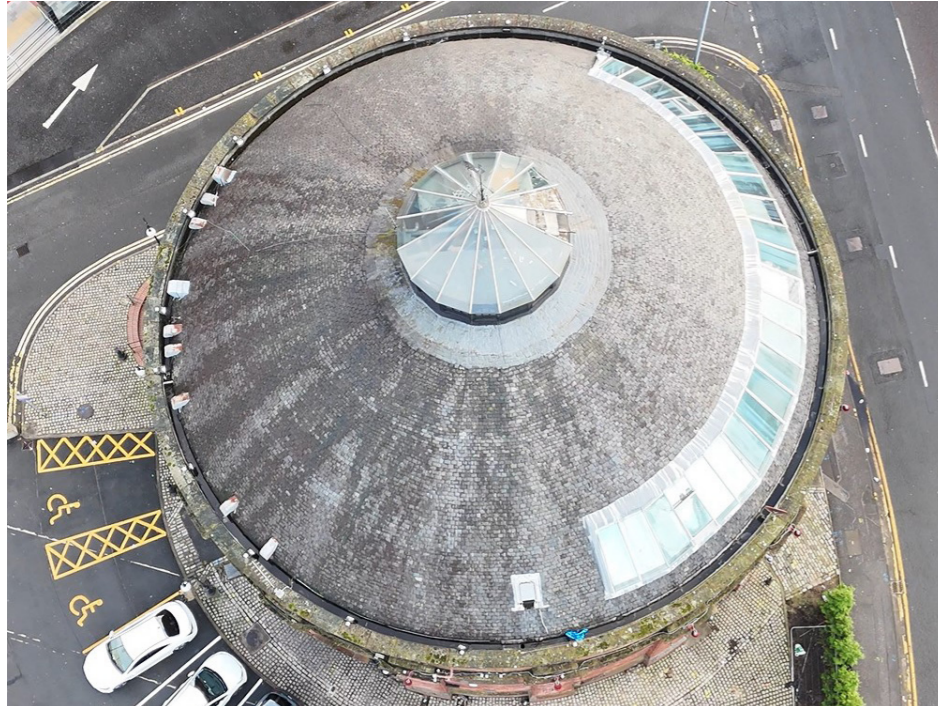
Image top left: aerial view of existing roof
Image top right: existing service penetrations and standing water in gutters
Image bottom left: general condition of existing roof
Image bottom right: existing weathervane (assumed not original)

- Strip-off existing slate
- Remove all redundant service/ventilation items
- Remove existing glazed rooflight, framing and leadwork
- Remove existing glazed cupola/lantern, wind-vane and framing
- Form new opening for ribbon rooflight
- Sarking to be assessed and retained in place with localised repairs if required (will be visible as internal finish)
- Install new roof membrane to sarking
- Install flexible Class O thermal insulation and associated framing.
- Install new slate, specification to be agreed (Cupa H3 or similar)
- Install new ribbon rooflights, framing, substrate and leadwork flashings
- Install new service outlet/inlet terminations at low edge of roof**
- Install low profile ladder over rooflight for cleaning and access
- Install pitched roof anchor point for maintenance access

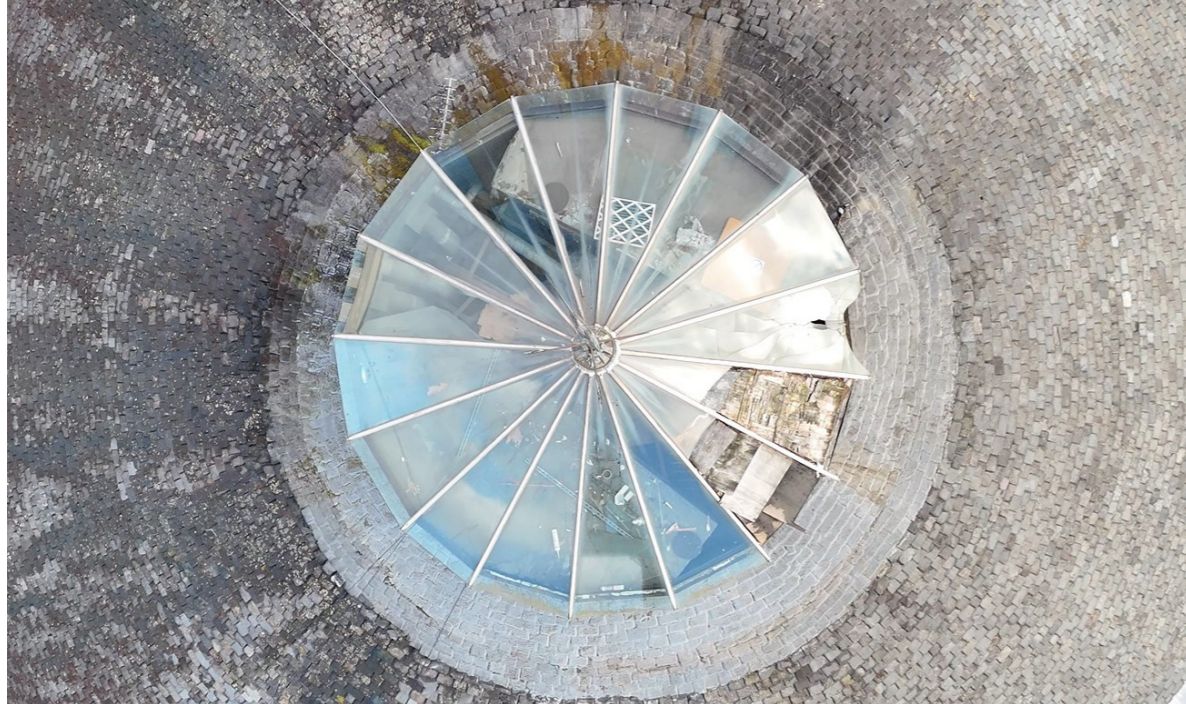
Image top left: aerial view of existing cupola
Image top right: internal view of existing cupola
Image bottom left: existing roof structure and sarking
Image bottom right: general condition of existing roof structure

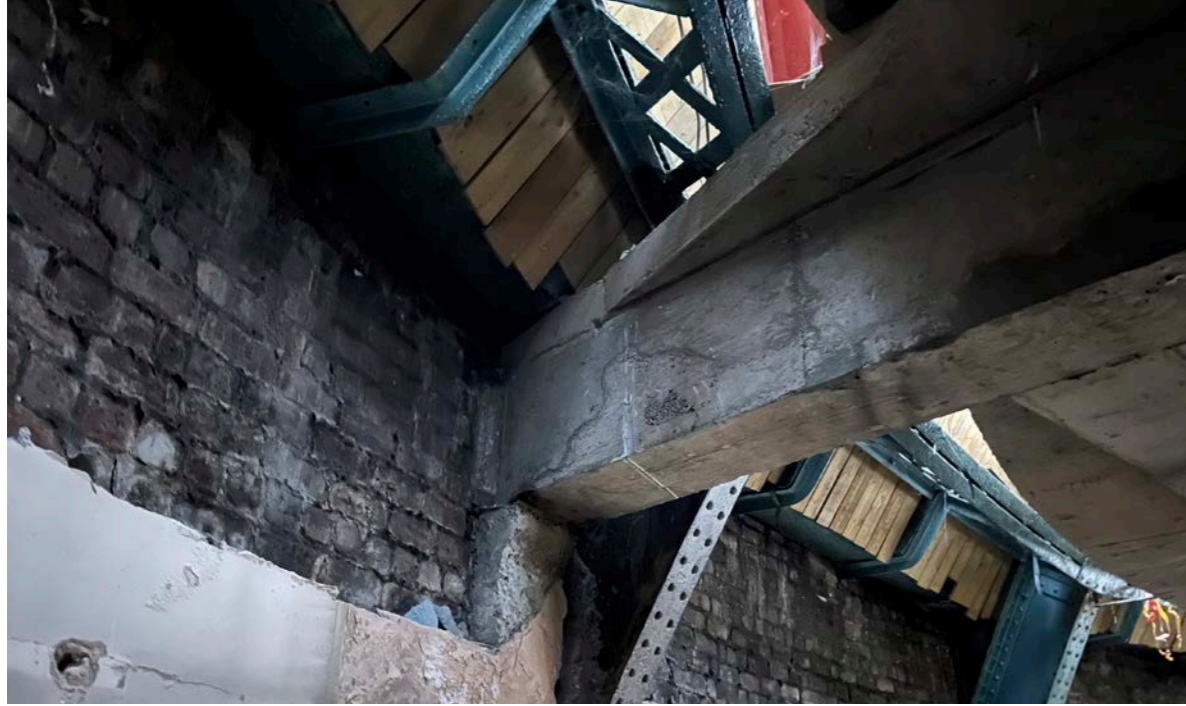
Image top left:
existing third floor
structure interface
with historic fabric
Image top right:
currently concealed
dome structure
Image bottom left:
existing brick gas
meter house
Image bottom right:
existing decorative
street furniture

It is proposed to completely remove the existing third floor slab and supporting structure (from second floor to underside of third floor). This is to create a space which fully encompasses the historic rotunda dome.
