**ASSESSMENT OF SURFACE WATER MANAGEMENT  
(SURFACE WATER DISCHARGE TO LAND)  
FOR  
RESIDENTIAL DEVELOPMENT AT ROTHERHAM TOP FARM,  
PRESTON ROAD, WHITTLE LE WOODS,  
CHORLEY, PR6 7PG.**

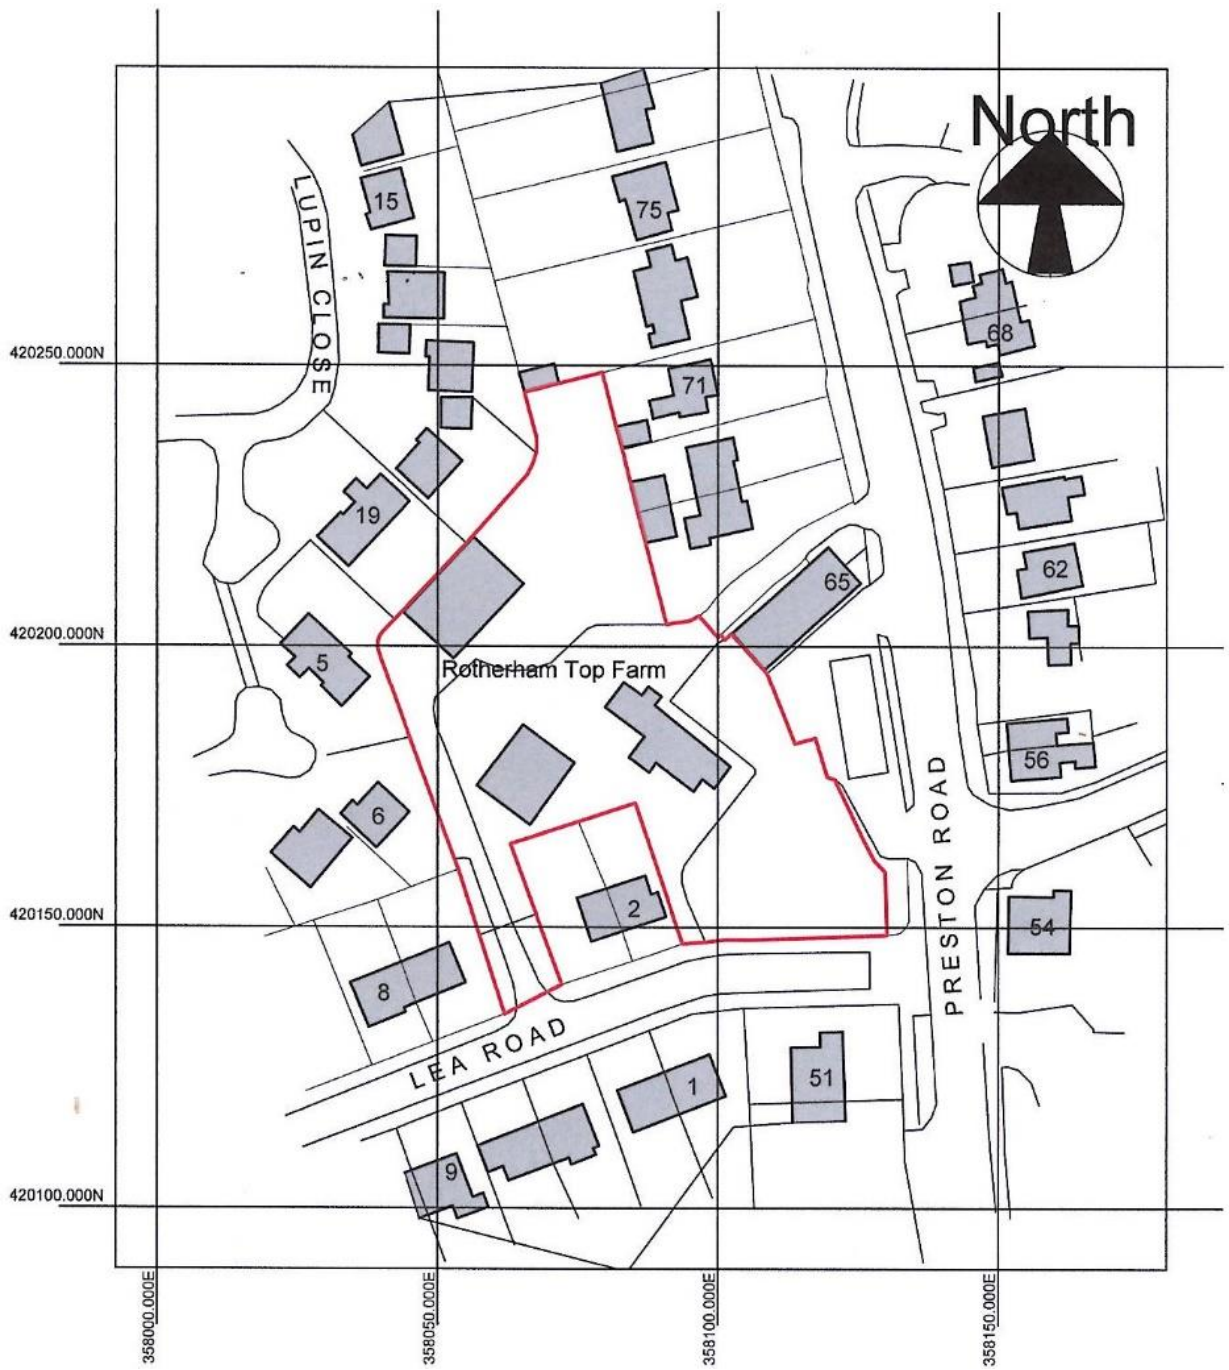
**Fig.1**

Located at National Grid Reference 358086 (E), 420192 (N) the site is currently a single residence comprising of a detached house, ancillary detached buildings, associated hardstanding, garden and driveways. The site is irregular in shape and covers approximately 0.46Ha. Fig 1 identifies the location of the site.
