Date: 23<sup>rd</sup> November 2023  
Ref: C8785E/8486/AS/AS

## GROUND GAS VERIFICATIONS – STEPHENSON ROAD, PETERLEE (PLOTS 23 TO 28, 31 AND 47 TO 59)

## Gas Protection Verification Photographs

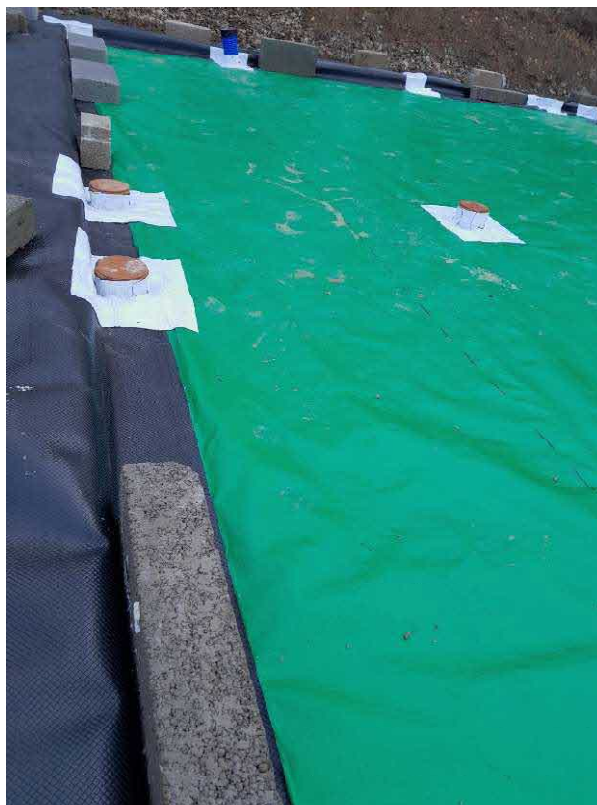
04 C8785E 23.01.23 Plot 31 Service Entry Ducts (client photo)

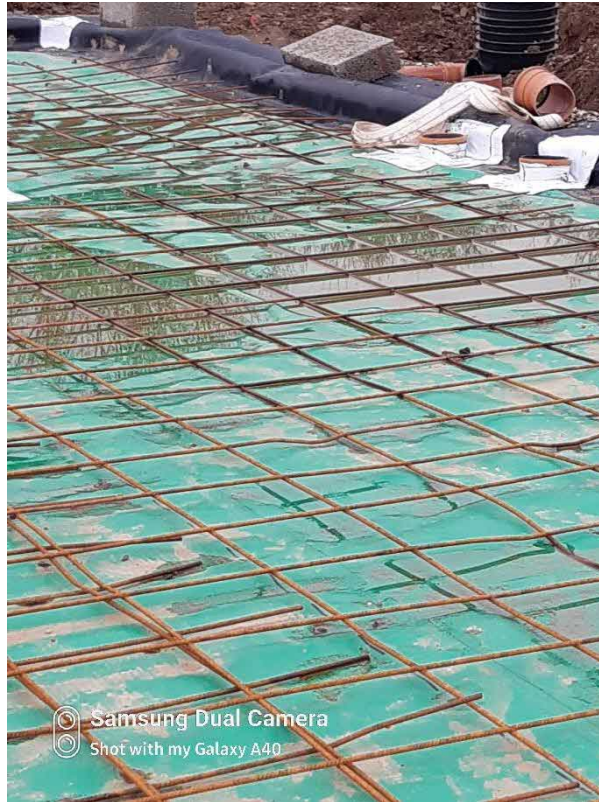
03 C8785E 29.03.23 Plot 54 Service Entry Ducts (client photo)

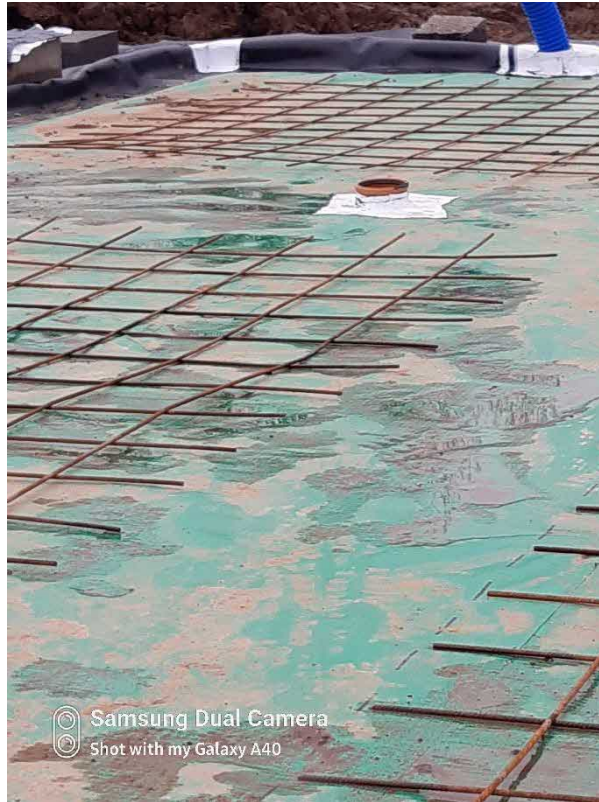
03 C8785E 29.03.23 Plot 55 Corners and Service Entry Duct (client photo)

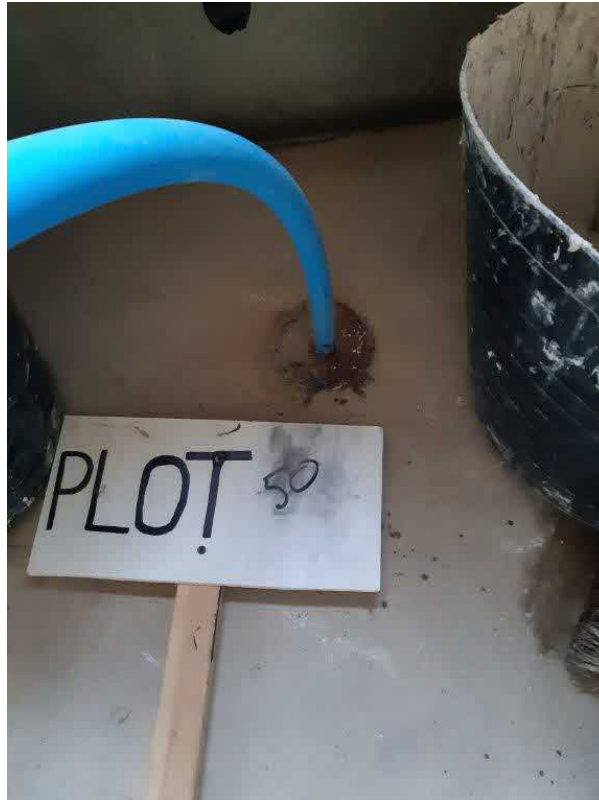
05 C8785E 10.11.23 Plot 50 Service Entry Seal (client photo)
