ARBORICULTURAL IMPACT ASSESSMENT REPORT

229 London Road, Wickford

CBS Developments

DATE: March 2024

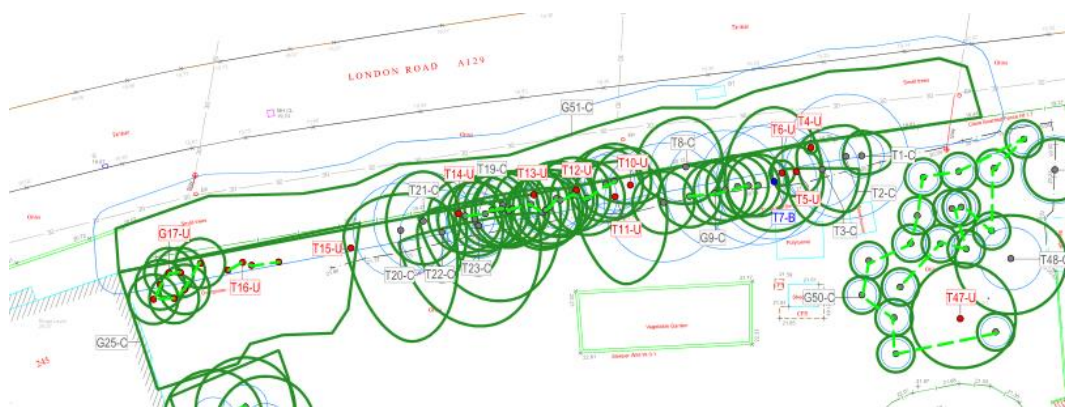
Plan 2 – extract from SHA 1776 TSP showing northern boundary. Do not scale, north is vertical. Green shapes – crown spreads and blue circles root protection areas.

- 4.3. *Trees on the road frontage (northern boundary):* The trees on the raised bank comprise a line of semi-mature trees which are mostly self sown. They are very close together, resulting in poor stem taper and asymmetric crown spreads. Whilst they provide collective screening and greenery up to 14m in height, many are in a poor condition. This is in part due to the species mix as the majority comprises ash (suffering with ash dieback disease) and elms (infected with Dutch Elm Disease – many of which are dead). The ash and elms have been topped in the past, resulting in decay at the pruning wounds and weakly attached branches. Within this group are plums in a poor condition (notably T11 which has partially collapsed), and oaks (T18, T19, T20) which have very distorted crowns weighted south due to the overcrowding. To the east of the group is G9, a dense conifer group 10m high which has been topped at 8m resulting in large dead branches in the inner canopy. To the west of the group is a dense thicket of bramble with dead and dying elm trees.

All trees on the northern boundary will be removed to enable necessary ground remodeling for the access. As previously discussed, the majority of the trees are in a very poor condition and some are dead and/or hazardous for reasons detailed in the tree survey sheets. All trees and scrub on the eastern boundary will also be removed. The middle and northern section is due to their poor quality, the potential for the ash to outgrow their situation near number 245 (unless they contract ash dieback disease) and to enable construction of the nearest plot. The scrub G32 is being removed to make good use of the garden space and to enable space for new sustainable landscaping with a greater longevity. Trees to be removed are shown red on the tree protection plan SHA 1776 TPP at appendix 3 and tree works are listed in full in the tree surgery schedule at appendix 4.

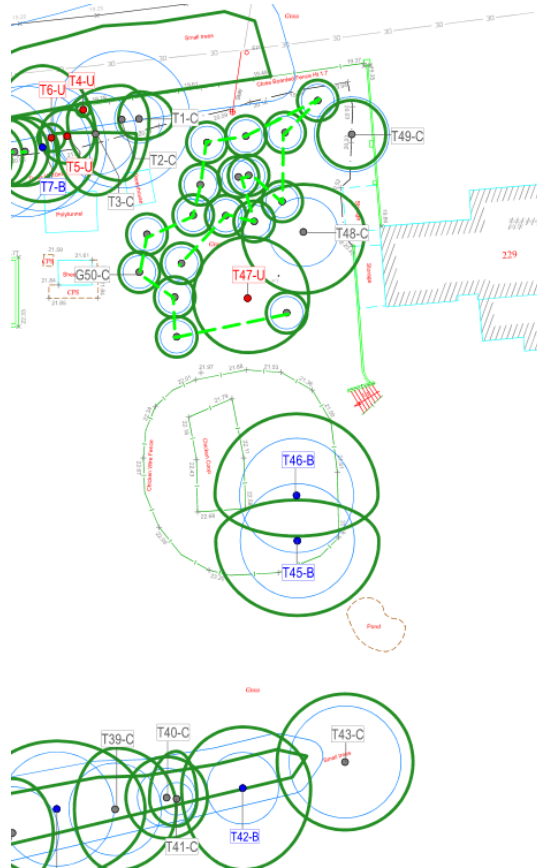
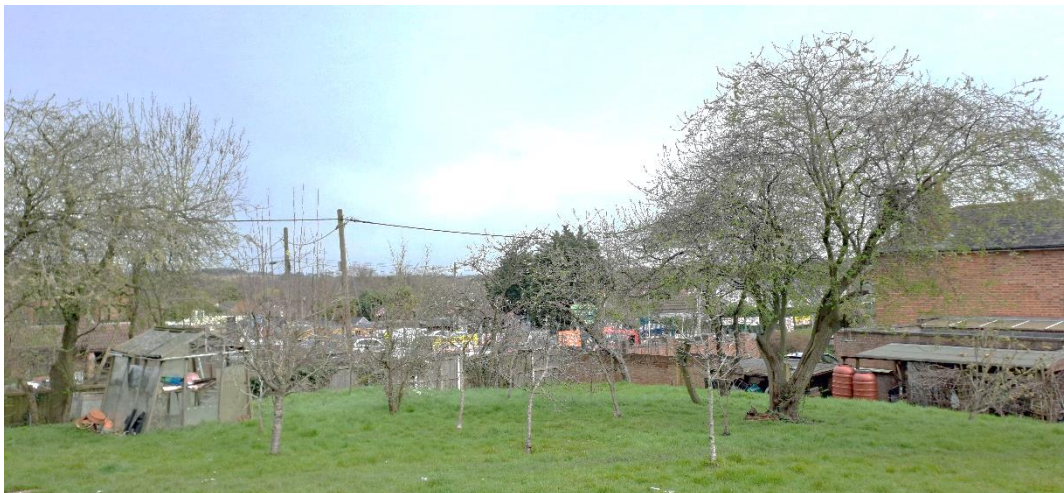
Plan 3 – extract from SHA 1776 TSP showing eastern boundary. Do not scale, north is vertical.

4.4. *Trees on the eastern side:* The eastern boundary has no onsite trees. The survey included the nearest offsite trees for completeness including a small young orchard (G50), an over mature decayed plum (T47) and two early mature oaks (T45 and T46). They provide a pleasant backdrop.

Photo 4– looking east at the north-eastern corner of the garden; outside of the site boundary.

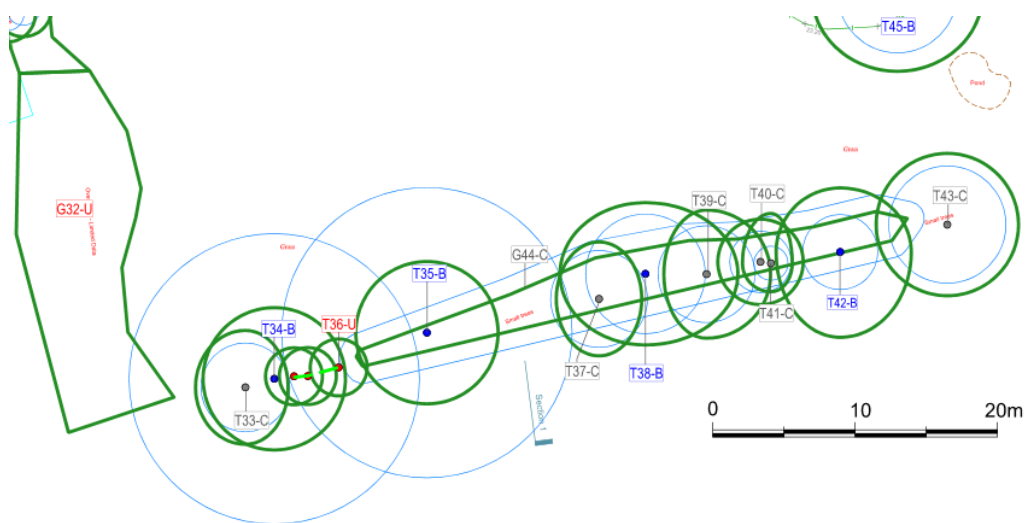
Plan 4 – extract from SHA 1776 TSP showing southern boundary. Do not scale, north is vertical.

4.5. *Trees on the southern side:* The collective vegetation provides an attractive filtered screen between the site and agricultural land to the south. The prominent trees are two Leyland cypress (T34 and T35), a poplar T38 and a birch T42. An informal group of blackthorn between 1 – 5m is growing amongst the line of trees.
