BS5837 Arboricultural Impact Assessment

21 The Headway, Ewell, KT17 1UN

Job Reference: 03638Rv2

July 2022

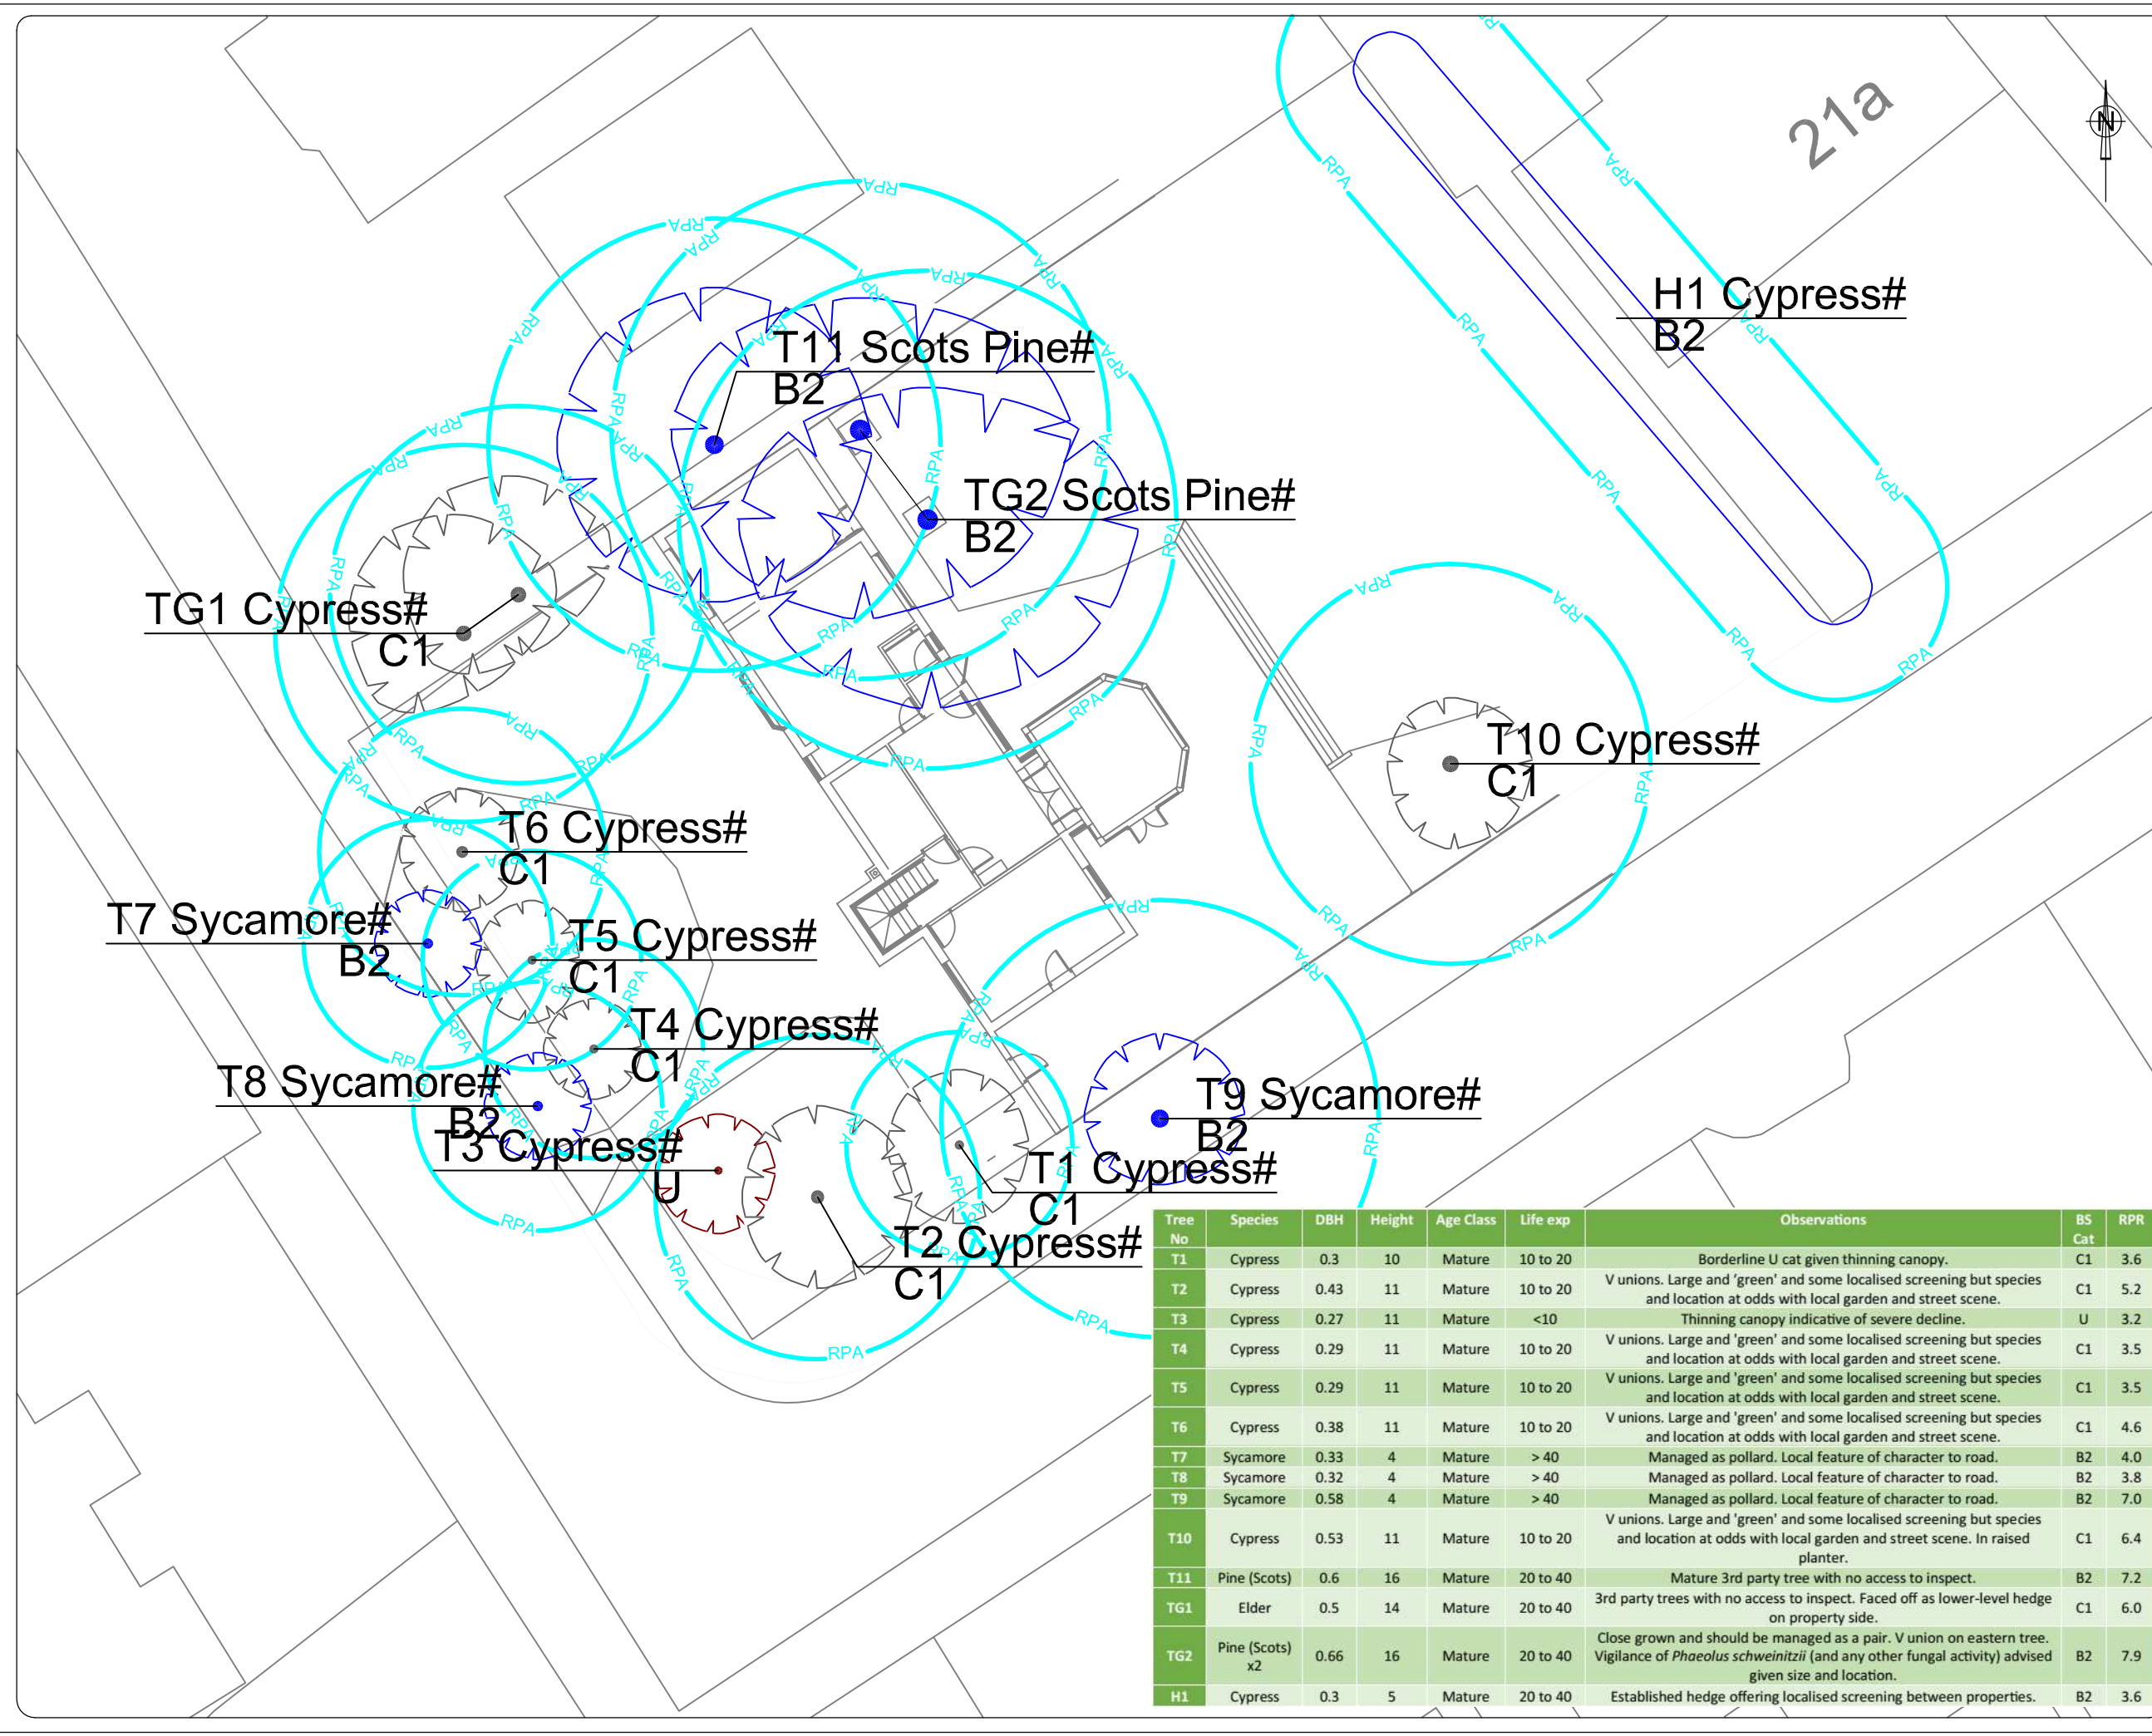
Job	03638R	Scale	1:200 @ A3	DRG NO		Revision	
Date	21/09/2021	Type	a		03638P_TCP_01		A

Tree No	Species	DBH	Height	Age Class	Life exp	Observations	BS Cat	RPR
T1	Cypress	0.3	10	Mature	10 to 20	Borderline U cat given thinning canopy.	C1	3.6
T2	Cypress	0.43	11	Mature	10 to 20	V unions. Large and 'green' and some localised screening but species and location at odds with local garden and street scene.	C1	5.2
T3	Cypress	0.27	11	Mature	<10	Thinning canopy indicative of severe decline.	U	3.2
T4	Cypress	0.29	11	Mature	10 to 20	V unions. Large and 'green' and some localised screening but species and location at odds with local garden and street scene.	C1	3.5
T5	Cypress	0.29	11	Mature	10 to 20	V unions. Large and 'green' and some localised screening but species and location at odds with local garden and street scene.	C1	3.5
T6	Cypress	0.38	11	Mature	10 to 20	V unions. Large and 'green' and some localised screening but species and location at odds with local garden and street scene.	C1	4.6
T7	Sycamore	0.33	4	Mature	> 40	Managed as pollard. Local feature of character to road.	B2	4.0

T8	Sycamore	0.32	4	Mature	> 40	Managed as pollard. Local feature of character to road.	B2	3.8
T9	Sycamore	0.58	4	Mature	> 40	Managed as pollard. Local feature of character to road.	B2	7.0
T10	Cypress	0.53	11	Mature	10 to 20	V unions. Large and 'green' and some localised screening but species and location at odds with local garden and street scene. In raised planter.	C1	6.4
T11	Pine (Scots)	0.6	16	Mature	20 to 40	Mature 3rd party tree with no access to inspect.	B2	7.2
TG1	Elder	0.5	14	Mature	20 to 40	3rd party trees with no access to inspect. Faced off as lower-level hedge on property side.	C1	6.0
TG2	Pine (Scots) x2	0.66	16	Mature	20 to 40	Close grown and should be managed as a pair. V union on eastern tree. Vigilance of <i>Phaeolus schweinitzii</i> (and any other fungal activity) advised given size and location.	B2	7.9
H1	Cypress	0.3	5	Mature	20 to 40	Established hedge offering localised screening between properties.	B2	3.6
