**Statement of significance and Heritage statement  
for the replacement windows to the front elevation, a small single storey rear and side  
extension and minor internal alterations  
at  
1 Albany Villas (left side), Salcombe Road, Sidmouth, EX10 8PW**

March 2023

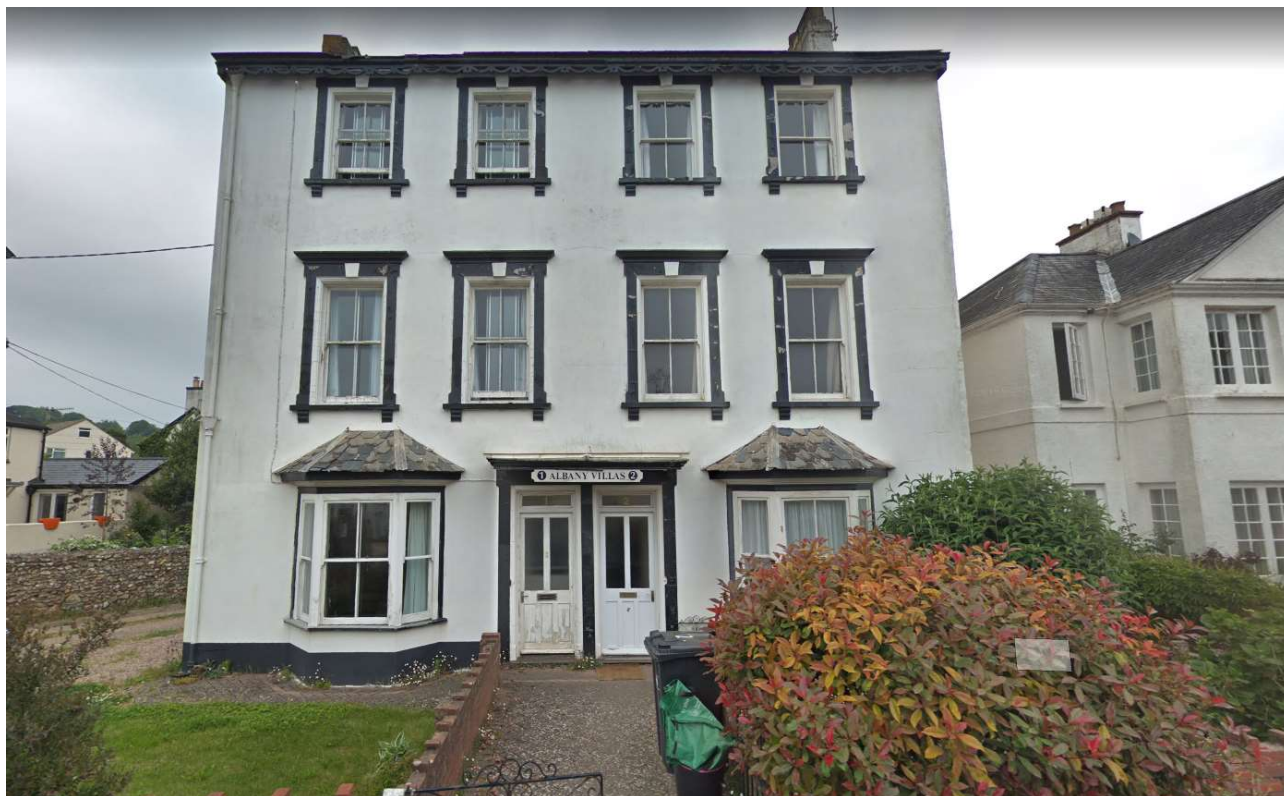
As can be seen in the picture above the house has rendered walls under a slate roof. The windows to the front elevation are timber single glazed sliding sash, while on the rear and side elevation they are a mixture of single/double glazed of varying materials.

The front elevation of this building faces due south and therefore receives the prevailing winds and rain. These windows, and especially the sills, have rotted and been repaired on many occasions. They are now beyond repair and require replacement (see joinery report below). At the rear of the building, on the more sheltered elevation, the windows although in a poor condition, are repairable and therefore do not require replacement.

As stated above the front elevation windows are beyond repair and where they are severely damaged they are leaking and beginning to damage the internal structure of the building. The rear windows are at a stage if they are not repaired within the near future they will also require replacement.

This proposal is to carefully remove and replace all of the timber windows and the door on the front elevation, replacing them with new windows to exactly match the original design including using single glazing fitted with external putty. The windows to the rear elevation will be repaired, leaving in place as much of the original timber as possible.

On completion all windows will be painted white.
