Report on St. Andrew's Church,  
Bishopstone,  
East Sussex.

By Chris & Rachel Butler

August 2023

- 1.2 Chris Butler Archaeological Services Ltd was commissioned by the PCC of Bishopstone Church to undertake an analysis of the west wall of the north aisle and the north wall of the tower, with a view to establishing dating and phasing, in connection with a potential planning application for a new toilet extension.

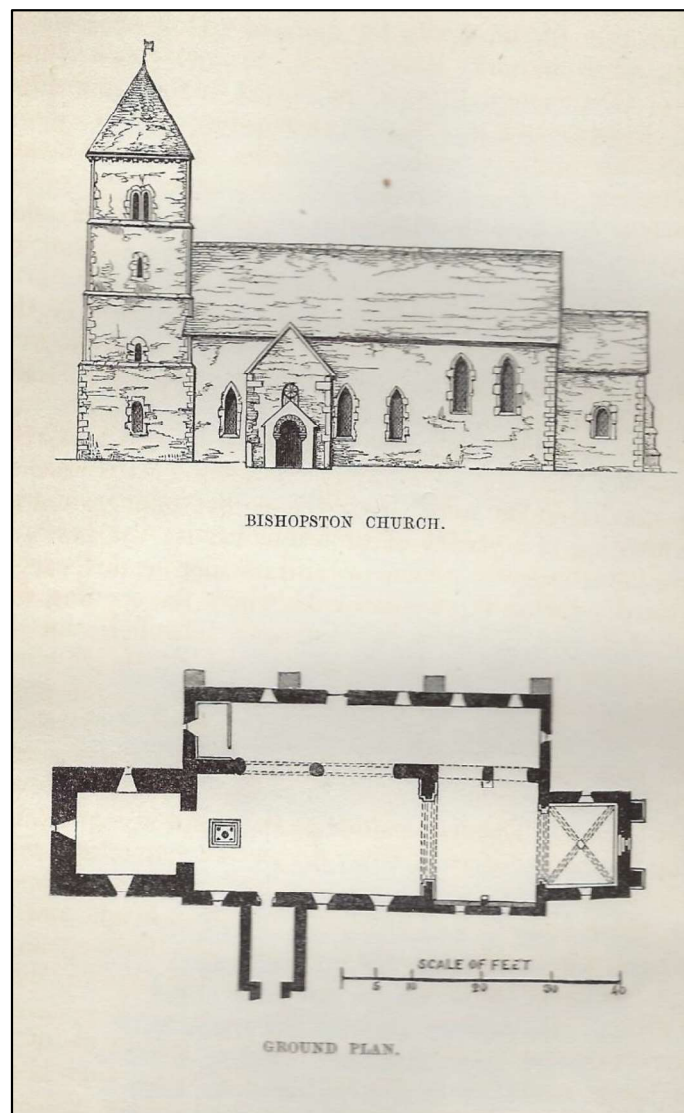
Fig. 2: Figg's plan & south elevation of Bishopstone Church 1849

1.4 Restoration work was undertaken at the church c1849 and again in 1885<sup>3</sup>, whilst the most recent restoration in 2006 rediscovered previously hidden features<sup>4</sup>. It was not possible to locate any historic drawings or photographs of the west elevation of the church, although the plan and south elevation (Fig. 2) were published in 1849<sup>5</sup>, and there is a drawing viewed from the southwest dated c1856, but this was not informative. Sources used in this report are listed below (Section 5).
