Tree Code: Sgl/013649

Common Name: Lime spp

Site: St Johns Avenue, Harlow

St Johns Avenue Harlow Resistograph readings

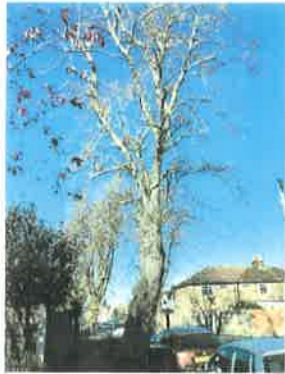
Readings 1 and 2 (Figures 1 and 2) were taken into the west of the main stem adjacent to the footway and evidence little residual wood fibres, with decay throughout. The measurements were ended prematurely based on the little resistance offered against the drill, as evidenced by little to no amplitude in the measurements, suggesting intensely decayed internal fibres.

Given the position of this tree adjacent to the footway and carriageway along St Johns Avenue, the proximity to resident car parking and private residential properties, as well as overhead cabling, it is recommended that this tree is felled and replanted.

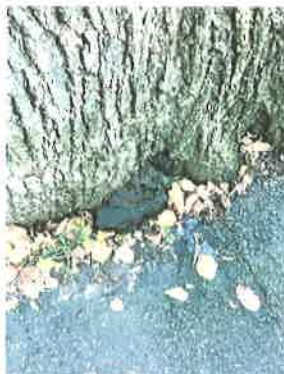
The reading taken to the southeast of the stem (Figure 3), between both footway and carriageway evidence high initial amplitude with a sporadic wave form. This indicates no clear separation between decay columns and a poor CODIT (Compartmentalisation of Decay In Trees) response by wood fibres on this axis. The area of amplitude from 2.5cm to 21.8cm evidence residual wood fibres as being present, however the lack of a clear and consistent wave form in amplitude indicates poor separation between annual growth rings and a clear sign of the progression of dysfunction from the centre of the stem outwards.
