Subject: Pendley Farm, Tring. Plots 1-4 Garden validation

Our ref: L-22473-2.4.2-24-232-KRP

This letter reports the results of a verification inspection of remedial activities with regards soil contamination in gardens areas of Plots 1 through to 4 inclusive, of the above development.

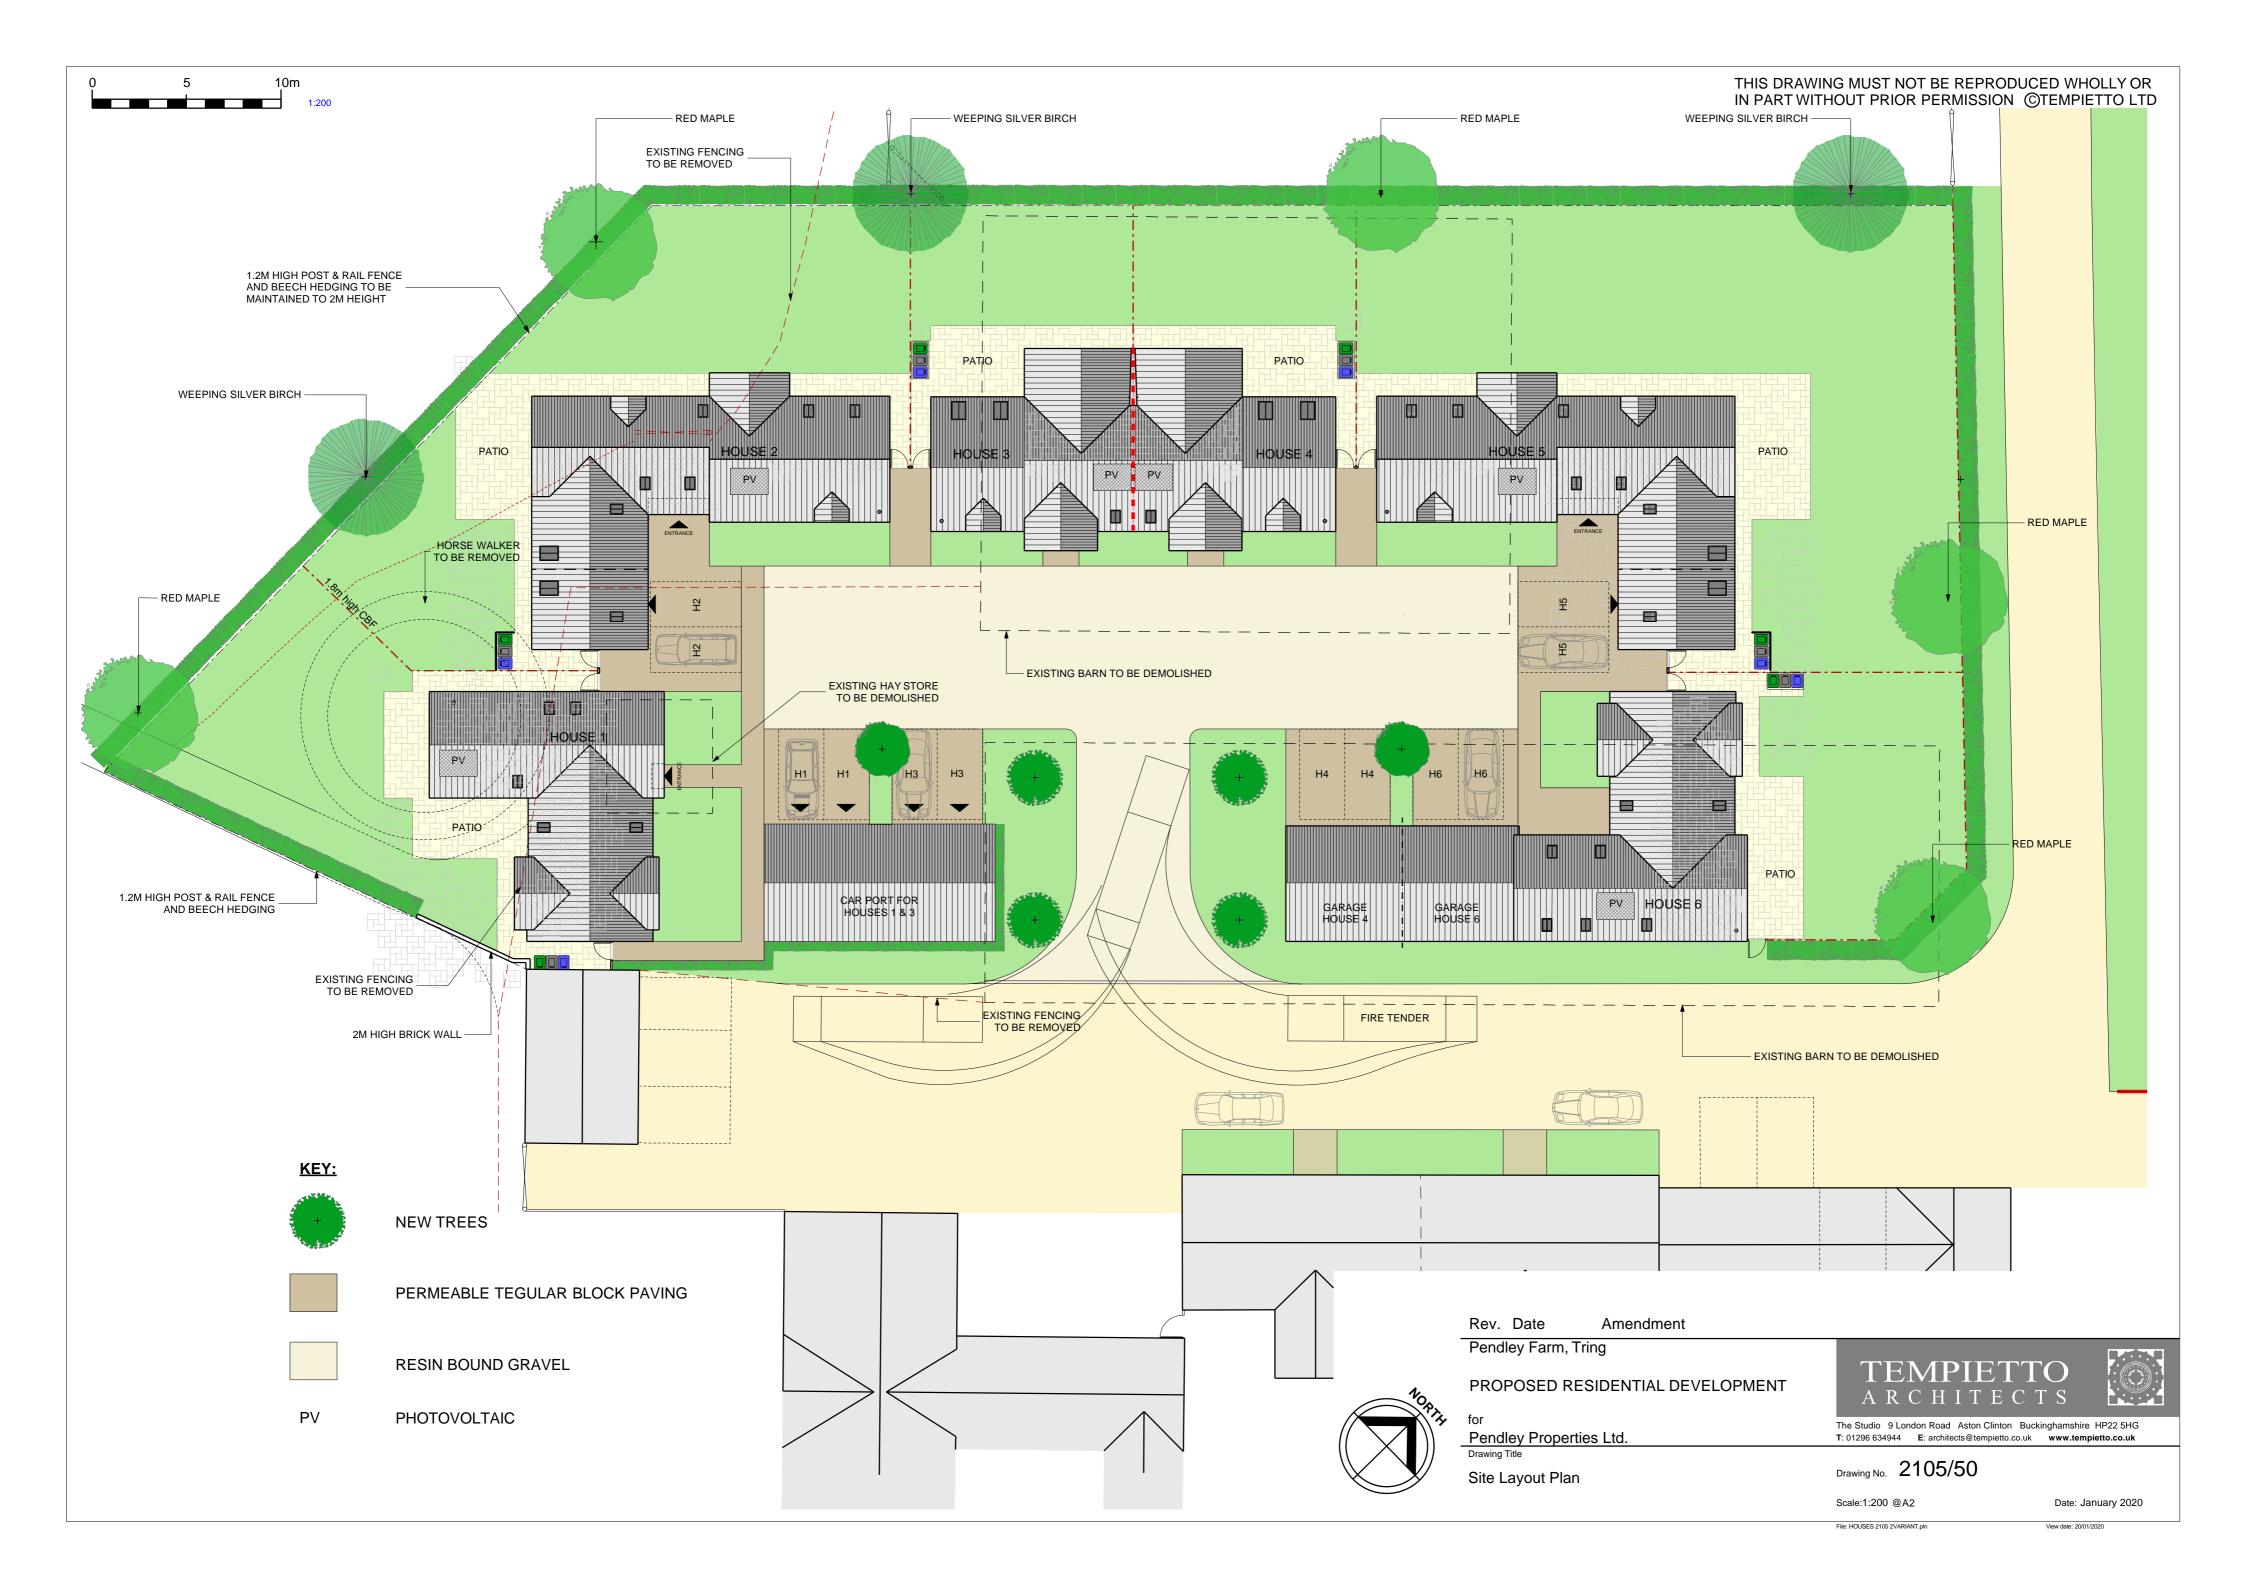
Courtyard area border ready for topsoil

The developer confirms that site-won topsoil stripped from greenfield areas to the north (currently in stockpile) will be replaced over the reduced dig and in the planted areas within the courtyard.
