J ROBERTS DESIGN LTD
STRUCTURAL AND CIVIL ENGINEERING CONSULTANTS

Ref – JR/4097

5 Bradleys Lane, Hoveringham, Nottingham, NG14 JG - Structural Inspection

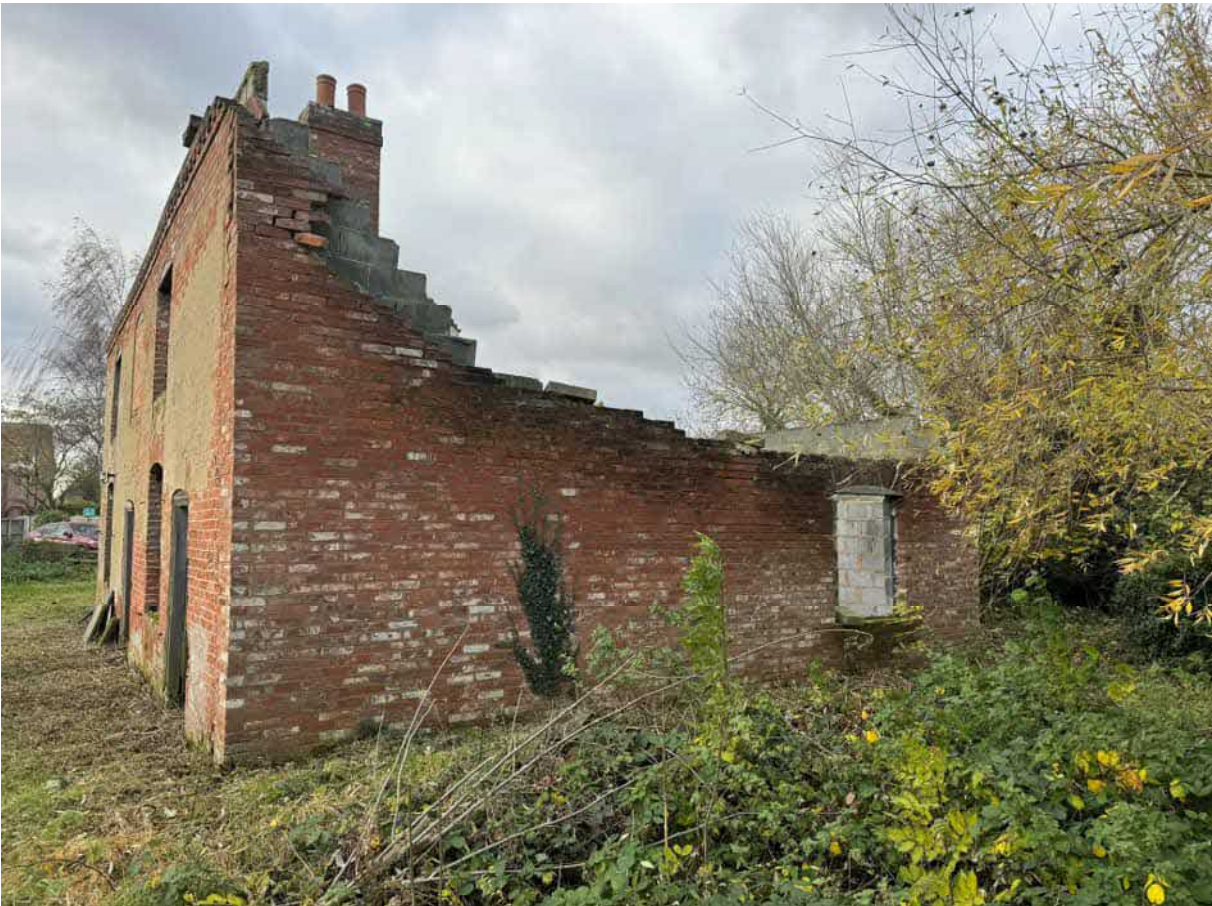
6. Continuing to the north east corner of the gable wall it appears that a section of wall had collapsed resulting in lateral movement of circa 200mm in the masonry and rotation of the masonry at the corner. Loose bricks are still present within the outerleaf of masonry. Internally cracking within the bedjoints are visible reflecting the movement observed. The corner is also noted to be an interface between the solid brick masonry and new cavity construction. The outerbrickwork has been toothed in around the corners, however the blockwork abuts the vertical face of the brickwork on the inner leaf. It is not known if masonry ties are present to the inner leaf of masonry.

NORTH EAST ELEVATION – RIGHT HAND SIDE

The defects to the north gable will require the partial demolition of the defective areas of masonry and effective re-building of the corner up to the proposed gable wall level. The inner leaf of blockwork will need to be effectively tied into the solid brickwork at the corner with remedial ties where new or crack stitching around the internal corner of the wall where the blockwork is to remain in place.

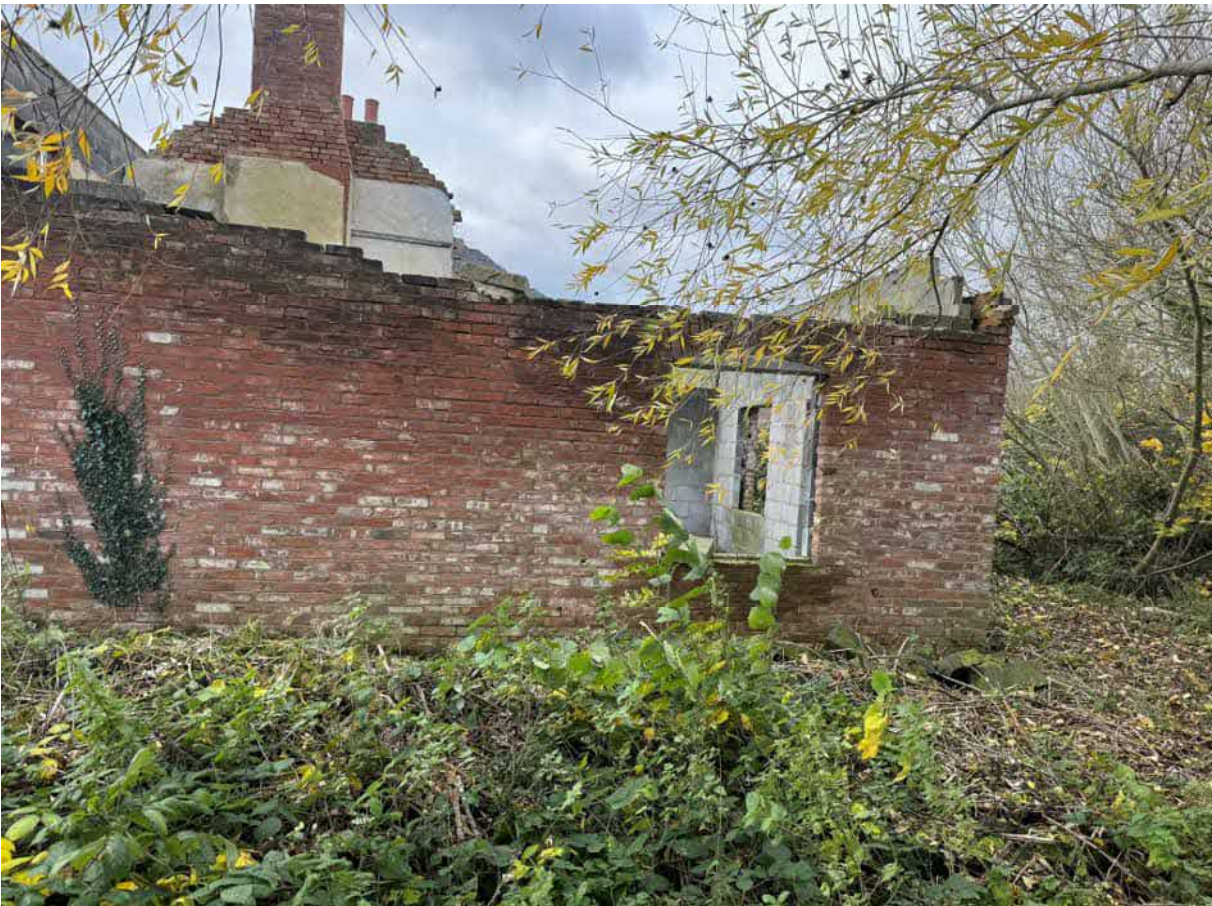
NORTH ELEVATION – RIGHT HAND SIDE

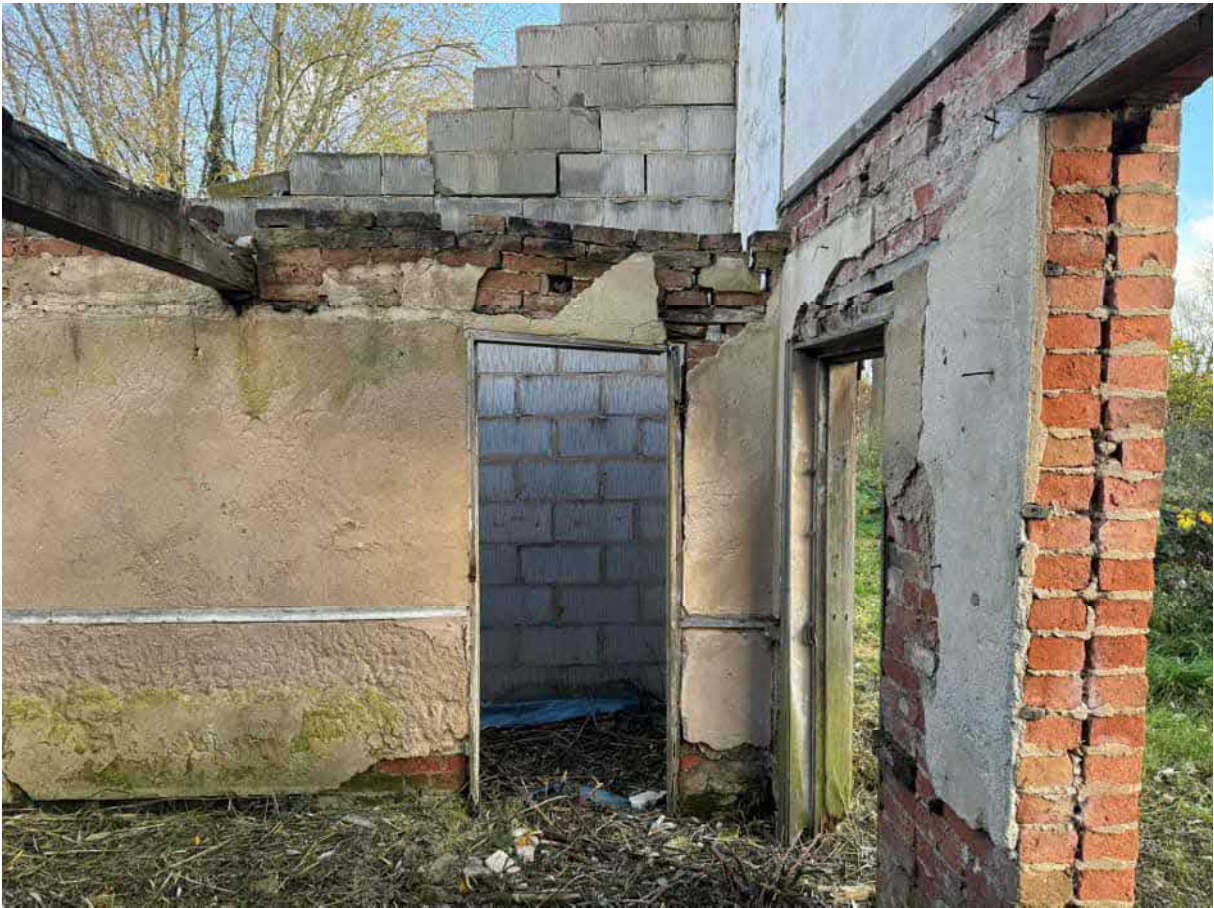
The remaining timber floor and ceiling beams are suffering from significant decay therefore should be replaced or the floors re-designed to span the full room length.

GENERAL VIEW WITHIN NORTH EAST ROOM – LOOKING NORTH
