STRUCTURAL REPORT - PLANNING

BARN AT MEADOWSIDE, TRESMERE,

DOCUMENT No. AO246-W-0001-A

CLIENT: MRS R.M DANIEL

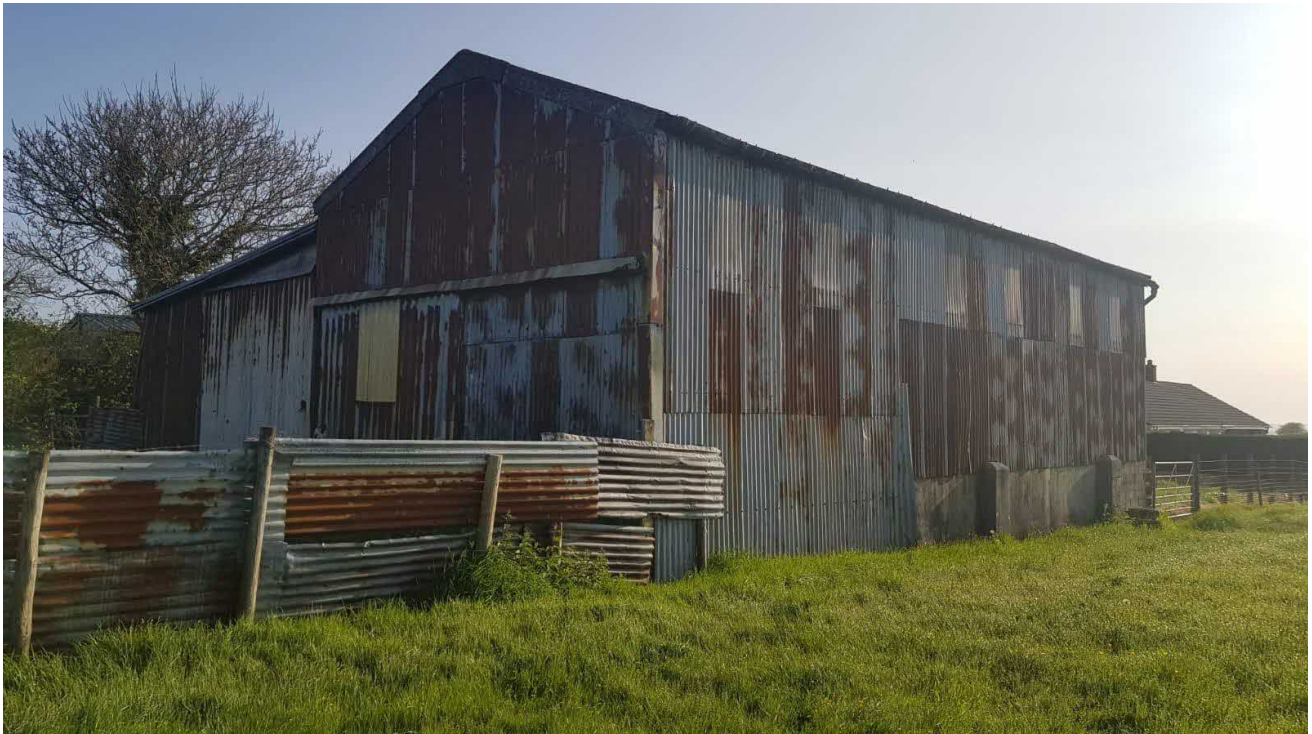
Above: Barn viewed from South West Elevation

The barn is split into two structural forms a lean too section (to the North) and duo pitched section to the South. The barn is rectangular on plan measuring approximately 14m x 12.1m.

The lean too section low eaves measures 3.38m above ground floor level and spans 6.3m. The duo pitched area has a clear span of 5.8m with the eaves and apex measuring 4.25m and 5.6m respectively.

Vertical loads in the duo pitched area are transferred via pre cast concrete purlins onto the pre cast concrete frames and onto the foundations below. Lateral stability is provided by moment connections at the eaves of the frames and assumed base fixity.
