# Hutton + Rostron Environmental Investigations Limited

## Grandpont House, Oxford: Roof drainage investigation

Site note 3 for December 2023-January 2024, job no. 160-42

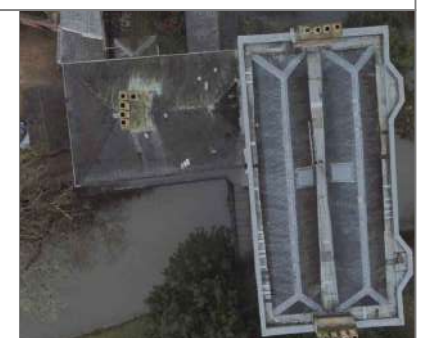
main roof:  
-code 4 lead parapet and valley gutters  
-previous patch repairs to holes/splits  
-poor detailing for movement joints

east drainage outlet:  
-introduced ~1910  
-iron goods replaced in PVCu ~1980  
-110mm diameter pipe run directly into gravel footpath and eastward into river  
-1910 era hopper remains set aside (nearby on bay roof, 550x400x250mm)  
-suggestion that this should be removed

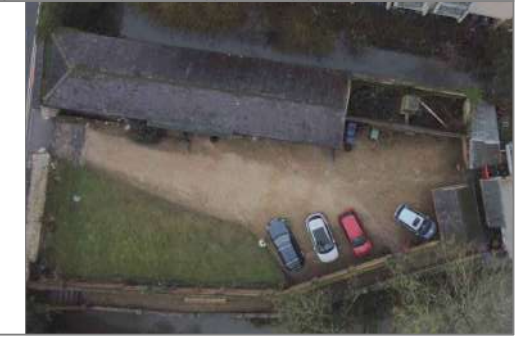
**Grandpont House, Stables - Roof**  
Roof drainage investigation  
December 2023 - January 2024

REFERENCE	ITEM	OBSERVATIONS	RECOMMENDATIONS	CLIENT COMMENTS
<b>SN3.2 STABLES ROOF DRAINAGE</b>				
<b>SN3.2.1</b>	Stables Roof drainage	<p>Eaves guttering was of PVCu in a half-round profile 120mm diameter</p> <p>Downpipes were arranged as shown on drawings (4no.) which were of PVCu in 70mm diameter</p> <p>The centre of the south elevation had a parapet wall feature, necessitating a parapet gutter lining (finished in mineral felt)</p> <p>Various parts of the gutter were overflowing, often due to poor setting-out of the slates which did not allow a proper eaves overhang to shed water effectively into the gutter. There were also areas where the gutter had sagged or was poorly flashed into the felt parapet</p> <p>The back-gutter for the west hip abutment to the stone boundary wall has become disguised by built-up debris. It was assumed that this might have been lined in lead. There were no major leaks internally to suggest failure of this gutter but it was not otherwise possible to gather further data at this stage</p>	<p><i>Eaves gutters and downpipes to be replaced in 100mm diameter cast iron goods. Architect to consider how surface drainage can be captured and shed at the feet of downpipes (i.e. all those which do not currently drain into the river)</i></p> <p><i>Careful detailing will be required to carry water from the south-central parapet gutter into the eaves gutters alongside, this may call for iron hoppers at each of these locations (2no.) to capture water from both the eaves gutter and the parapet gutter via a lead flashing</i></p> <p><i>As part of renewing the roof finishes (suggested within H+R Site Note 2), the existing eaves overhang deficiency should be rectified, fascia boards replaced (or made good and redecorated) and the west back-gutter replaced</i></p>
