# Hutton + Rostron Environmental Investigations Limited

## Grandpont House, Oxford: Window and door unit investigation

Site note 5 for December 2023-January 2024, job no. 160-42

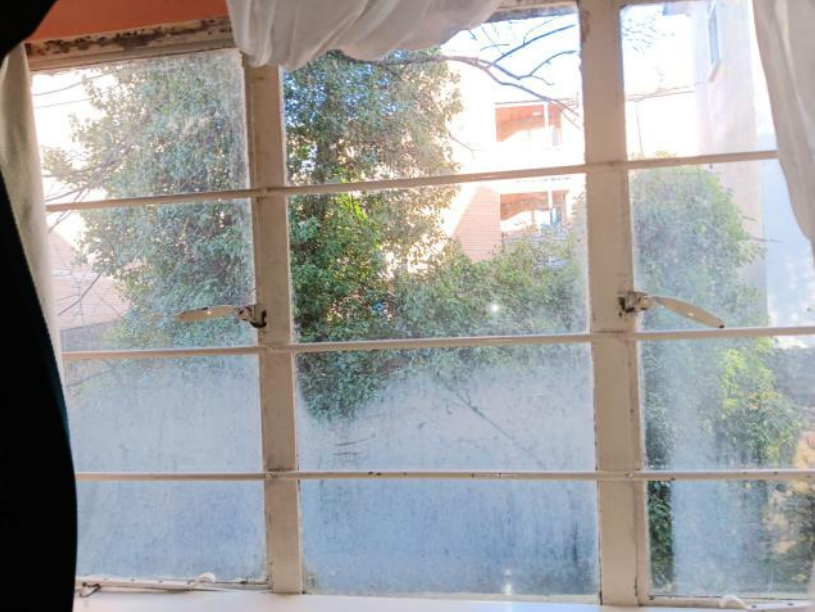
<b>Reference</b>	H+R window 54

<b>Location</b>	Main House Ground floor North side	
<b>Type</b>	This was a modern early c20th wing of the building. The steel frame and single glazed windows were original to this period. All glazing was provided with security bars at the inner face  The east and west parts of the window were side hung casements with catches and stays	
<b>Strategy</b>	Poor thermal performance and limited historic value may justify replacement	
<b>Item</b>	<b>Works/Observations</b>	<b>Tender</b>
<b>Dimensions</b>	Overall aperture size 900 x 1500mm	
<b>Decoration</b>	The condition of the paintwork was fairly poor but the original galvanised coating to the steel frame seemed to be largely effective (main issue being the bond between paint and zinc coating)	
<b>Corrosion</b>	The west casement in particular seems to have developed some kind of damage or corrosion, meaning that it could not close properly

<b>Operation</b>	Correcting the corrosion issue mentioned above may be more difficult and costly than total replacement of the window unit  (price for window replacement, tbc)

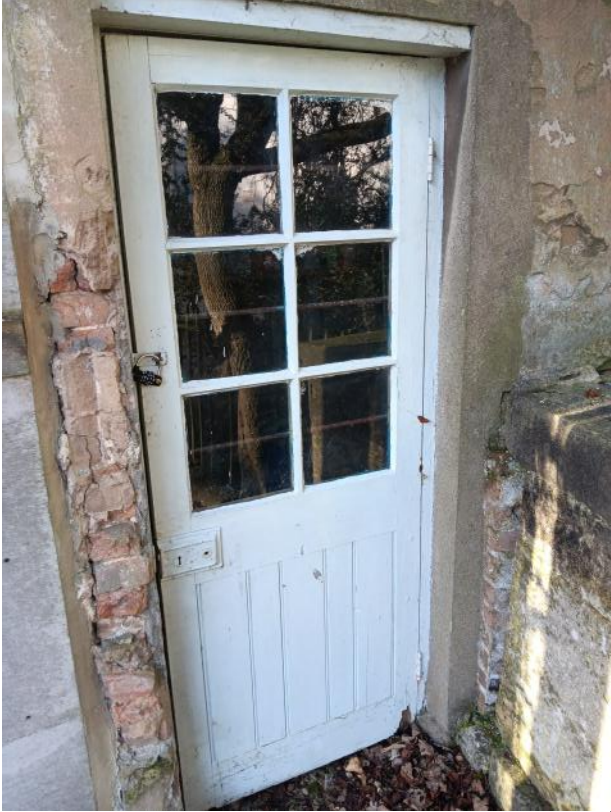
<b>Reference</b>	H+R door 55

<b>Location</b>	Main House Ground floor North side	
<b>Type</b>	The door features 6 panes of glass over the lock rail and timber panels below  The door, along with the extension section of the building as accessed, was not expected to be historic. It may date from the early to mid-c20th  Security bars were mounted internally	
<b>Strategy</b>		
<b>Item</b>	<b>Works/Observations</b>	<b>Tender</b>
<b>Dimensions</b>	Overall apertures size 2000 x 800mm	
<b>Decoration</b>	Moderate; prep and re-dec (if door is to be retained)	
<b>Timber decay</b>	The base of the frame was decayed at both sides and both stiles of the door were decayed at low level. This also appeared to be allowing rodent access into the room  This may justify total replacement of the door and frame	
<b>Operation</b>	The face mounted lock was broken and missing its handle; replace (if door is to be retained)

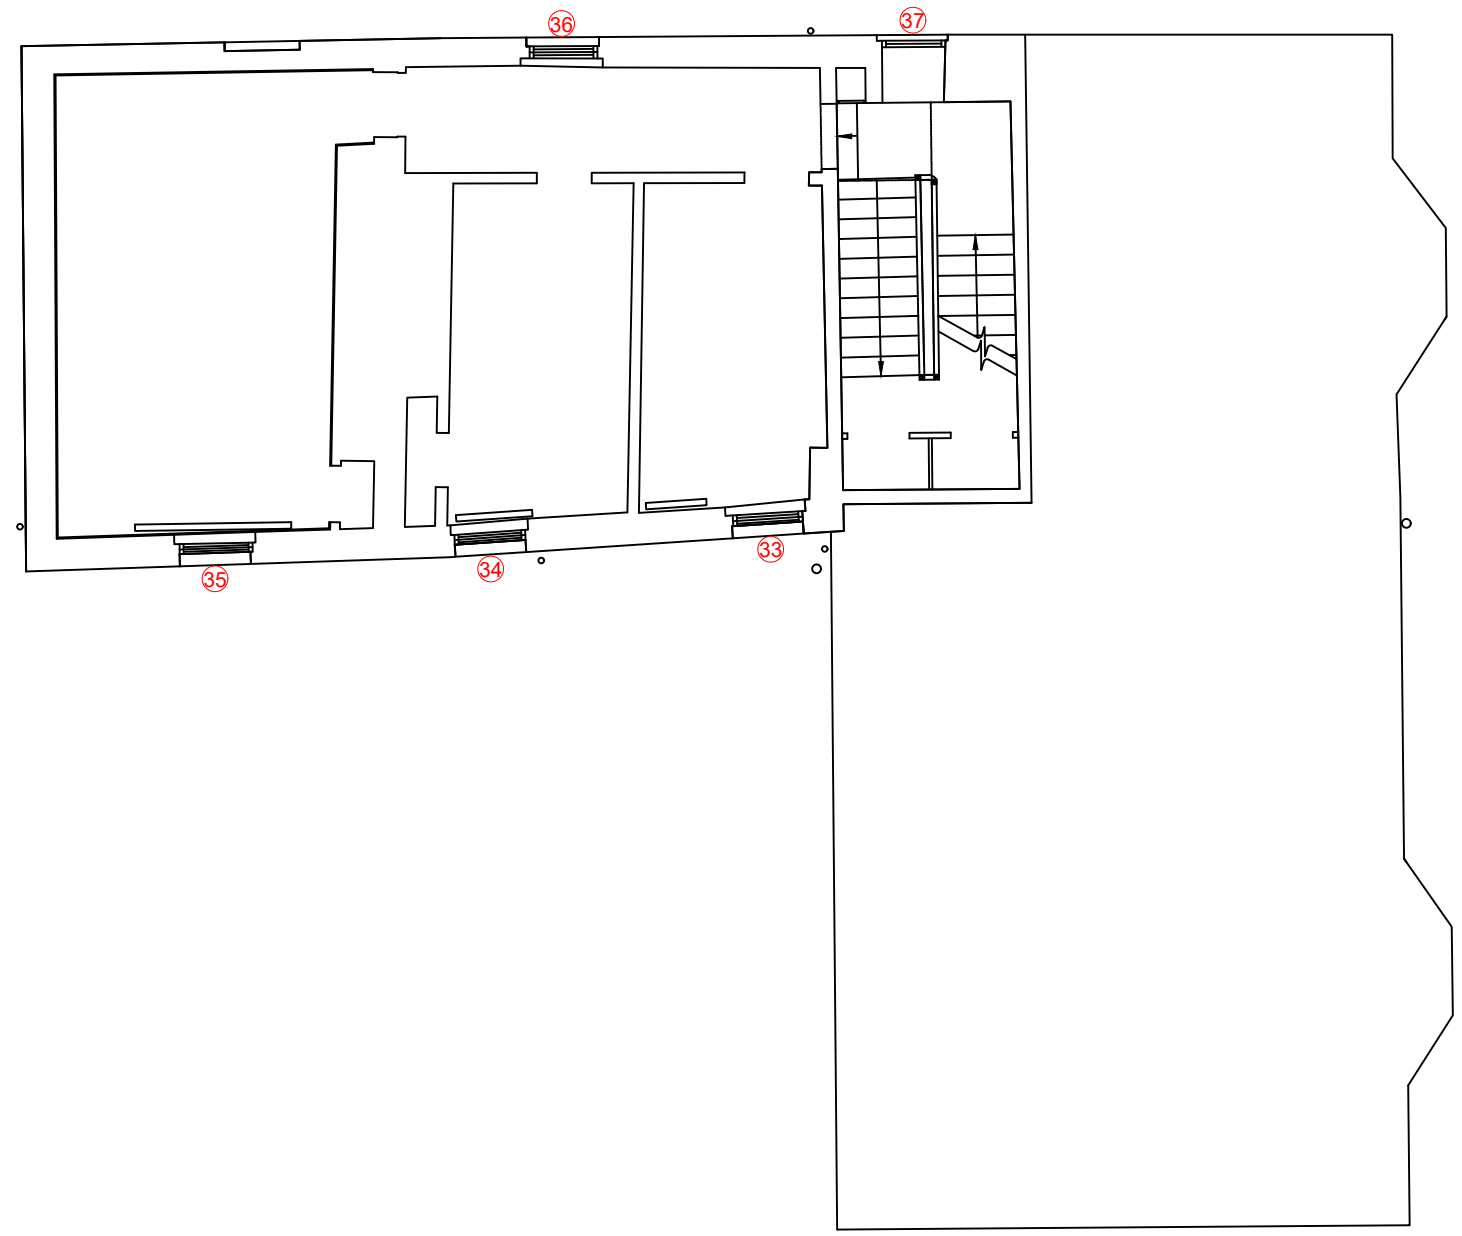
**Grandpont House, Main House - Mezzanine above ground**  
Window and door unit investigation  
December 2023 - January 2024

Misc. Stores  
various doors and  
windows in poor condition
