Hutton + Rostron Environmental Investigations Limited

Grandpont House, Oxford: Chimney investigation

Site note 1 for December 2023-January 2024, job no. 160-42

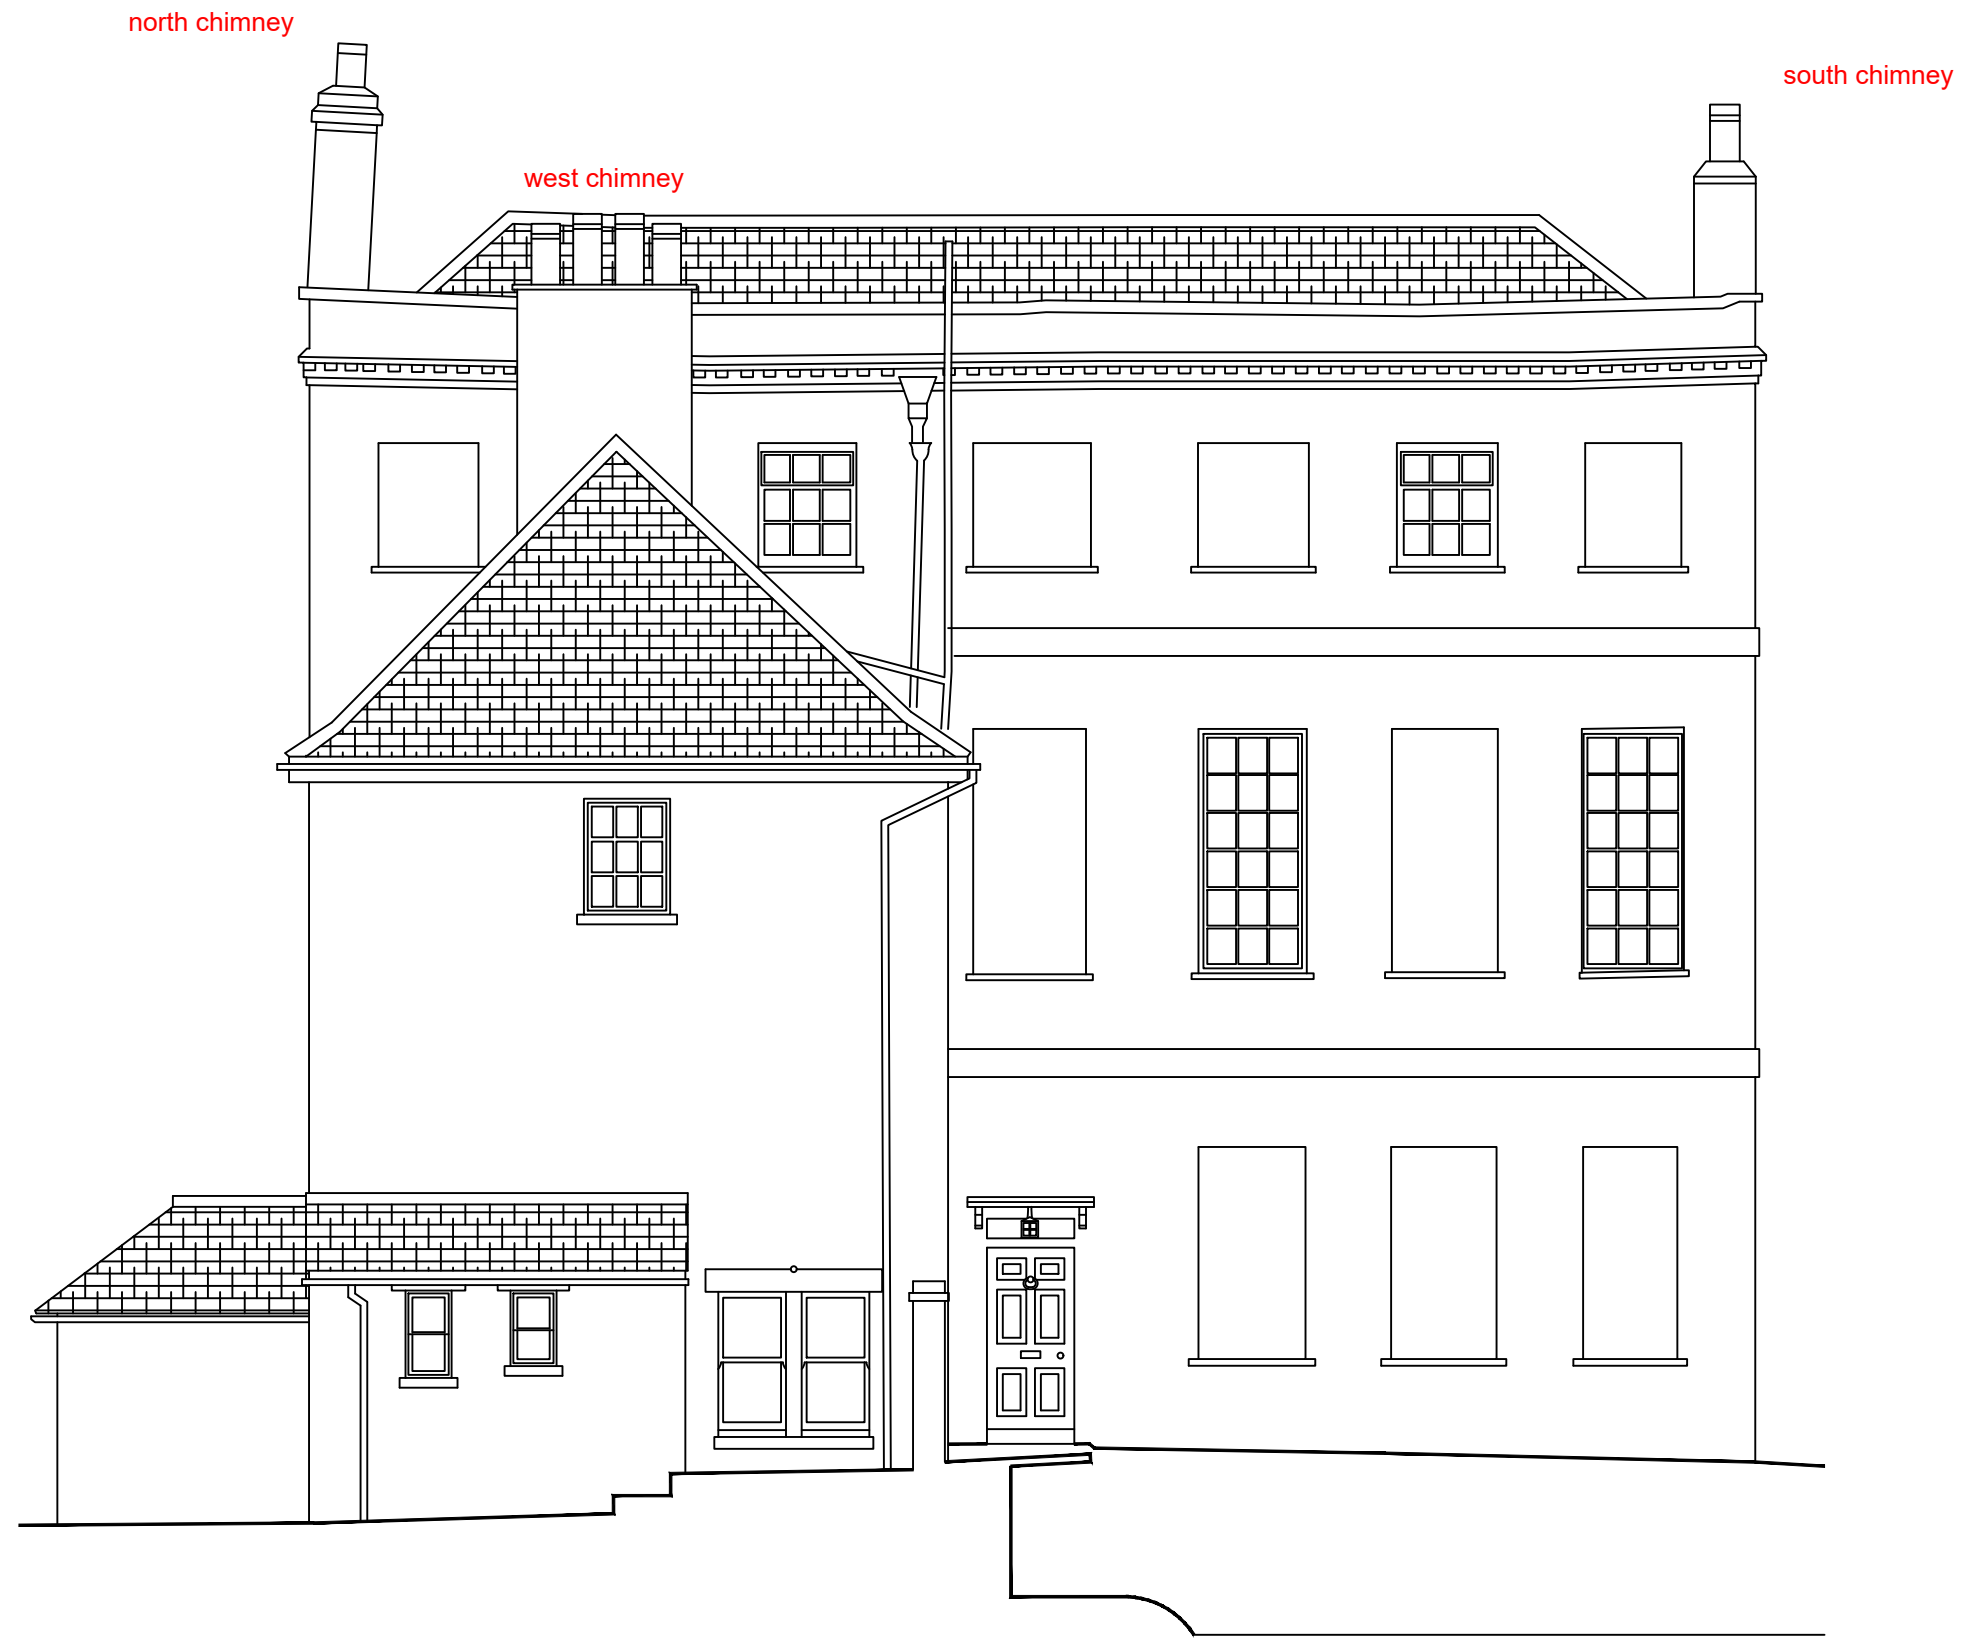
Grandpont House, Main House - Roof
Chimney investigation
December 2023 - January 2024

south chimney:
-steel flue liner for
ground floor stove noted

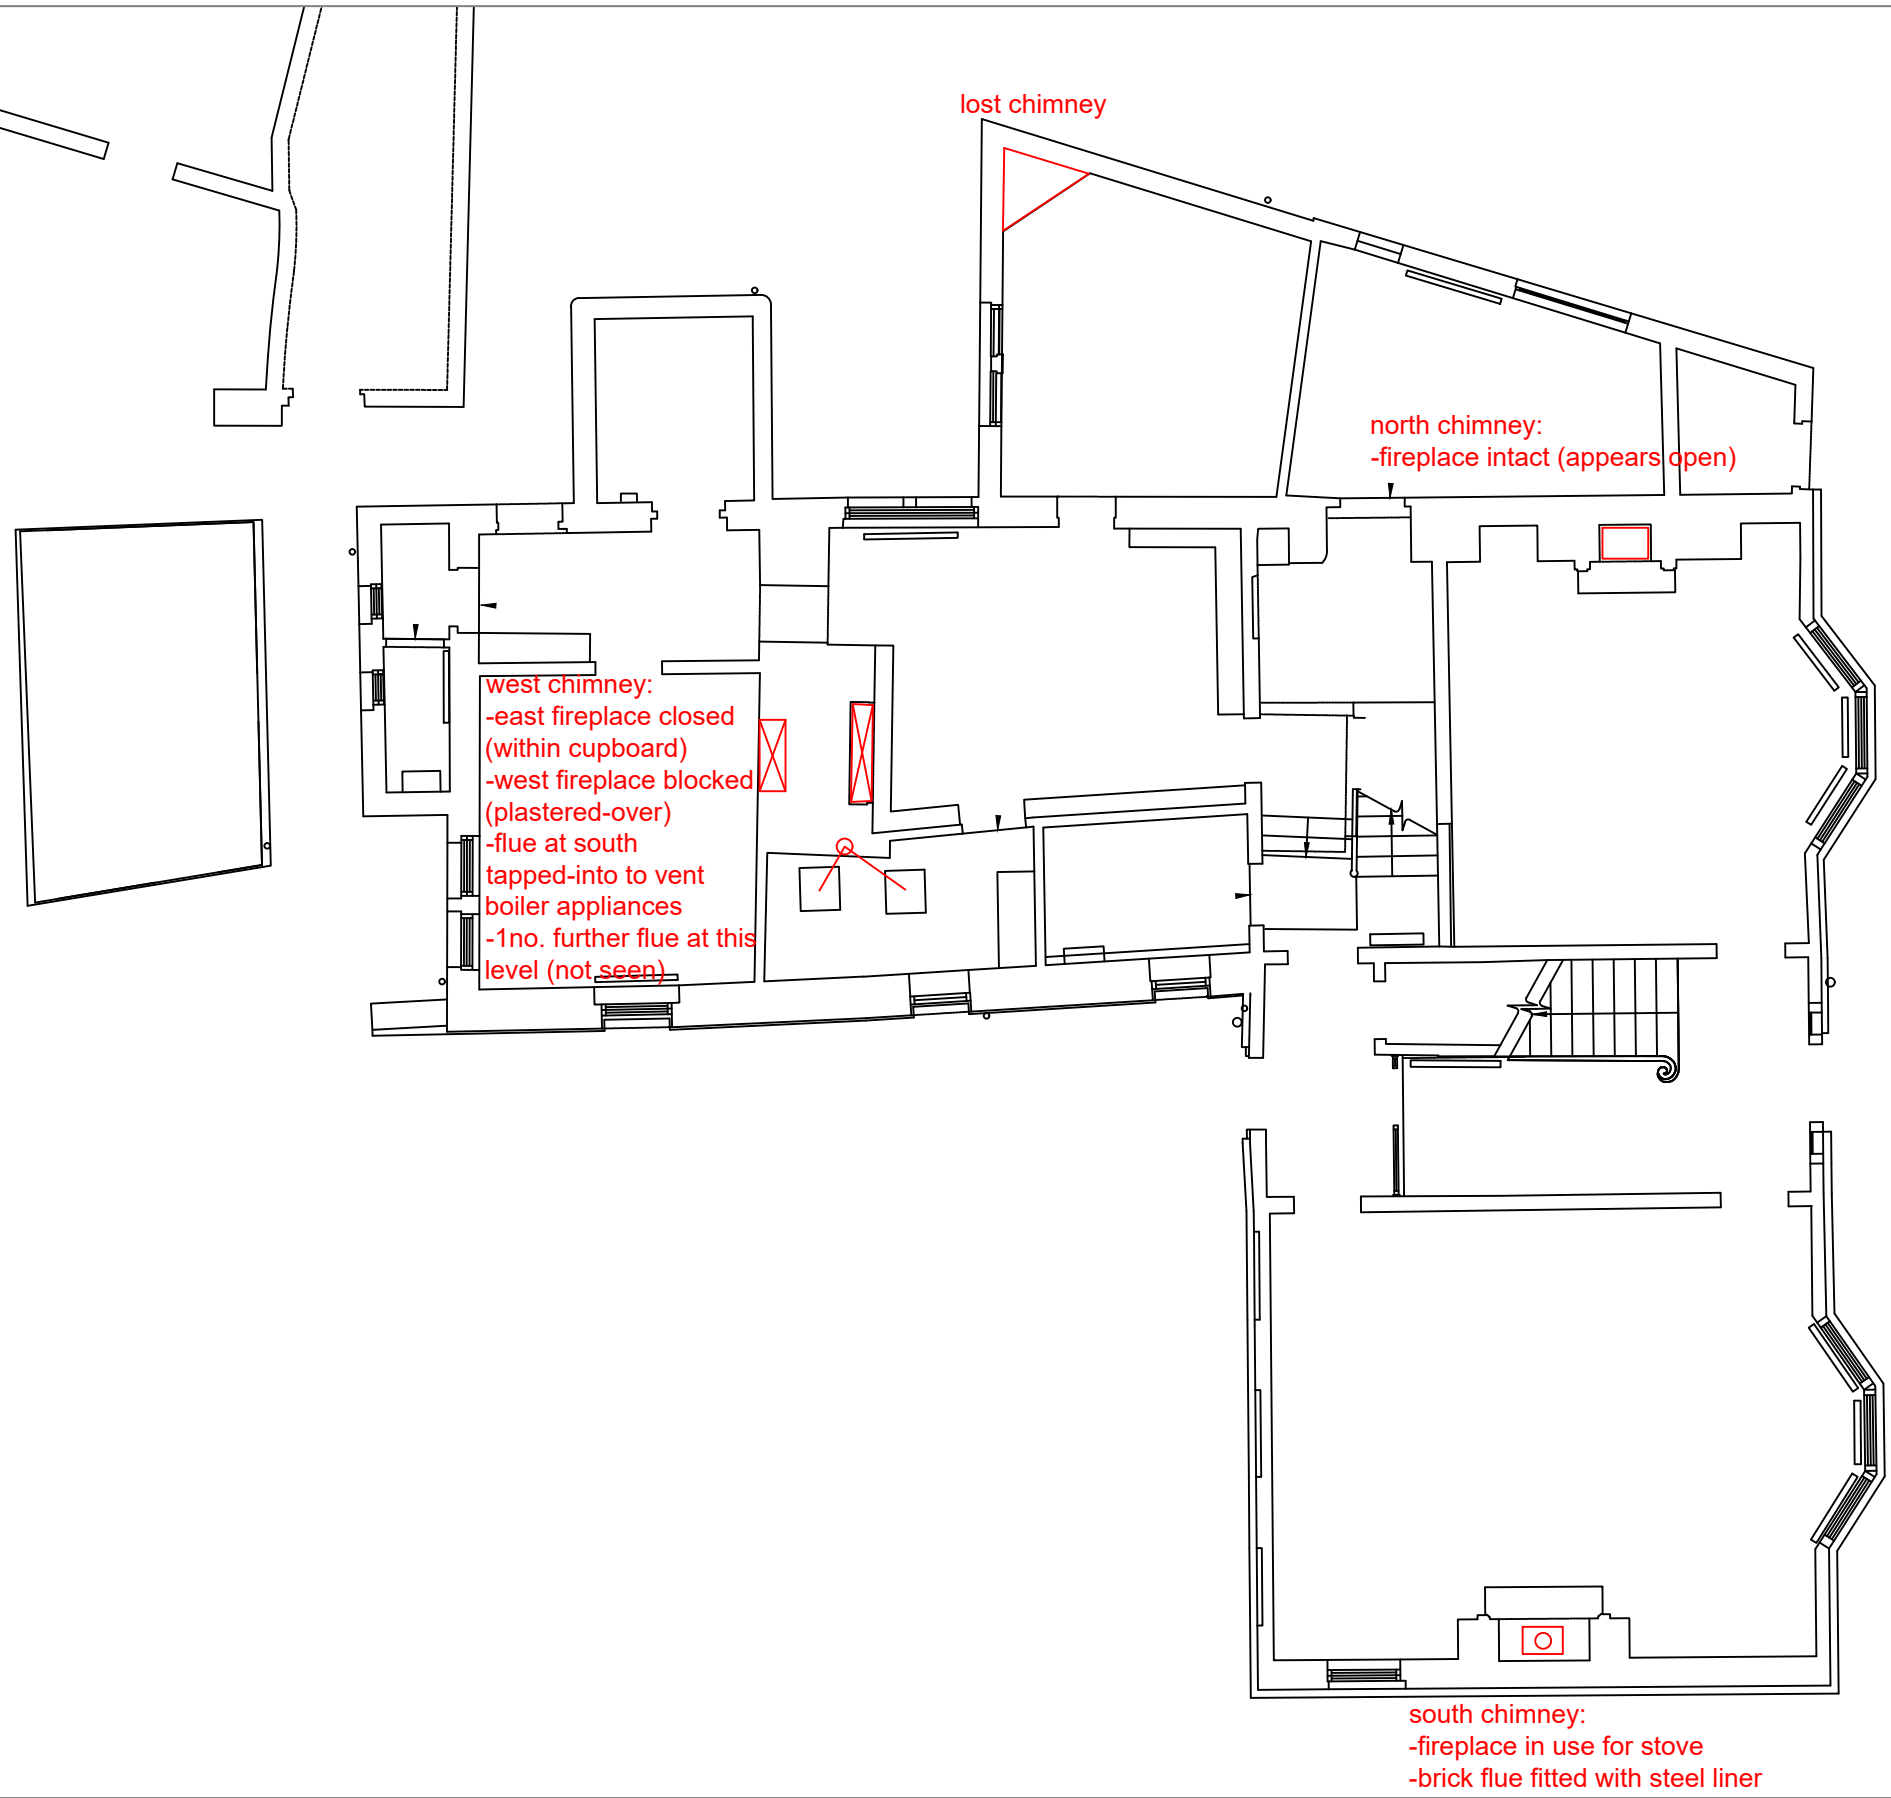
Grandpont House, Main House - Ground floor
Chimney investigation
December 2023 - January 2024

SN1.2.4	Main house South chimney Ground floor	The chimneybreast, fireplace and decorative surround remained. A modern 'log-burning' stove has been installed within the fireplace aperture and a flexible steel liner run up the brick flue void. H+R suspected that there may be various non-compliant aspects of the stove installation (e.g. lack of cowl and potentially under-size flue diameter)	<p><i>At this stage, H+R would caution against use of the stove</i></p> <p><i>As part of the refurbishment scheme, H+R would suggest that the stove and flue liner should either be removed, replaced or at least overhauled. Caution is required in relation to potential asbestos-containing materials within the stove/liner installation</i></p> <p><i>H+R can provide further advice on the south chimney, if instructed. Any proposals to reinstate operation of chimney systems for combustion should be according to the design of a fire engineer</i></p>

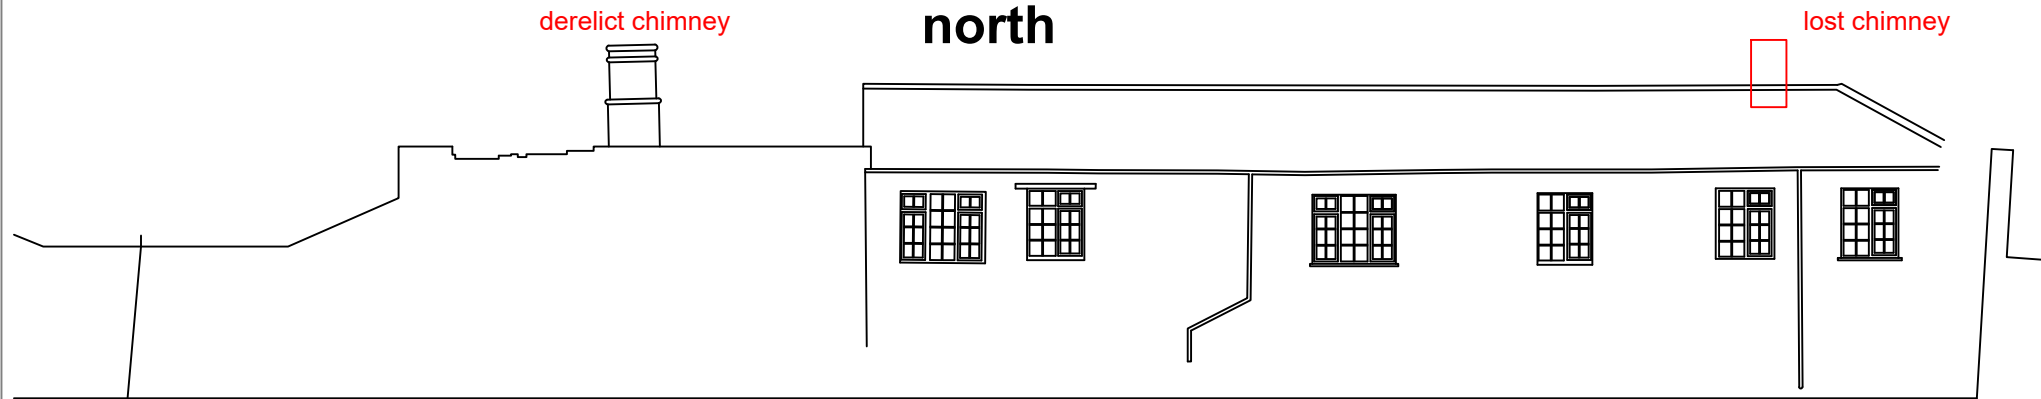
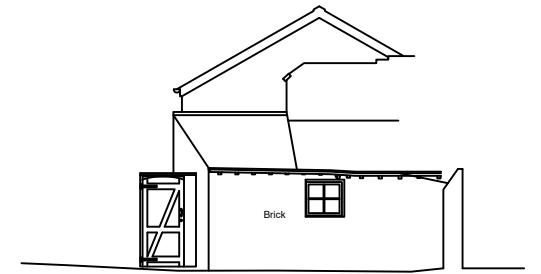
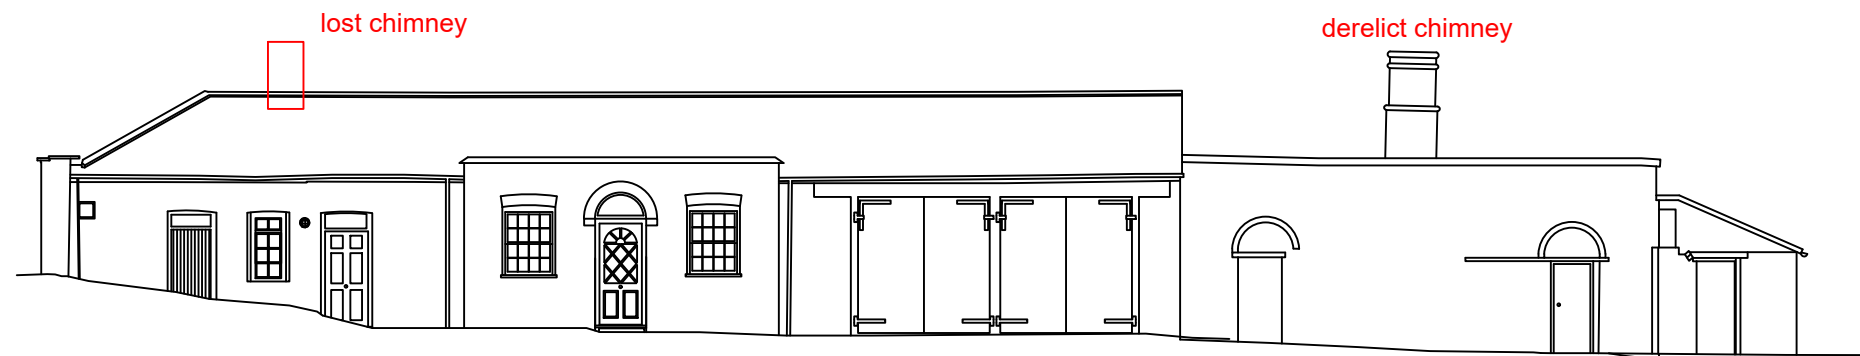
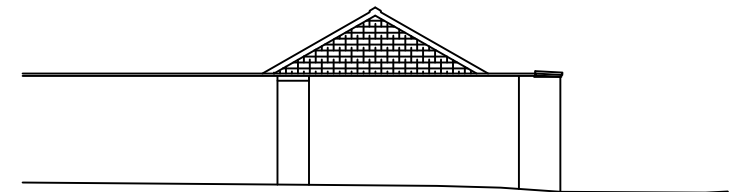
Grandpont House, Stables - Elevations
 Chimney investigation
 December 2023 - January 2024

SN1.4.3	Stables Lost chimney	As shown on drawings, there appears to have originally been a single-flue stack towards the east end of the stables (central to the ridgeline)	<i>At this stage, there seems little benefit in restoring this chimney to operation. Depending on proposed layouts internally upon refurbishment of the stables, it may be beneficial to consider demolishing the redundant chimneybreast</i> <i>H+R can provide further advice, if instructed</i>
