# Arboricultural Consultancy for Lloyds Bank

Insured	Mrs Pauline Wright	Address	37 West End, March Amby Cottage, Cambridgeshire, PE15 8DN		
Client	Subsidence Management Services	Contact	Nigel Buxton	Claim No.	IFS-LBG-SUB-22-0104134
ES Ref	SA-252510	Consultant	Kirk Thompson	Contact No.	0330 380 1036
Report Date	16/03/2023

# GEOTECHNICAL

# SOIL ANALYSIS

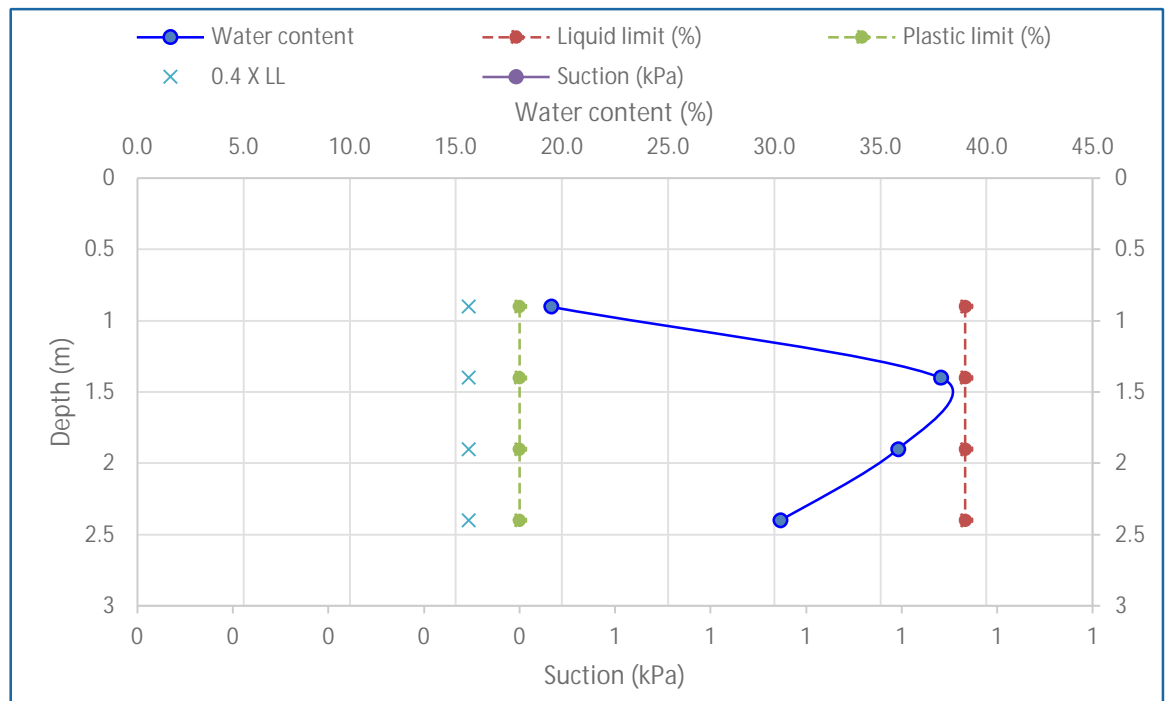
### Samples from BH1

Lab Ref	Depth (m)	WC (%)	LL (%)	PL (%)	PI (%)	.425 mm(%)	mod. PI (%)	Av. Suc. (kPa)	Description
1	0.9	19.5	39	18	21	85	18		Soft to firm brown silty CLAY with rare gravel. Gravel is fine and medium.
2	1.4	37.9	39	18	21	85	18		Soft dark brown silty CLAY with rare gravel. Gravel is fine and medium.
3	1.9	35.8	39	18	21	85	18		Soft brown/dark brown silty CLAY with rare gravel. Gravel is fine and medium.
4	2.4	30.3	39	18	21	85	18		Soft brown silty CLAY with rare gravel. Gravel is fine and medium.
