ADDENDUM TECHNICAL REPORT

Crawford Reference: SU2206126

**Stanton Guildhouse Ltd
The Stanton Guildhouse
Broadway
Worcestershire
WR12 7NE**

SUBSIDENCE CLAIM

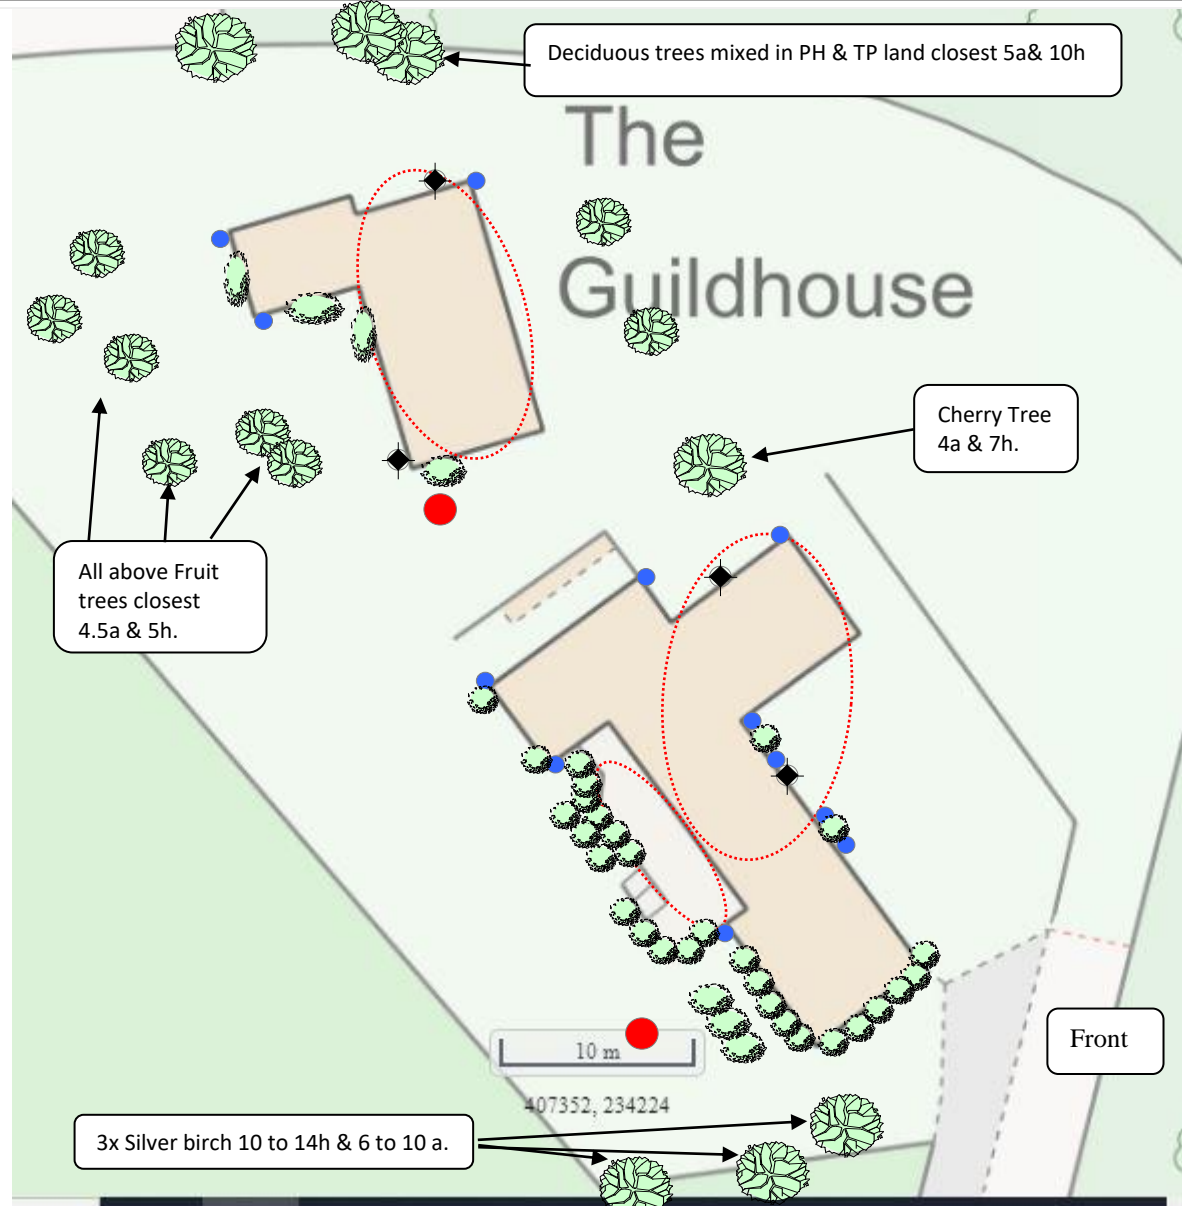
Site Plan

A trial hole was excavated to expose the foundations - see site plan for location and the diagram below for details. Four trial holes have been undertaken at the property as follows.
