Tree Decay Investigation Report -
The Station, Ottery Saint Mary
T00 1 – Mature Oak

TREE DECAY INVESTIGATION REPORT

SITE ADDRESS (THE SITE):	The Station, Mill Street, Ottery Saint Mary EX11 1AH
LOCAL PLANNING AUTHORITY:	East Devon District Council

HI-LINE JOB REFERENCE:	RSKHL_8289.24		
SURVEYED BY:	Mark Read	DATE:	6 th March 2024
REVIEWED BY:	David Hansford	DATE:	13 th March 2024

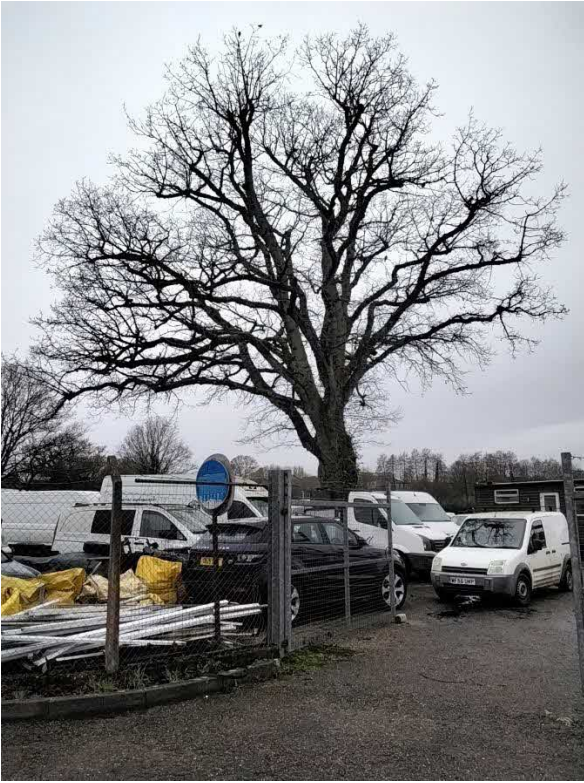
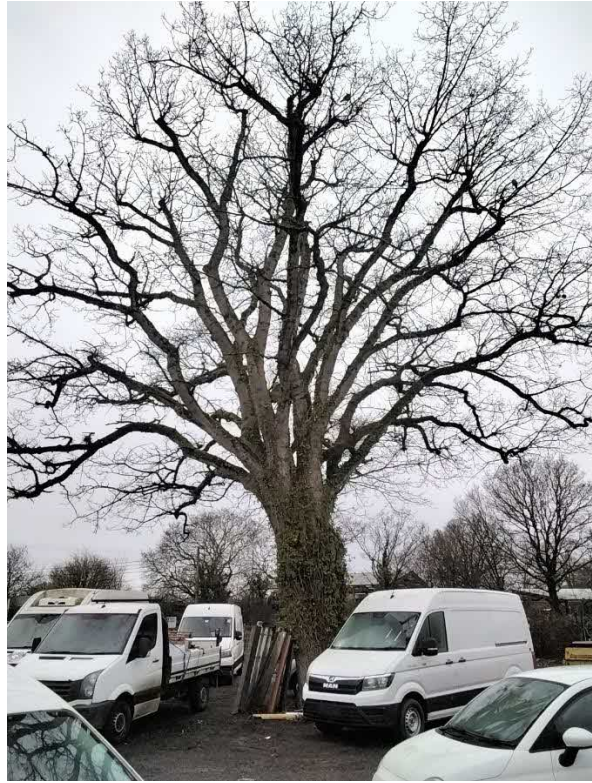
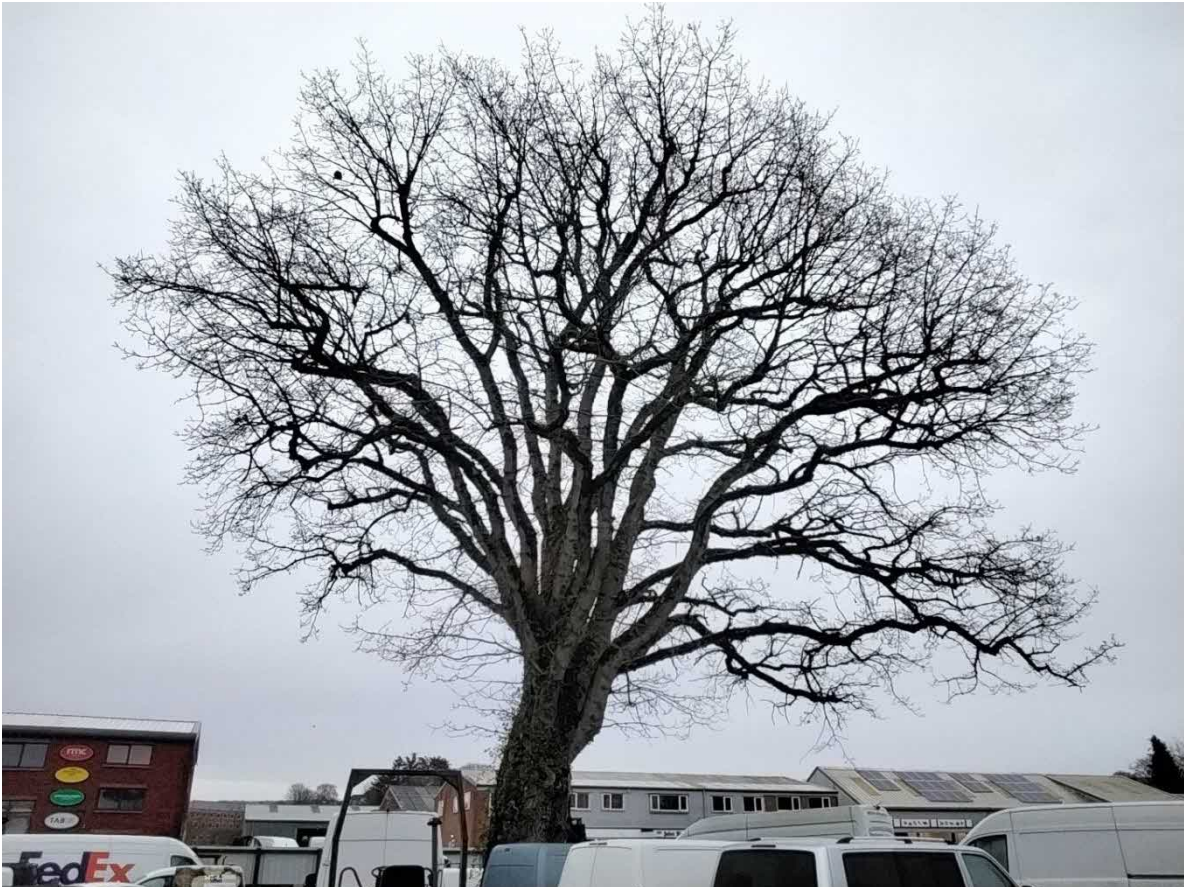
- 5.6 The southern aspect of the stem and basal area shows a visible and significant decay cavity, measuring approximately 1m across and to approximately 800mm above ground level. This cavity appears to have developed over many years, following likely mechanical damage at the buttress and lower stem. As is common in oak and due to the tree's weakest wall of defence being that which resists the vertical spread of decay, the cavity is expected to extend vertically beyond the visible openings. It is estimated that approximately 50-60% of the basal circumference of the tree is compromised via fungal decay and/or open cavity. Buttressing on the western side of the tree appears to be good, however *ganoderma* fungal fruiting bodies are present and the buttressing may not be adequate to compensate for overall strength loss in the future. A southerly lean bias of the tree compounds the risk of basal failure posed by the above factors, as both the tension and compression wood at the base of the tree appears to be structurally compromised; the tension side due to decay associated with wood decay fungi, and the compression side due to the large basal cavity – primarily on the western side of the stem. Evidence of compensatory reaction wood is present on the eastern side of the base/stem in addition to the aforementioned buttressing on the western aspect, however this is not confirmed to be adequate for structural support of the whole tree alone.
