# Verification Report

Client: Greene King

Emersons Green, Bristol

Report No: 938.04.01

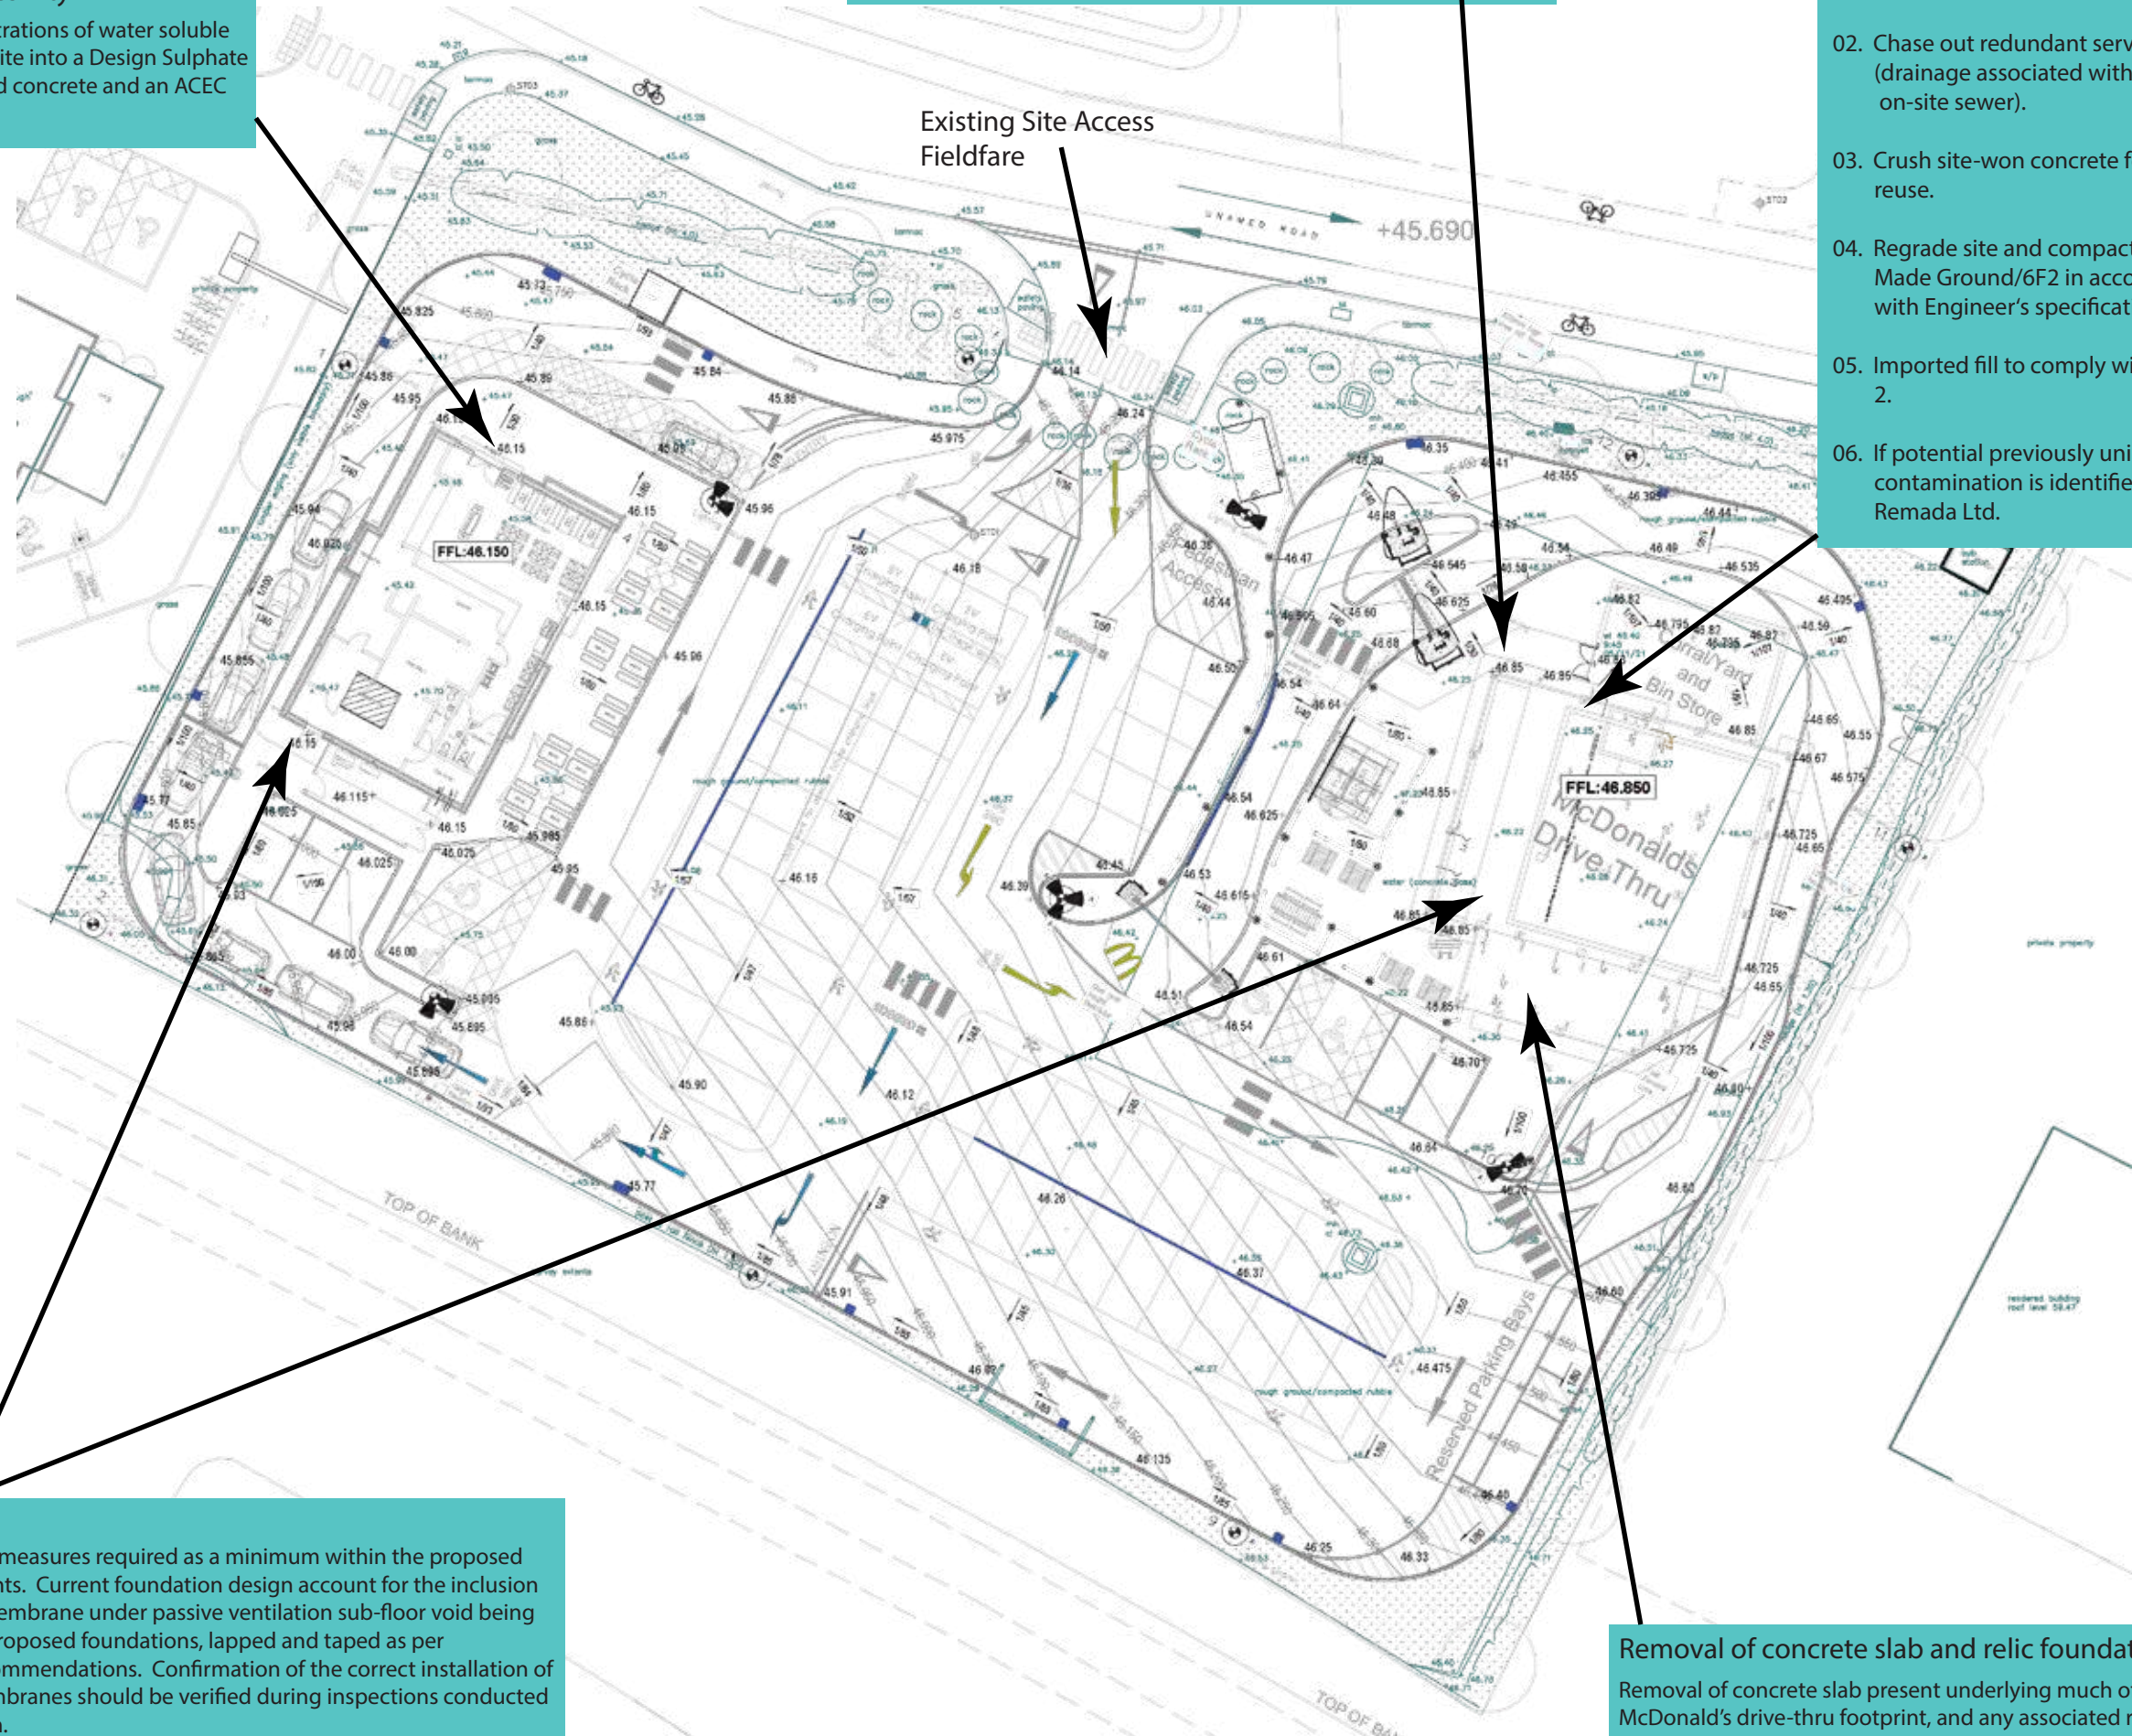
Drawing Title  
 Figure 1: Remediation Strategy Activities

**Concrete Aggressivity**  
 The pH and concentrations of water soluble sulphate place the site into a Design Sulphate Class DS-1 for buried concrete and an ACEC Class of AC-1s.

**Ground Gas**  
 CS2 gas protection measures required as a minimum within the proposed drive-thru restaurants. Current foundation design account for the inclusion of a gas resistant membrane under passive ventilation sub-floor void being installed over the proposed foundations, lapped and taped as per manufacturers' recommendations. Confirmation of the correct installation of gas protection membranes should be verified during inspections conducted during construction.

**Removal of concrete slab and relic foundations**  
 Removal of concrete slab present underlying much of the McDonald's drive-thru footprint, and any associated relic foundations. Removed material to be crushed, screened, and processed into 6F2 engineered fill designated for reuse on-site.

- General Requirements**
01. Break out concrete slab and any associated foundations.
  02. Chase out redundant services (drainage associated with on-site sewer).
  03. Crush site-won concrete for reuse.
  04. Regrade site and compact Made Ground/6F2 in accordance with Engineer's specification.
  05. Imported fill to comply with Table 2.
  06. If potential previously unidentified contamination is identified, consult Remada Ltd.

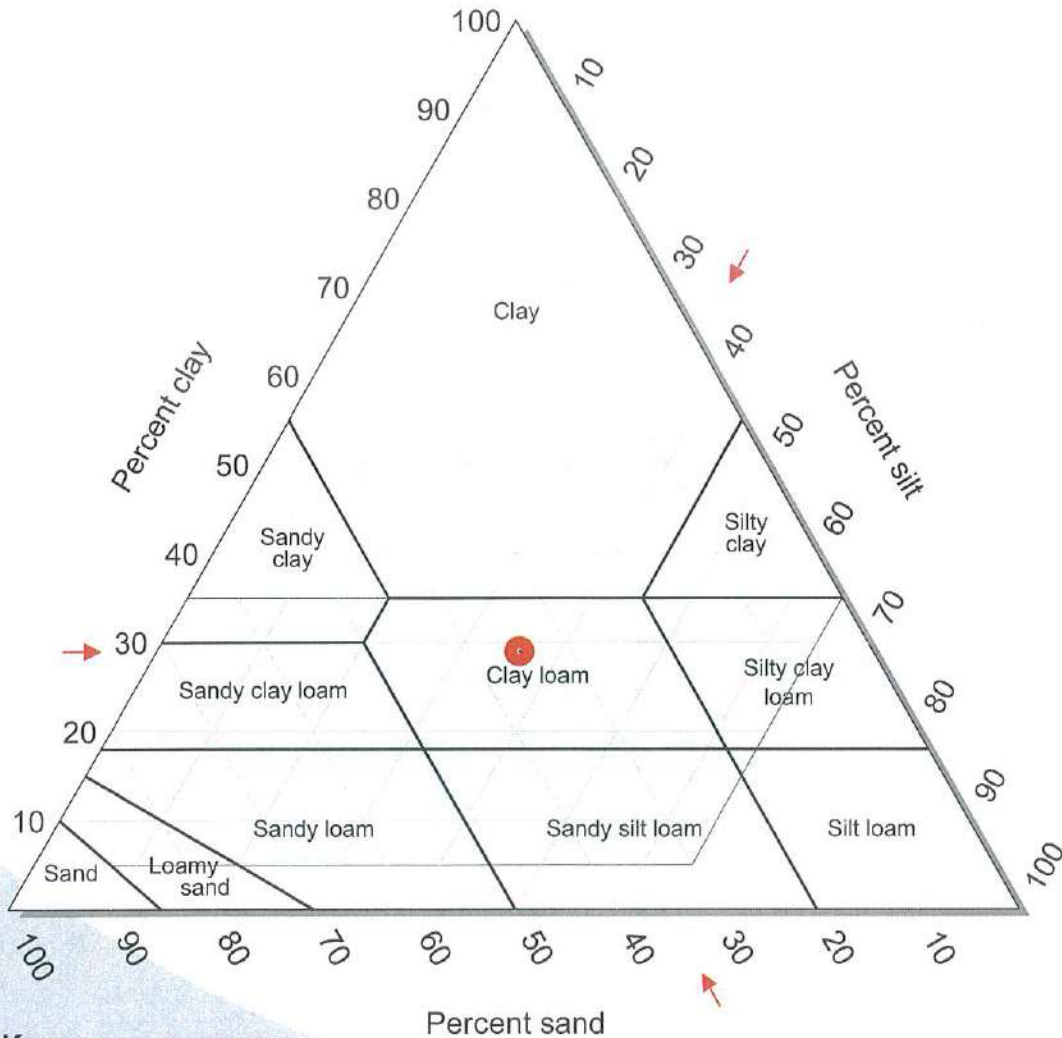
**Fig. 1. Textural Class: Clay Loam (compliant)**

Unit	Result	Multi-P	Compliant with range (Y/N)					
				Acid	Calc	Low-F Acid	Low-F Acid	Low-F Calc	
<b>Texture:</b>	Clay	% w/w	29						
	Silt	% w/w	36						
	Sand	% w/w	35						
	Textural Class		Clay Loam	Y	Y	Y	Y	Y	Y
				<i>See area of permitted soil textural classes in Fig. 1.</i>					
<b>Organic Matter:</b>		% w/w	7.5	Y	Y	Y	Y	Y	Y
<b>Coarse Fragment Content:</b>	>2 mm	% w/w	0.4	Y	Y	Y	Y	Y	Y
	>20 mm	% w/w	0.0	Y	Y	Y	Y	Y	Y
	>50 mm	% w/w	0.0	Y	Y	Y	Y	Y	Y
<b>Soil pH:</b>			6.8	Y	N	N	Y	N	N
<b>Carbonate:</b>		% w/w	1.2			Y			Y
<b>Available Plant Nutrients:</b>	Nitrogen	% w/w	0.430	Y	Y	Y			
	Phosphorus	mg/l	26.2 (3)*	Y	Y	Y	N	N	N
	Potassium	mg/l	149.1 (2-)*	Y	Y	Y			
	Magnesium	mg/l	165.8 (3)*	Y	Y	Y			
<b>Carbon:Nitrogen Ratio:</b>		:1	10.1	Y	Y	Y	Y	Y	Y
<b>Exchangeable Sodium Percentage:</b>		%	1.0						
<b>Phytotoxic Contaminants:</b>	Total Zinc	mg/kg	94.2	Y	Y	Y	Y	Y	Y
	Total Copper	mg/kg	21.2	Y	Y	Y	Y	Y	Y
	Total Nickel	mg/kg	22.8	Y	Y	Y	Y	Y	Y
