# Arboricultural Consultancy for Lloyds Bank

Insured	Mrs Iryna Kotsur	Address	21 Bargrove Close, London, SE20 8DU		
Client	Subsidence Management Services	Contact	Kyza Derby	Claim No.	IFS-LBG-SUB-20-0088174
ES Ref	SA-246851	Consultant	Giles Mercer	Contact No.	0330 380 1036
Report Date	06/11/2020

# GEOTECHNICAL

# ROOT IDENTIFICATION

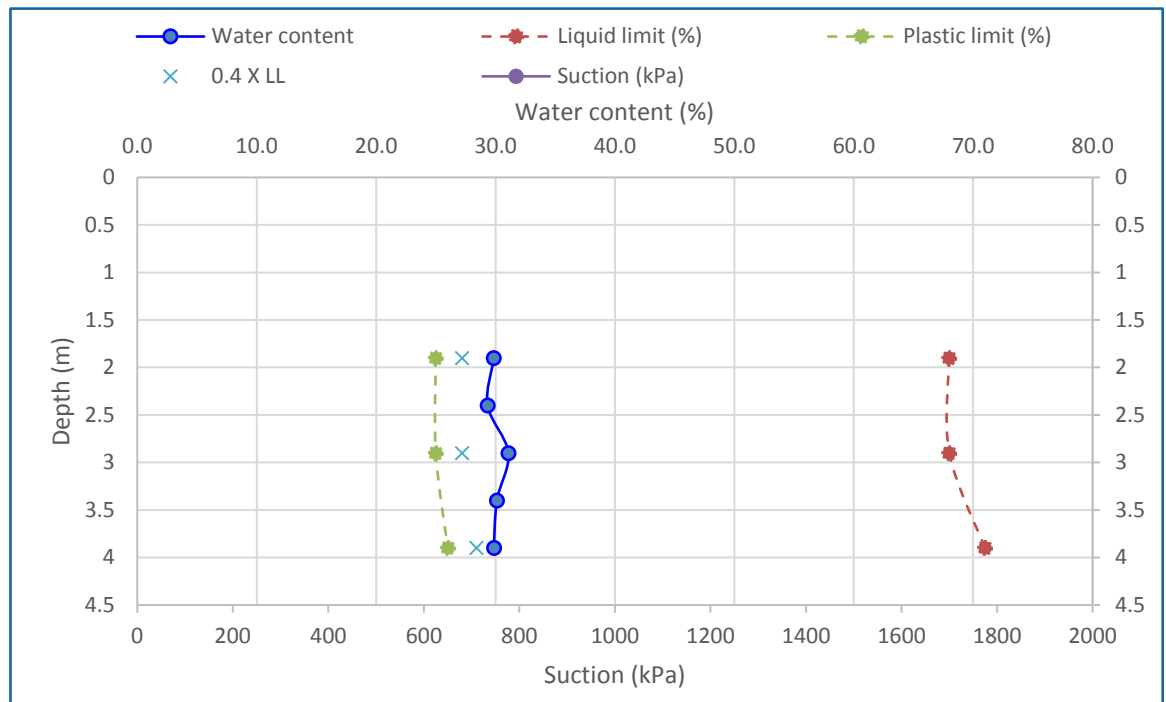
Lab Ref	Depth (m)	MC (%)	LL (%)	PL (%)	PI (%)	.425 mm(%)	mod. PI (%)	Av. Suc. (kPa)	Description
1	1.9	29.9	68	25	43	97	42		Soft to firm brown/orange-brown/grey veined CLAY with rare gravel and sand. Gravel is fine
2	2.4	29.3							Firm brown/orange-brown/grey veined CLAY with rare gravel and sand. Gravel is fine
3	2.9	31.1	68	25	43	95	41		Soft to firm brown/orange-brown/grey veined CLAY with rare gravel and sand. Gravel is fine
4	3.4	30.1							Firm brown/orange-brown/grey veined CLAY with rare gravel and sand. Gravel is fine
5	3.9	29.9	71	26	45	97	44		Firm brown/orange-brown/grey veined CLAY with rare gravel and sand. Gravel is fine
