Thompson
CONSULTANCY

Arboricultural Report: Tree Condition

Client: Whitehurst, Rebecca
Site: 23 Spring Hill Terrace
Leeds
Postcode: LS6 4EY
Date: October 2023
Prepared by: Mike Kiss BSc (Hons), Dip Arb L6 (ABC), Tech Cert (ArborA), MArborA
Checked by: David Robinson FdSc (Arb), Tech Cert (ArborA), MArborA

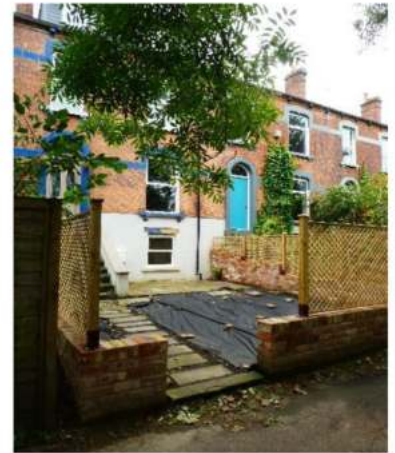
T2 Alder & T3 Ash

The eastern stem has an open cavity from ground level to approximately 1.5m, with visible hollowing to a depth of approximately 300mm. An adventitious root is present at the base of this stem, immediately below a slightly sunken strip between the buttresses. Probing into the ground at this location was met with little resistance, indicative of decay of roots on this side.

Sounding with a nylon mallet indicates extensive decay of the buttress to the north, the sunken strip to the east and of the eastern stem to a height of at least 2m.

The eastern stem has a moderate lean to the southeast, with a small, high crown, and is partially suppressed by the adjacent sycamore and ash. The first branch is at approximately 9m. Wounds below this are indicative of historic branch failure or pruning and are partially occluded with some visible decay. An opening at 5m to the north-northeast has smoothed edges and may be used by birds or mammals.

The western stem is subdominant and has a moderate lean to the west. Sounding of the western stem doesn't indicate audible decay, and the branch architecture of this stem suggests a younger life stage.

Throughout the crown, the foliage is moderately affected by pest damage. Some of the leaves show skeletal remains symptomatic of alder leaf beetle (*Agelastica alni*), and larger areas of damage symptomatic of alder sawfly (*Eriocampa ovata*). This pattern of damage is also present on other alder trees in the vicinity.

There is minor historic damage to west of main stem at ground level to a height of approximately 250mm. This appears to be superficial and is occluding well. Sounding with a nylon mallet doesn't indicate any audible decay of the lower main stem.

In my assessment, alder (T2) is currently in fair physiological condition and fair to poor structural condition.

There is extensive decay of the lower part of the dominant eastern stem and northern buttress. However, the crown of this stem is small relative to the stem diameter, and well sheltered. There appears to be low to negligible target values (occupation) within the area likely impacted in the event of failure. Although the pest damage to the foliage detracts a little from the aesthetics of the tree, it is unlikely to greatly stress the tree at current levels. However, repeated attack and loss of photosynthetic area may contribute to the future decline of the tree.

In my assessment, ash (T3) is currently in fair physiological condition and fair structural condition.
