Claim Information

Client Ageas (All Accounts) Claim Number 6516549G
Claim Type Subsidence Policy Number 8848688X
Policyholder Name [REDACTED]
Risk Address 83 YEW TREE COTTAGES, MIDGLEY, LUDDENDENFOOT, HALIFAX, WEST YORKSHIRE, HX2 6UG

Summary

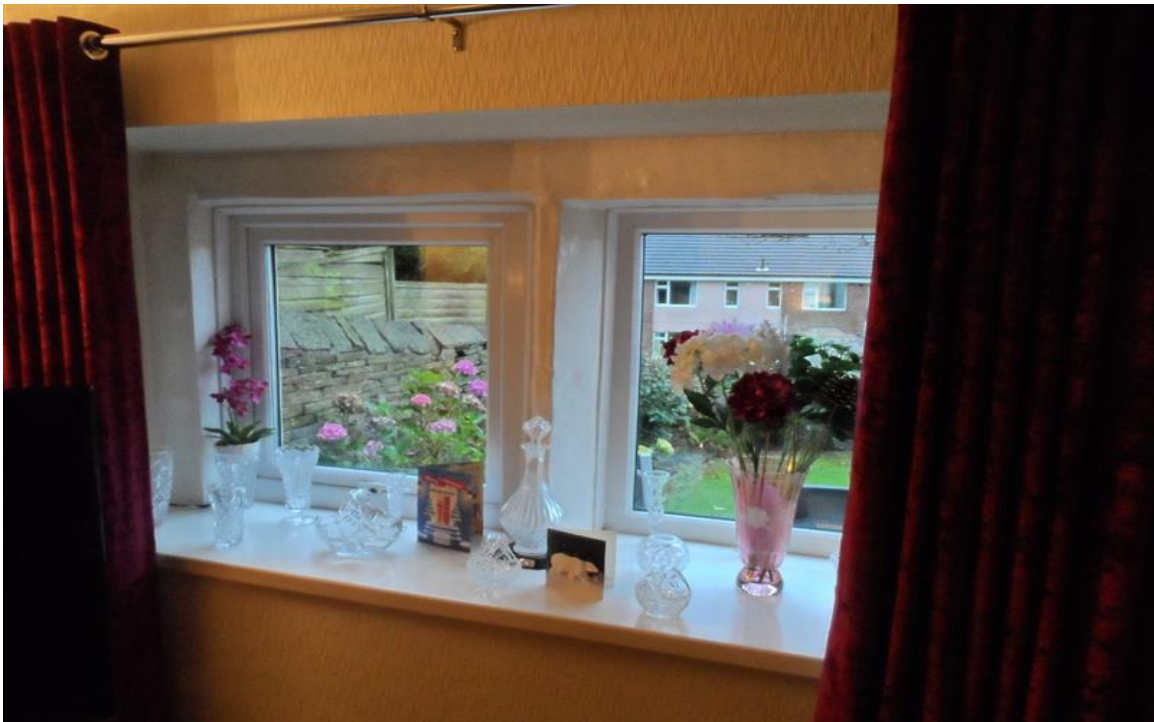
Living room 2

Damage Cause Description	In our opinion, taking into consideration the cracking to the gable wall and the rising of the asphalt floor to the living room, we believe that the tree to the front boundary may be an influence as to the external damage. We are advised that the Local Authority have had issues with roots in the road from the tree.
Peril	Subsidence
Damage Cause Type	Tree Roots
Recovery Opportunity	No
Claim Outcome	Valid
Validity Reason	We believe that the tree roots, the tree which is owned by the neighbour has damaged the foundation.
Party Structure Damage	No
BRE Damage Category	3- Crack widths of 5 to 15mm (or several of e.g. 3mm). Cracks that require some opening up.
Damage Details	The cracks runs down the stone work from the roof at the front of the side gable but is not mirrored internally. There is a large rise in the centre of the living room floor.

Damage to Main Dwelling	Yes
Internal Rooms	Front Living room - 4.5 x 5.0 x 2.3 The centre of the floor has a substantial rise in its surface although this is covered with carpet.
External Areas	Gable end - 8.7 wide x 4.8 high There is a vertical crack running down from roof level and takes in the side of the blocked up window.
