Geotechnical Survey Report

FSI Ref: 21735

Risk Address: 83 Yew Tree Cottages

Claim Ref: 6516549G

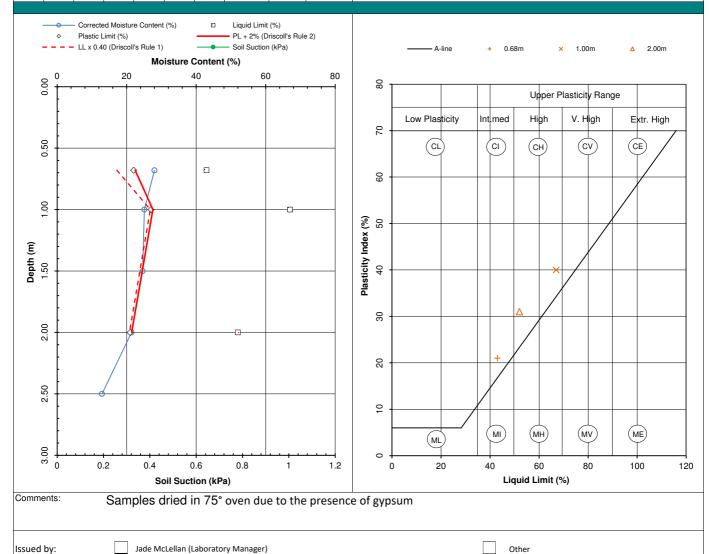
BORE	EHOLE 1
Depth	MC	Corr. MC	LL	PL	PI	Class	% Retained		Condition of test	Soil Description
(m)	(%)	(%)	(%)		(%)	0	(425µm)	ı) (kPa)		
0.68	28	28	43	22	21	CI	0		Natural	Brown sandy, silty CLAY containing grey mottle and gypsum
1.00	25.1	25.1	67	27	40	CH	0		Natural	Brown sandy, silty CLAY containing grey mottle and gypsum
1.50	24.6	24.6					0		Natural	Brown sandy, silty CLAY containing grey mottle and gypsum
2.00	20.7	21.42	52	21	31	CH	3.35		Natural	Brown sandy, silty CLAY containing grey mottle and gypsum
2.50	12.9	12.9					0		Natural	Brown sandy CLAY containing gypsum

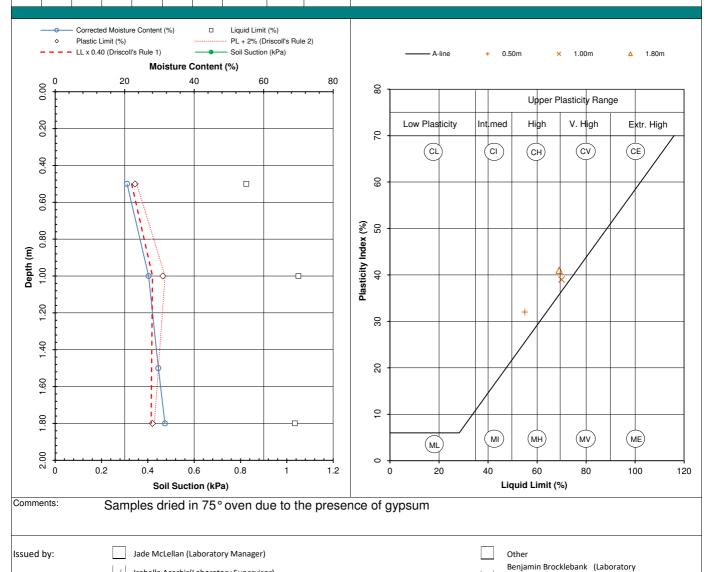
BORE	HOLE 2
Depth		Corr. MC	LL	PL	PI	Class	% Retained	Soil Suction	Condition of test	Soil Description
(m)	(%)	(%)	(%)	(%)	(%)		(425µm)	(kPa)		
0.50	20.7	20.7	55	23	32	CH	0			Brown sandy CLAY containing grey and orange mottle
1.00	26.9	26.9	70	31	39	CH/V	0			Brown sandy CLAY
1.50	29.7	29.7					0		Natural	Brown sandy, silty CLAY
1.80	31.6	31.6	69	28	41	CH	0		Natural	Brown sandy, silty CLAY containing grey mottle

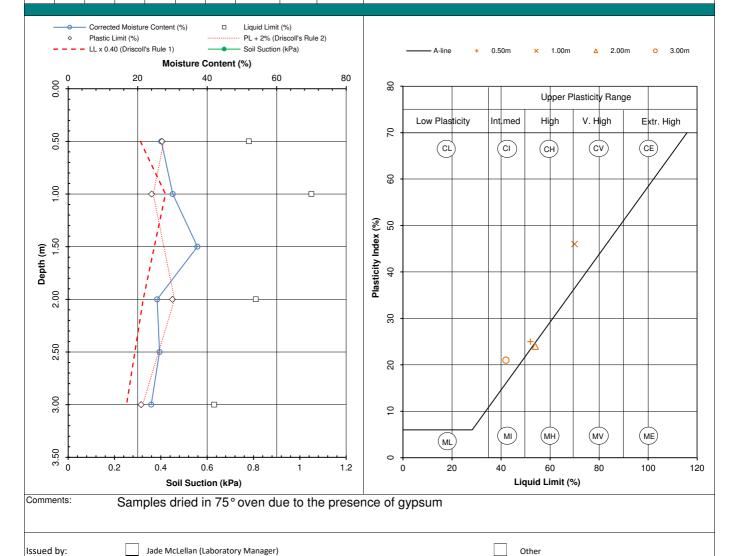
BORE	:HOLE 4
Depth	МС	Corr. MC	LL	PL	PI	Class	% Retained	Soil Suction	Condition of test	Soil Description
(m)	(%)	(%)	(%)	(%)	(%)	Ö	O (425μm)			·
0.50	26.8	26.8	52	27	25	CH	0		Natural	Brown sandy, silty CLAY containing grey and orange mottle
1.00	30.1	30.1	70	24	46	CH/V	0		Natural	Brown sandy, silty CLAY
1.50	37.2	37.2					0		Natural	Dark grey silty, sandy CLAY
2.00	25.6	25.6	54	30	24	MH	0		Natural	Dark grey silty, sandy CLAY
2.50	26.3	26.3					0		Natural	Brown silty, sandy CLAY
3.00	23.9	23.9	42	21	21	CI	0		Natural	Brown sandy, silty CLAY containing gypsum
