## PLOTS B, WINDRUSH INDUSTRIAL ESTATE

TREE SURVEY TO BS 5837:2012

**our ref:** 2343 / EH / TR001 **date:** 17<sup>th</sup> May 2023

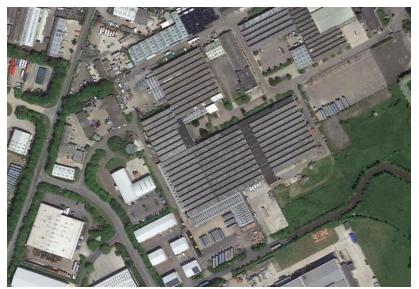
Figure 2. Aerial Photograph

- 2.2 The area surveyed is currently occupied by industrial buildings with associated service yard, access road and car parking (refer to Figure 02. Aerial Photograph below).
- 2.3 The topography of the site is generally level with gradual fall from North to South with localised level changes around the building including retaining walls and slopes.
