ASBESTOS SURVEY REPORT

MANAGEMENT SURVEY

**HARLECH COURT
BUTE TERRACE
CARDIFF
CF10 2FE**

Survey reference:	Report Issue		Lead surveyor	Authorised signatory
A397	01	10/04/18

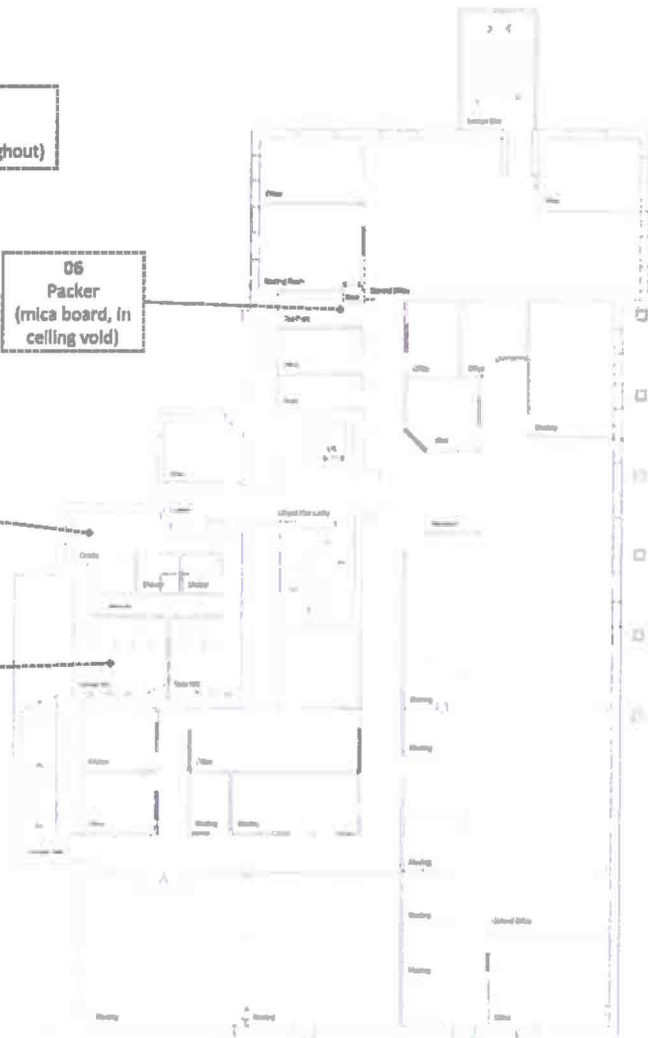
04
Beam coating

**Not
accessed**

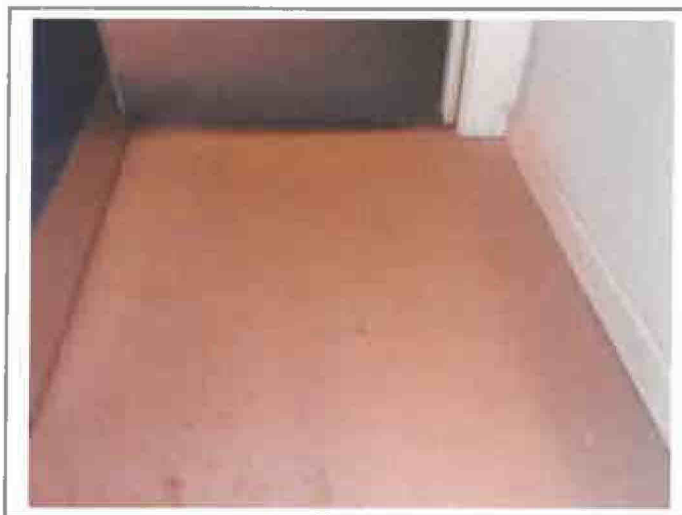
Suspect material:	Floor tiles
-------------------	-------------

Approximate extent:	-	Level of identification:	Strongly presumed
Accessibility:	-	Sample reference:	As 02

Material assessment		
Parameter	Score	Description
Product type:	-	Composite
Damage/deterioration:	-	-
Surface treatment:	-	-
Asbestos type:	-	No asbestos detected

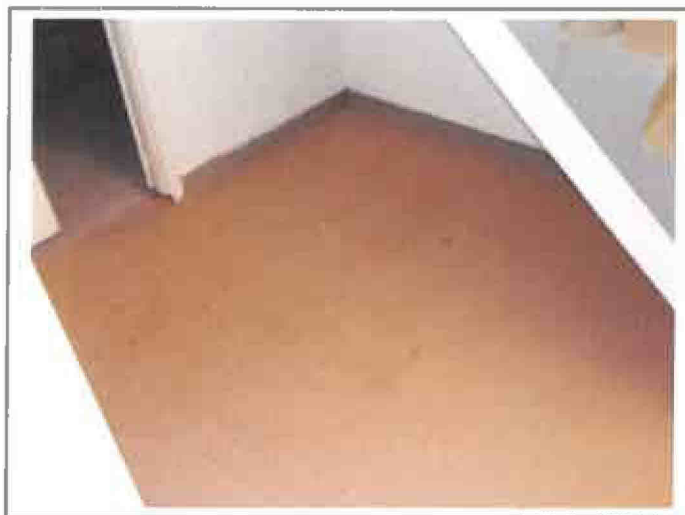
Suspect material:	Floor tiles
-------------------	-------------

Approximate extent:	-	Level of identification:	Strongly presumed
Accessibility:	-	Sample reference:	As 02

Material assessment		
Parameter	Score	Description
Product type:	-	Composite
Damage/deterioration:	-	-
Surface treatment:	-	-
Asbestos type:	-	No asbestos detected
Total:	-

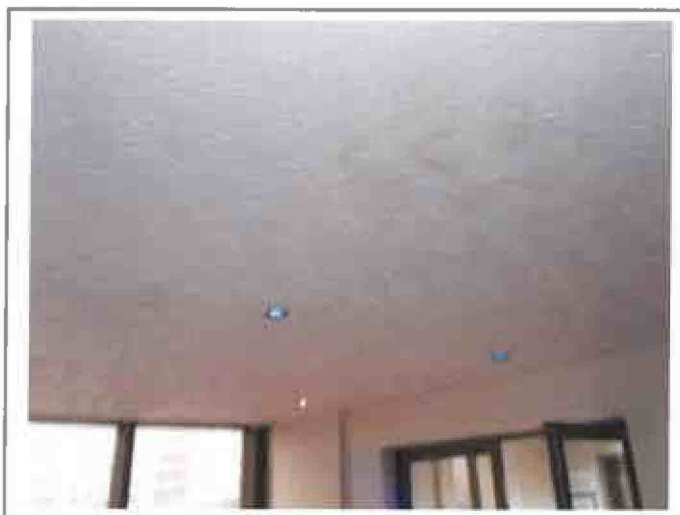
Suspect material:	Textured coating
-------------------	------------------

Approximate extent:	-	Level of Identification:	Sampled
Accessibility:	-	Sample reference:	03

Material assessment		
Parameter	Score	Description
Product type:	-	Composite
Damage/deterioration:	-	-
Surface treatment:	-	-
Asbestos type:	-	No asbestos detected

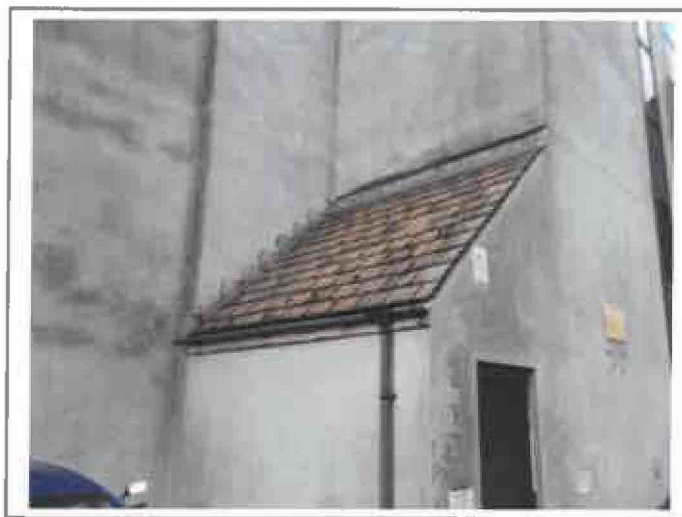
Suspect material:	Roof tiles
-------------------	------------

Approximate extent:	-	Level of identification:	Sampled
Accessibility:	-	Sample reference:	07

Material assessment		
Parameter	Score	Description
Product type:	-	Cement
Damage/deterioration:	-	-
Surface treatment:	-	-
Asbestos type:	-	No asbestos detected
Total:	-

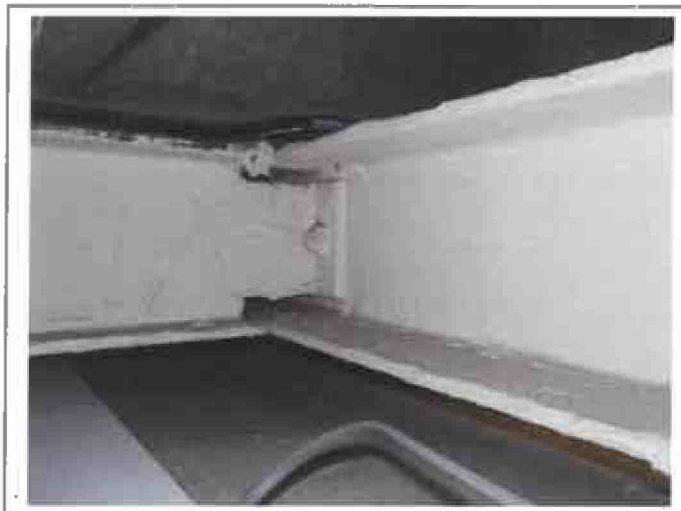
Suspect material:	Beam coating
-------------------	--------------

Approximate extent:	-	Level of Identification:	Sampled
Accessibility:	-	Sample reference:	04

Material assessment		
Parameter	Score	Description
Product type:	-	Composite
Damage/deterioration:	-	-
Surface treatment:	-	-
Asbestos type:	-	No asbestos detected
Total:	-
