CLIENT
OWNERS OF 74-76 HIGH ST,
DUNBAR

PROJECT
74-76 HIGH ST,
DUNBAR

DRAWING TITLE
EXISTING ELEVATIONS

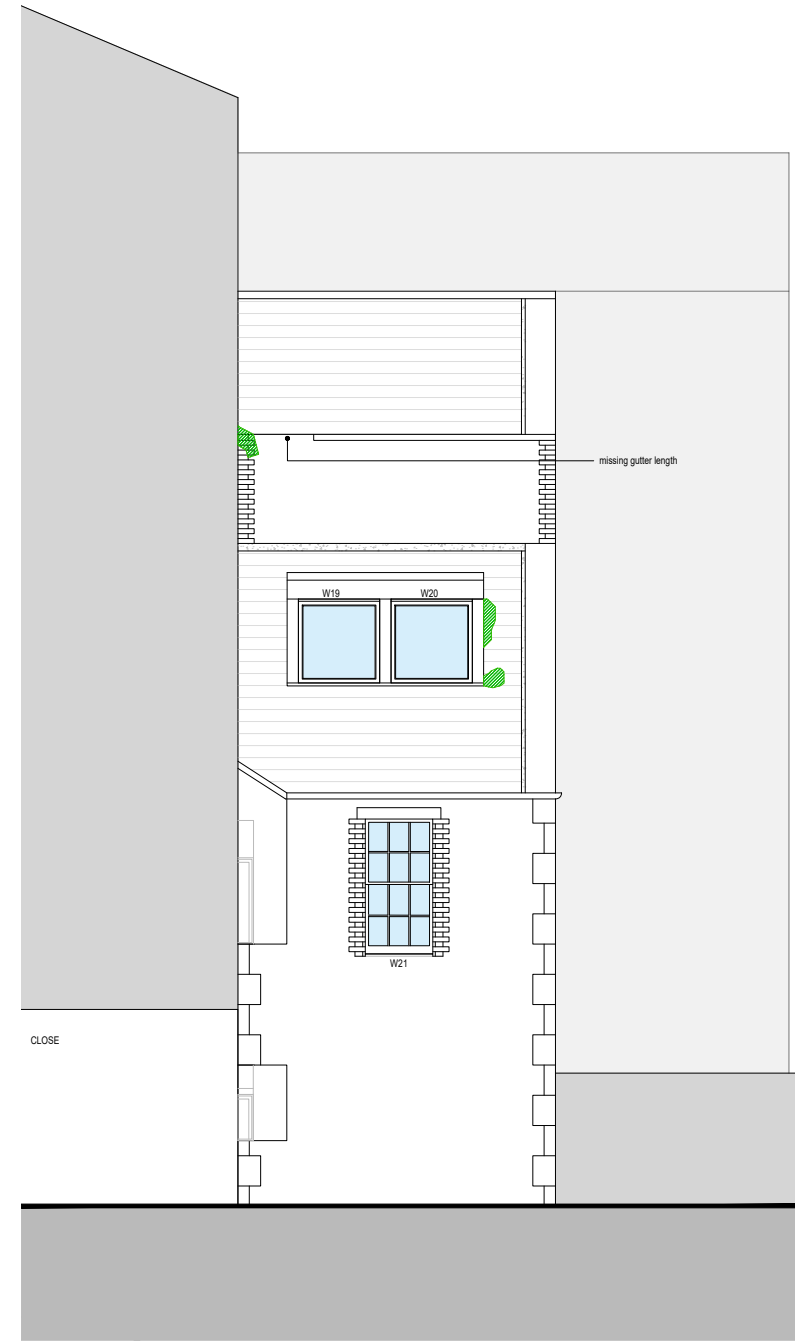
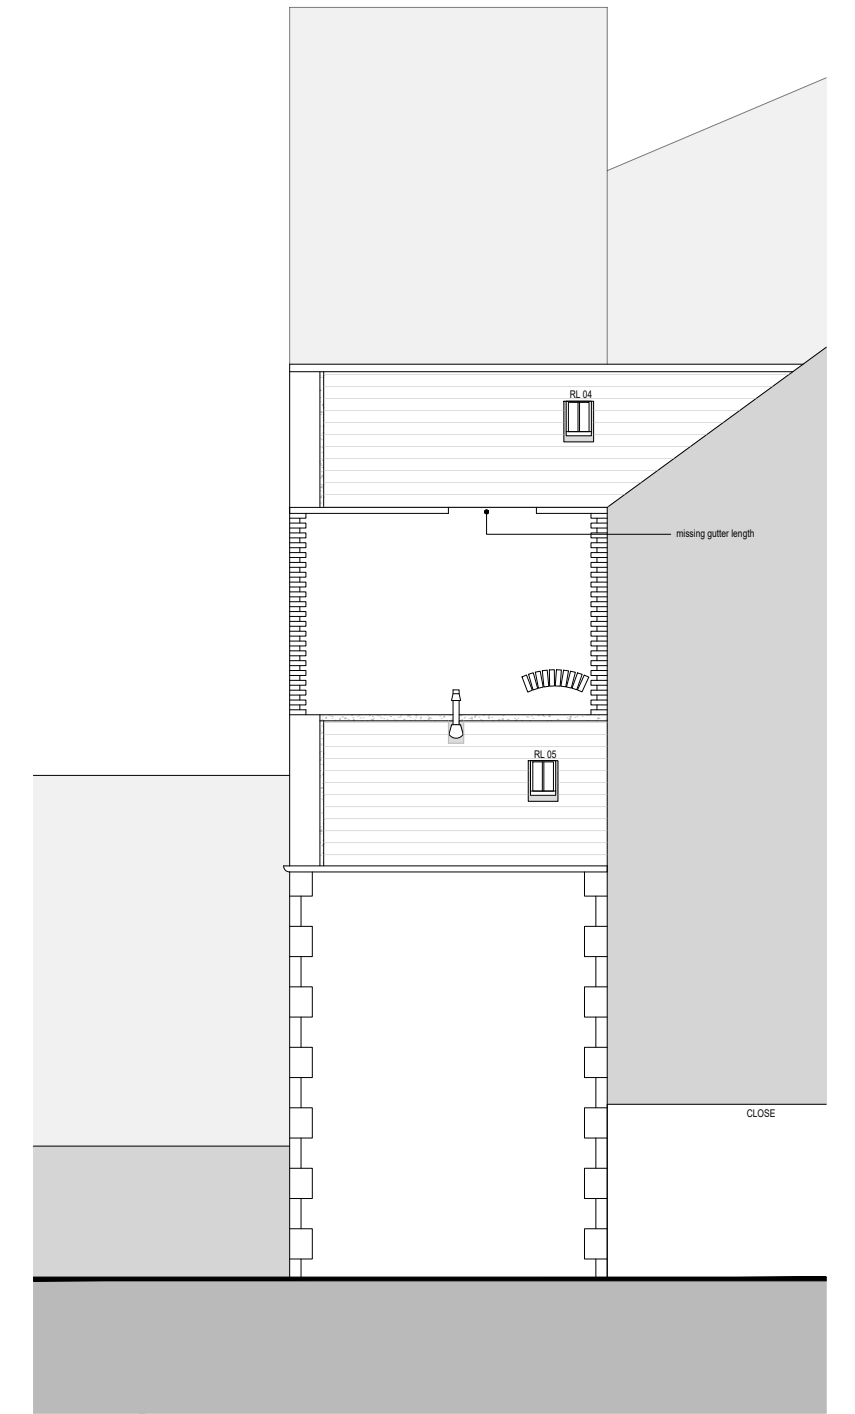
REAR SIDE ELEVATION

OVERALL REAR ELEVATION IS IN EXTREMELY POOR CONDITION WITH DELAMINATED STONEMWORK, LOOSE COPES, ROTTEN TIMBER WINDOWS AND EXPOSED ROTTEN TIMBER LINTOLS, MISSING AND CRACKED GLAZING, MISSING GUTTER RUNS, VEGETATION GROWTH, SLIPPED SLATES AND INADEQUATE CEMENT MORTAR REPAIRS. REFER TO PHOTO SHEETS FOR DETAILED EXISTING DEFECTS.
