**SUPPORTIVE STATEMENT**

To form part of a Planning & LBC Application

**74-76 High Street, Dunbar**

**APRIL 2024**

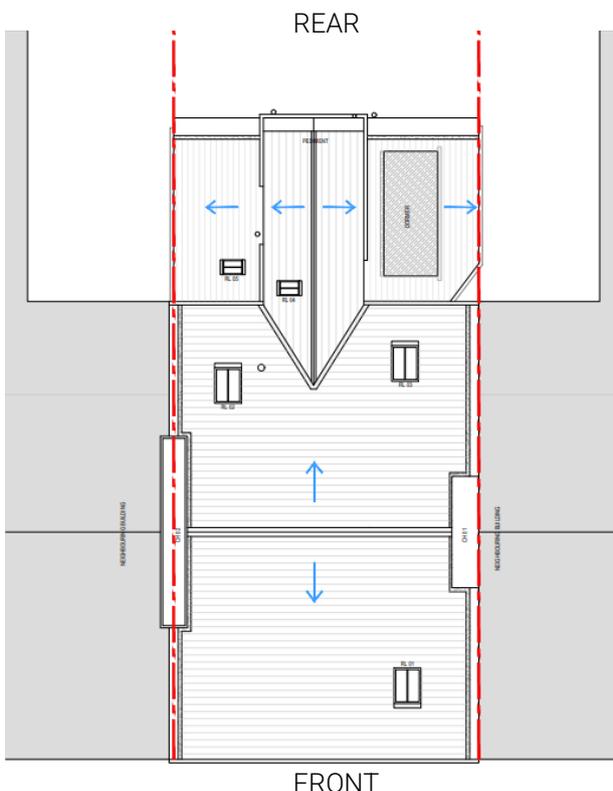
1.4 Existing Drawings:

The roof plan, shown to the left, shows the building as a main T-shape with lower roofs to either side of the rear pediment, with 1no mutual chimney (Chimney no.02) shared with 74 High Street and a dwarf chimney (Chimney no.01) sitting within its own right within the curtilage of no 76.

Although relatively small in size the roof has been a constant source of problems due to its deteriorated condition, in turn its ridge tiles, slates, guttering and defective skewes (the main junctions of the roof) are all in an extremely poor condition and this now must be addressed as a matter of urgency.

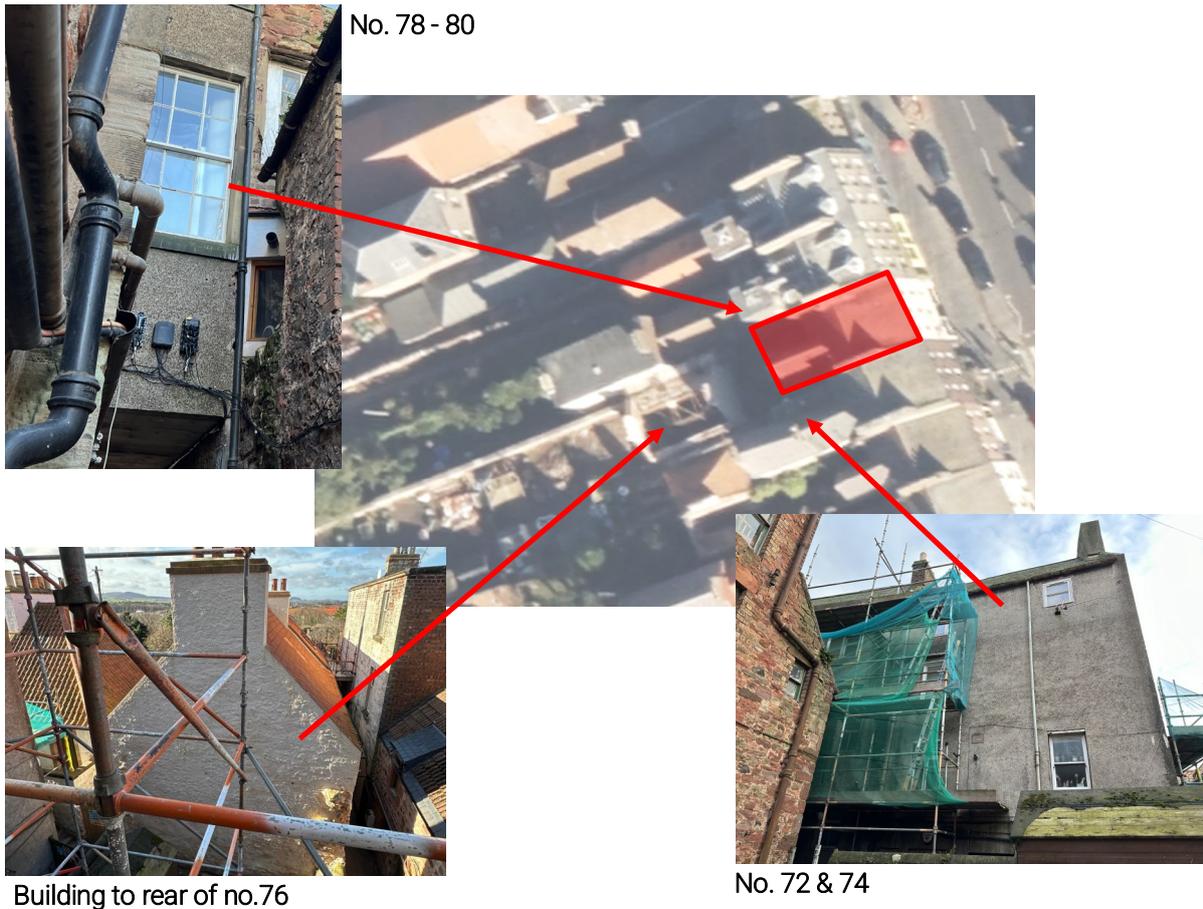
As noted above there are neighbouring buildings that have been rendered. Both buildings either side of the site (no. 72 - 74 and no.78 - 80) are category 'B' listed and have been rendered to their rear elevations. Additionally the building directly behind the site has been recently rendered.

It is hoped that a view of practicality be considered with the proposed rendering to the rear elevation. Having carried out a detailed conditional assessment of the rear elevation (a rear scaffolding was erected to assess its condition in detail) it is noted that the rear elevation is in such a bad condition that the rooms sitting against this are becoming uninhabitable. The cost of repairing this on a like for like basis (noting there has been significant inappropriate repairs carried out already) would be in excess of £500K which is not feasible taking into account the other repairs that are also required. It is felt that as this elevation is located to the rear off the Main Street and is surrounded now with rendered properties that an appropriate lime based render coating would provide the following benefits:
