Design & Heritage Statement (incl. Statement of Significance)

Replacement Windows,
Replacement Mechanical Extract Ventilation (toilets and kitchen),
and Proposed Through Wall Vents to Below Floor Void.

Sidmouth YMCA, Mill Street, Sidmouth, EX10 8DF

Revised 22 April 2024

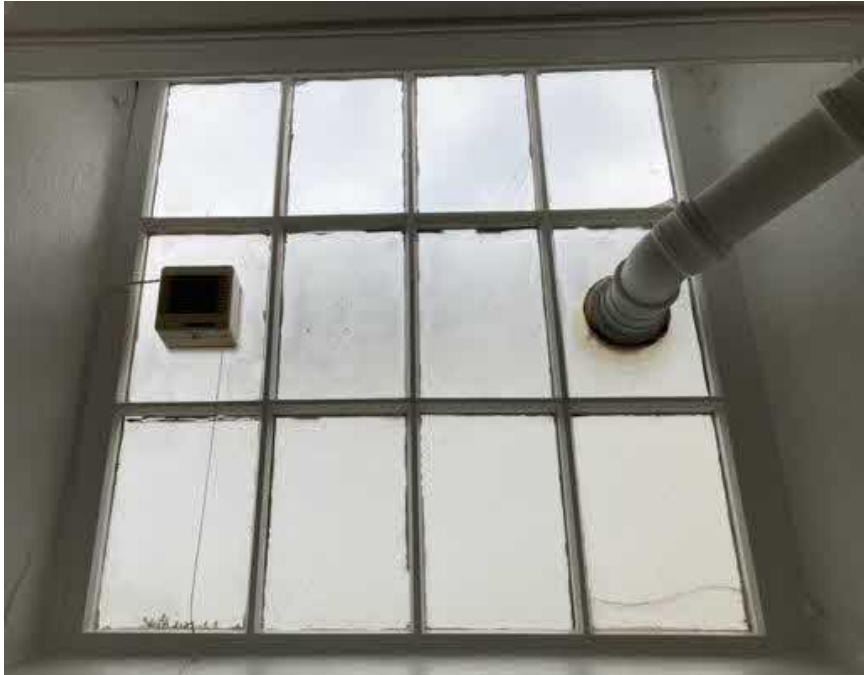
Fig 4 - Window W.2. - Inside View.

Existing windows W.1, W.2 and W.3 all have modern mechanical extract vents set into the windows, and which are unsightly and cause loss of light.

5.3.0 Windows W.2. / W.7. and W.3. / W.8. have been repaired and adapted over time, with replacement casements. What appears to be original frames with internal bead detail can be seen in places, although now in poor condition. The internal moulding to casements consist a plain chamfer and nothing more. There are significant signs of replacement / repairs undertaken over time, refer to figs 13 and 14 which show casements at first floor level not aligning with the half round windows at the top. Many of the repairs / replacement sections appear to have been undertaken by persons with little carpentry or joinery ability. A site visit would be helpful to see and understand this in more detail. One would assume that the main windows on the South and East elevations would have originally been the same. What we see today for windows W.2. and W.3 are four panes wide and three panes high (same for W.4, W.5 and W.6), however referring to fig 17 (see also 5.5.0 below) we see that in 1993 window W.5. was four panes wide and four panes high. Section 5.1 of 'HETW' discusses '*Replacing a traditional window that is beyond repair and all the details of which are known*', however for the main windows on the South and East elevations, we don't have complete windows with known details to replicate. We don't consider any of the casements in windows W.2, W.3, W.7 and W.8 are original.

4.2.1 It is proposed to replace the existing windows with new bespoke joinery as shown on drawings 1271/24/15 and /16.
